*Published in:*  
Nuclear Materials and Energy

## Study of cracking and microstructure in Co-free valve seat hardfacing

This study is based on the investigations of one cracked NPP swing check valve plug. This work aims to investigate the potential cause of the through-the-thickness cracking of the hardfacing deposit made from

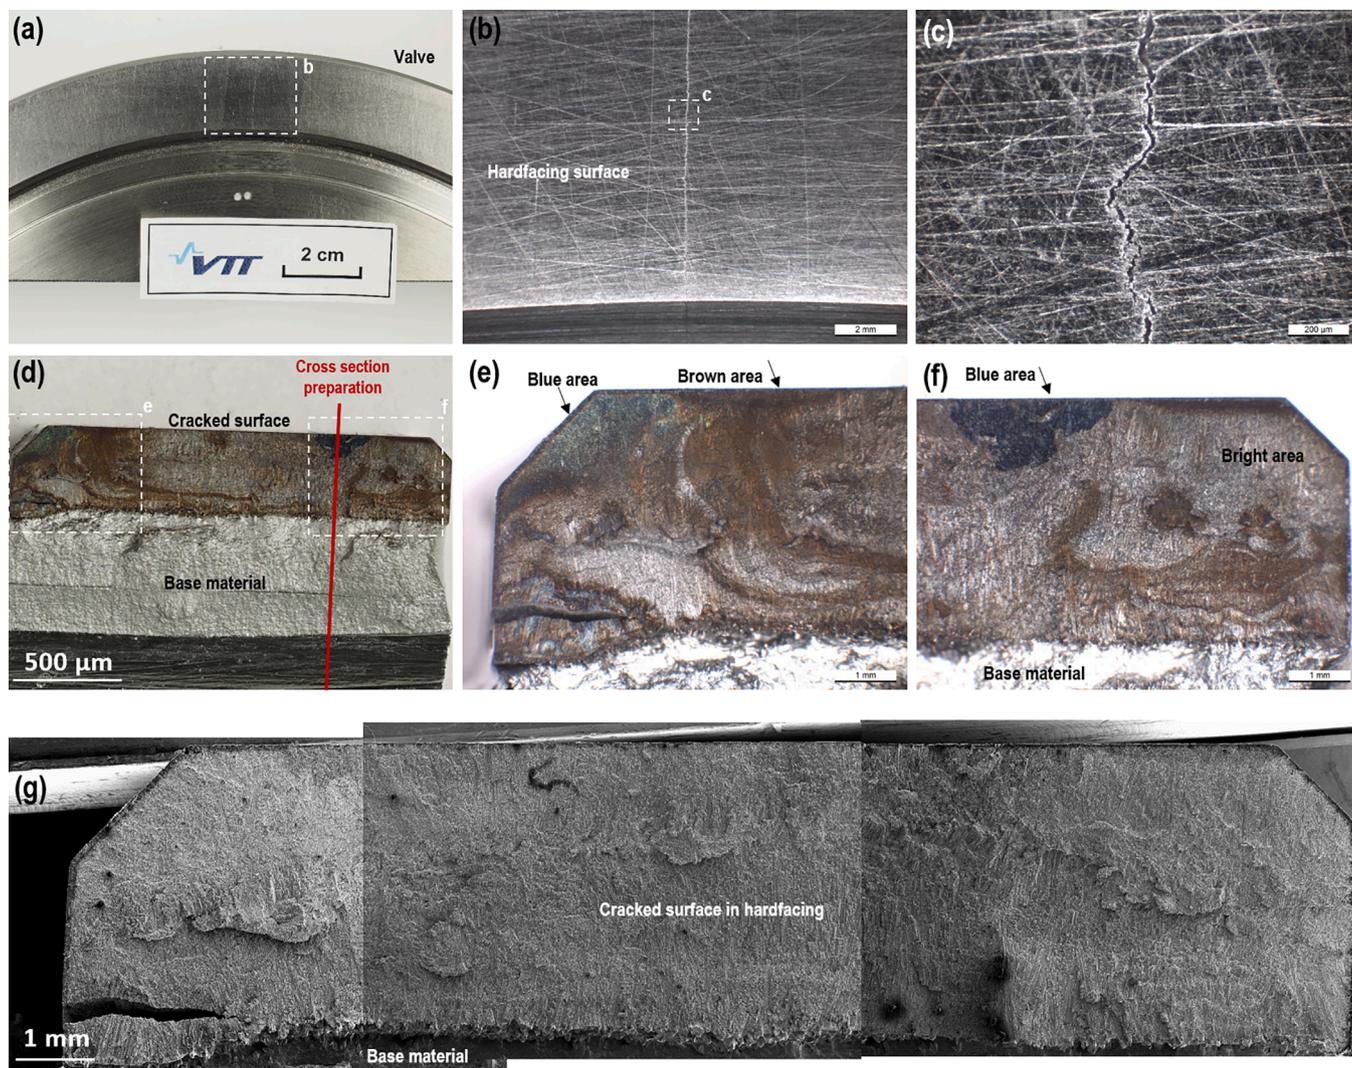
**Fig. 1.** (a) Photograph showing the appearance of the valve piece in as-received condition. (b-c) Stereomicroscope images of the crack in the hardfacing, depicted from the upper surface of the valve. The crack is straight and axial (radial). (d-f) Optical images showing the fracture surface of the cracked hardfacing. The hardfacing is in the upper part of the picture. The crack covers the whole hardfacing, and the part with metallic appearance is the stainless steel base material, formed during the opening of the crack. Blue, brown and metallic bright areas were seen in the hardfacing. (g) Overview of the cracked NOREM 02 hardfacing surface under SEM.

A valve with sealing surface made from NOREM O2 hardfacing and valve body base material from austenitic stainless steel 316L, contained a crack over the whole width of the hardfacing (about 22 mm), as seen in the Fig. 1(a). The straight and axial (radial) crack has propagated through the full thickness of the hardfacing deposit (Fig. 1(b–c)). Cracks were limited to the NOREM O2 hardfacing layer (Fig. 1(d)) and did not propagate into the stainless steel base metal, which has a more ductile behaviour and a higher ductility than the NOREM O2 hardfacing material. Since such cracks were not detected during the dye penetrant testing performed by the manufacturer, they were not supposed to be present after short service time either.

The fracture surface is seen in the Fig. 1(d). Fracture surface in different colours (blue, brown and bright areas) were observed, as shown in Fig. 1(e–f). Two blue areas were clearly separated from the rest of the brownish fracture surface and they were in direct contact with the outer surface. The brown coloured areas covers the majority of the fracture surface until the fusion boundary between the hardfacing and the base material. Additionally, a radial crack of 2–3 mm detaching the weld and base material along the fusion boundary was found (lower left part in Fig. 1(e,g)).

The blue areas, which have a clear border to the rest of the brownish fracture surface, resembles that of tempering colours, mainly due to chromium oxides. Based on this, it seems most likely, that the blue areas have encountered high temperatures (*i.e.*, higher than during plant operation) and oxygen in the environment. Therefore, it seems likely that these blue areas have formed during the manufacturing of the hardfacing, either during welding or cooling of the weld, or during the stabilisation heat treatment. The brown colour forms curved patterns, with the imaginary centre being on the sealing surface. That indicates that these brown areas have also been in contact with an oxygen-containing atmosphere. It is probable that these brown areas had

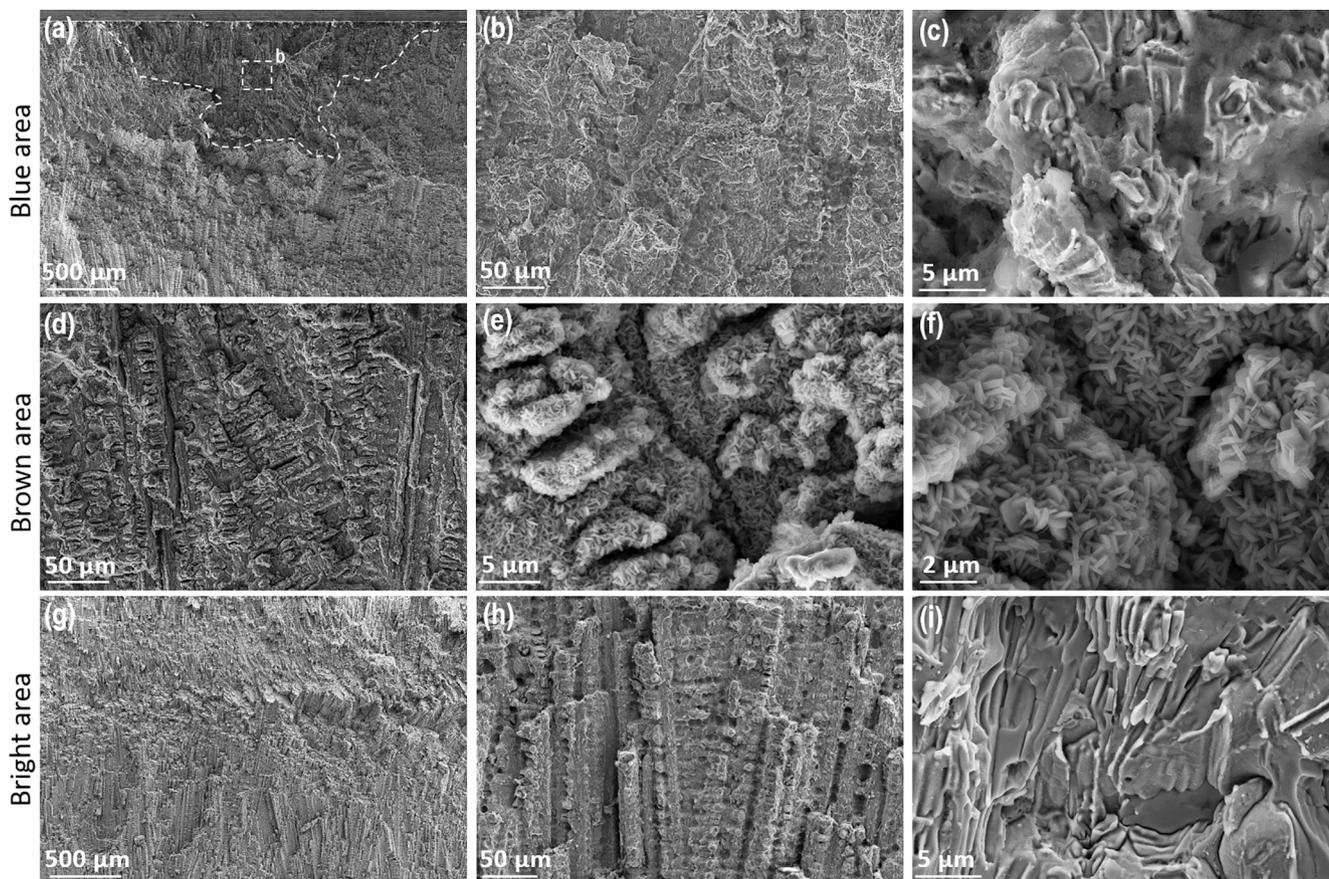
Fig. 2. (a-c) SEM-SE images showing the area, which appears as blue area in the optical photograph of the fracture surface. Thick and discontinuous oxide layer was observed on the blue area of fracture surface. (d-f) SEM images of the brown area of the fracture surface. The fracture surface is dendritic. A large amount of sub-micron needle- and flake-like oxide particles, covering the fracture surface almost completely in the brown area. (g-i) SEM images of the metallic bright area of the fracture surface. Pure brittle features along the dendritic microstructure were observed.

The SEM investigations in Fig. 2 revealed that the general fracture surface has a brittle dendritic appearance. The fracture surface of the blue area (Fig. 2(a-c)) does not differ substantially from the overall surrounding area, other than by having denser oxide on the fracture surface. The surface is covered by a solid but discontinuous oxide layer (Fig. 2(c)). The brown area has a similar surface appearance in SEM as the other areas, concerning the dendritic morphology of the fracture surface and the overall appearance (Fig. 2(d-f)). However, at a larger magnification it clearly shows a different appearing oxide structure with distinctly formed oxide needles (Fig. 2(f)). No significant signs of weld defects, such as hot cracks, were observed in the blue or brown areas on the fracture surface, which could be due to the covering of the fine details by the oxide structure. EDX reveals a higher oxygen content in blue area than in the brown area and the Fe/Cr ratios are 1.5 and 4.5 in the blue and brown areas, respectively, indicating a different compositions of the oxides covering the surfaces. The bright areas exhibits a dendritic

solidification structure without oxide layer (Fig. 2(g-i)).

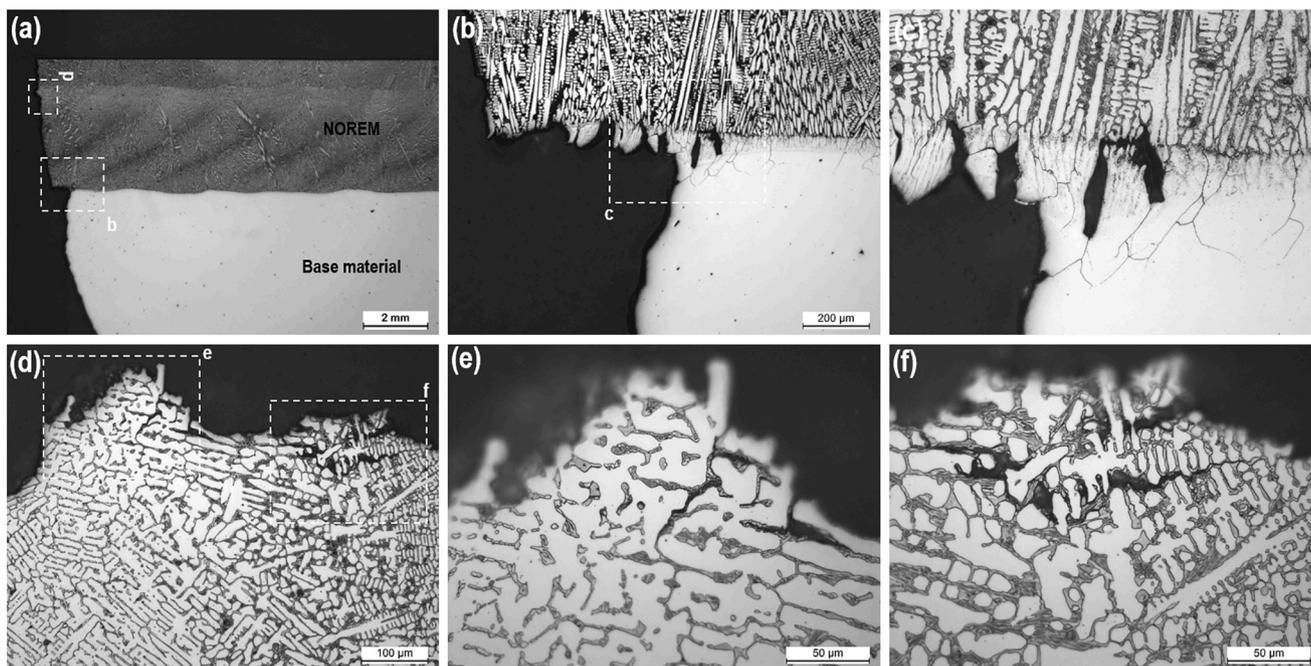
Fig. 3. (a-f) Optical micrograph of the cross-section in etched condition. (a) The weld beads seem to be about 1 mm thick in the main part of the hardfacing. The top layer has been welded separately. (b) On this side of the opened piece, the stainless steel is missing from about 0.6 mm long portion of the cross-section next to the crack. (e-f) Cracking occurs along the carbide structure.

Based on the visual inspection of the broken half, the depth of the crack along the fusion line varies slightly along the hardfacing width. A cross-section was prepared from the location with a blue area next to the outer surface of the hardfacing (cutting location shown in Fig. 1(d)). The cross-section was investigated using a light optical microscope in etched condition and by SEM in fine-polished condition. The thickness of the coating varies between 3.9 and 4.1 mm (Fig. 3(a)). As revealed in Fig. 3 (a), the weld beads are about 1 mm thick in the bottom part of the hardfacing and have been welded along the circumference of the valve seat. The top layer(s) of the hardfacing is about 0.7 mm thick, and has been welded on top of the bottom layers. A 0.6 mm long portion along the fusion line of the stainless steel valve body material is missing next to the main crack, which was due to the crack growth along the fusion line of the hardfacing. The cracking did not extend into the valve body material (Fig. 3(b-c)). The microstructure at the interface between the top and bottom hardfacing beads is shown in Fig. 3(d). The microstructure of the top layer of the hardfacing is finer, *i.e.*, the dendrites are smaller in the top layer bead (Fig. 3(f)) compared to the bottom beads (Fig. 3(e)). Furthermore, there appears to be more continuous carbides in the top layer based on the macroscopic appearance. It is worth

mentioning that the blue area was found in the top bead layer. Interdendritic (ID) cracking occurs along the carbide structure (Fig. 3(e-f)).

As shown in Fig. 3 and Fig. 7, the cracking occurs along the ID carbide structure where the hard and brittle carbide structure is continuous (the blue area in the top layer) and where the dendrite packages were more perpendicular to the main stresses. The hardfacing matrix has a

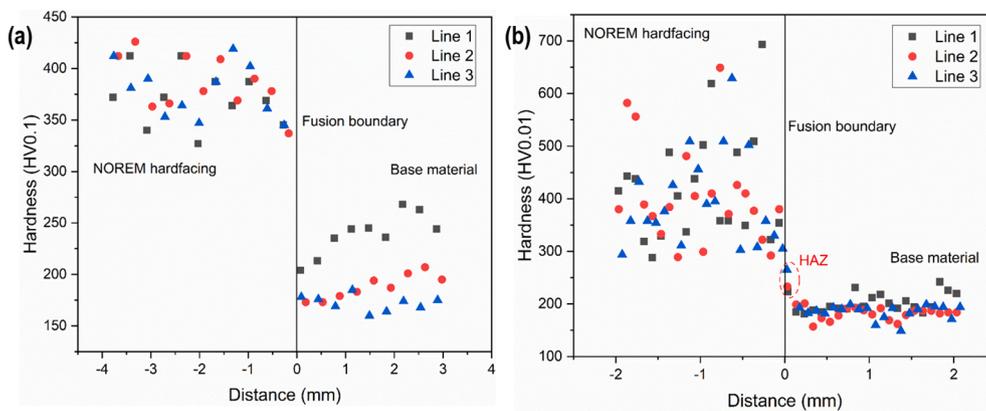
Fig. 4. (a) HV0.1 Line 1 - Line 3 and (b) HV0.01 Line 1 - Line 3 across the fusion boundary between the NOREM 02 hardfacing and base material.

The microhardness measurements data and the corresponding SE images of HV0.1 and HV0.01 across the NOREM 02 hardfacing-base material fusion boundary are shown in Fig. 4 and Fig. 5, respectively. As shown in Fig. 5(c-d), the NOREM 02 hardfacing has a dendritic microstructure while the base material 316L has a typical austenitic microstructure with equiaxed grains. The HV0.1 indents exhibit a more uniform microhardness in the NOREM 02 hardfacing part compared to HV0.01. This is due to that a smaller indent size of HV0.01 can hit either the ID carbides or the interior of the matrix in the fine dendritic microstructure of the hardfacing. When measuring the microhardness of base materials 316L, HV0.1 indents exhibit a higher scatter compared to HV0.01, which is because of that the majority of HV0.01 indents are within the austenitic grain interior while the HV0.1 has a bigger indent size and thus higher chance of hitting grain boundaries (GBs). Both HV0.1 and HV0.01 show the significant hardness difference across the fusion line (twice the average microhardness in hardfacing than the base material). Furthermore, microhardness of heat-affected zone (HAZ) of base material 316L was revealed in the Fig. 4(b) with a smaller indentation spacing of HV0.01 than HV0.1.

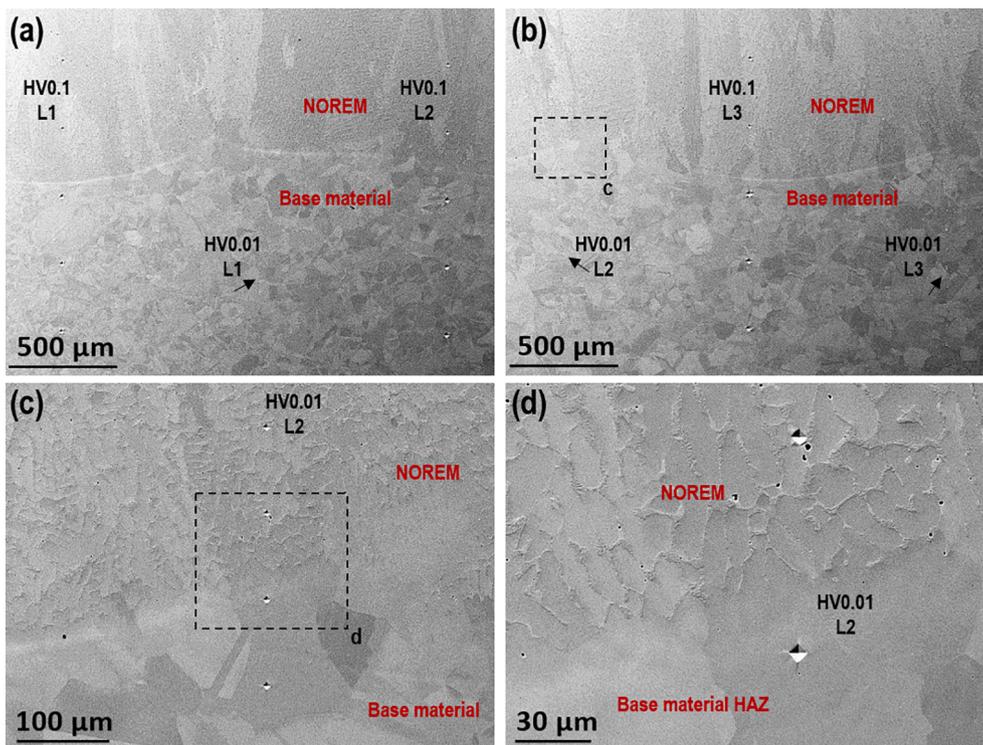
Fig. 5. (a-d) SE images showing the HV0.1 L1-L3 and HV0.01 L1-L3 across the fusion boundary between the NOREM 02 hardfacing and 316L base material. The HV0.01 has a smaller indent spacing and smaller indent size compared to the HV0.1.

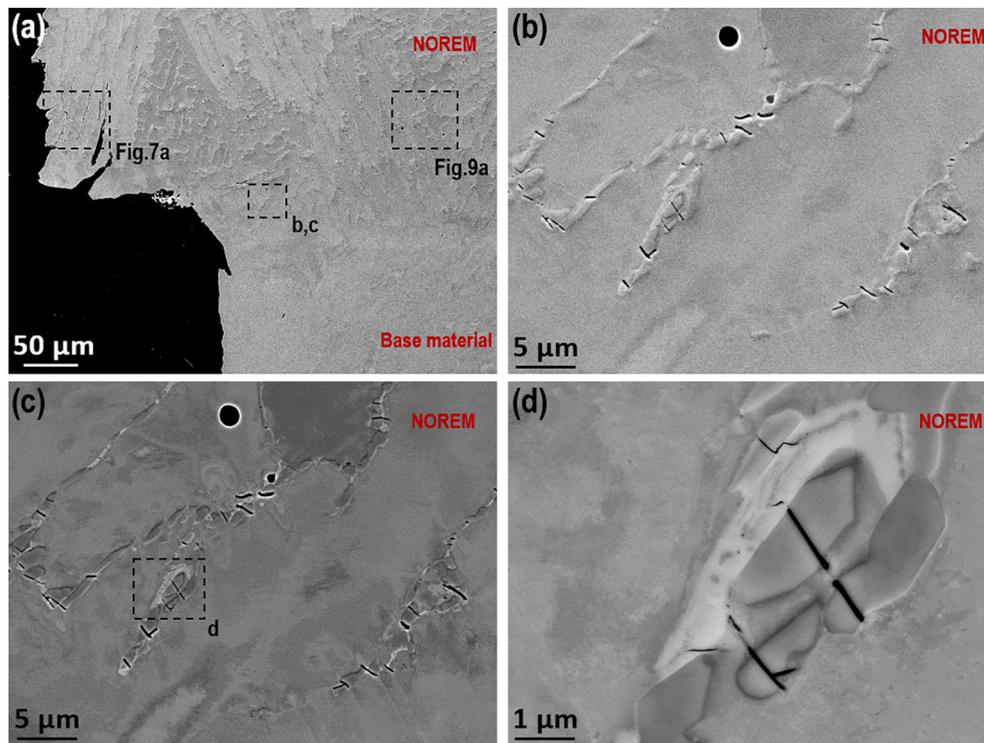
**Fig. 6.** (a–b) SE images and (c–d) BSE images of cracked carbides in the NOREM O2 hardfacing at locations close to the main cracked surface and fusion boundary between the hardfacing and the base material.

Detailed characterizations were performed for the locations next to the main crack and close to the fusion line, where the crack growth along the fusion line of the hardfacing was observed (Fig. 6(a)). As shown in Fig. 6(b-d), SE images and BSE images revealed the cracked ID carbides in the NOREM 02 hardfacing. This indicates that the ID carbides are more brittle and have lower resistance to cracking when subject to external loading compared to the hardfacing matrix. In the studied component, no *trans*-dendritic cracking was observed in the crack path in the hardfacing material. In Fig. 7, low kV SE images and high kV BSE images of the same areas from Fig. 6(a) showed that the ID cracking was associated with the cracked carbides in the NOREM 02 hardfacing. The cracks propagated and grew along the interface between the matrix and the cracked carbide and merged. The cracks propagated preferentially along the areas where the carbide structure is continuous, and some cracks seem to be arrested in locations of discontinuous carbide structure. Furthermore, the crack growth direction was parallel to the dendrite growth direction and the dendrite packages that were

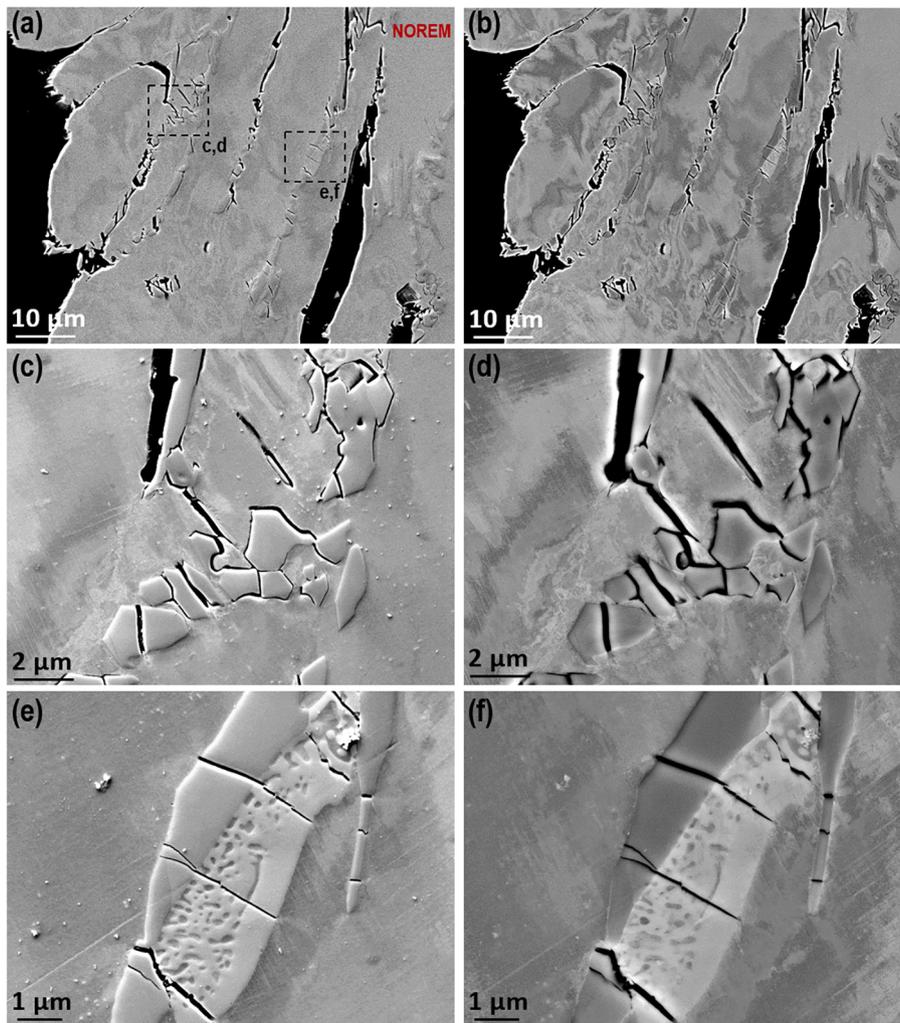
**Fig. 7.** (a,c,e) low kV SE images and (b,d,f) BSE images of the same areas with cracked carbides in the NOREM O2 hardfacing. The area investigated was from Fig. 6 (a). The cracking followed the ID network of cracked carbides in the NOREM O2 hardfacing.

perpendicular to the main stresses were found to be the most susceptible to cracking. Both eutectic and non-eutectic carbides in the ID networks were observed, as shown in Fig. 7(e-f). The eutectic part reveals large amounts of 150–300 nm carbide particles. The carbides in Fig. 7(e) were further investigated by EDX mappings in Fig. 8. The micron size eutectic carbide phase is mainly formed by Mo-Si rich precipitates and decorated with a large amount of nanometre size (Fe, Ni) carbides. The pre-deposited non-eutectic carbides are (Cr, V) carbides. In Fig. 9, low kV SE images and BSE images of the area from Fig. 6(a) close to the HAZ of the NOREM 02 hardfacing-base material fusion boundary revealed the presence of ID cavities. Since the studied area is further away from the main crack, there was no observation of cracked carbides. It was found that a high concentration of ID cavities was found within the HAZ induced by the 2nd bead of the hardfacing layer. This indicates that the hardfacing material has experienced sort of reduction in ductility at certain temperature range, which has led to the formation of ID cavities or ID decohesions. The clusters of ID cavities in the HAZ can easily join together by micro-cracks. In Fig. 9(e-f), the 3 categories of carbide were observed and some of the nanometre size carbide particles in the eutectic phase seem to be interconnected. ID decohesions were observed not only in the HAZ of weld beads in the hardfacing layer but also at the triple joint location of two weld beads in the NOREM 02 hardfacing-base material fusion zone boundary. As shown in Fig. 10, at the triple joint location the low kV SE images and BSE images reveals cracked carbide and iron phase lamella. It is worth mentioning that the metallographic (Fig. 3(d)) and fractographic SEM images (Fig. 7(a)) of the cross-sectional area close to the main crack surface showed cracking along the ID phases, while the discrete iron phase dendrites exhibit certain amounts of plastic deformation before their necking failure. The hardfacing matrix has a more ductile behaviour compared to the ID carbides.

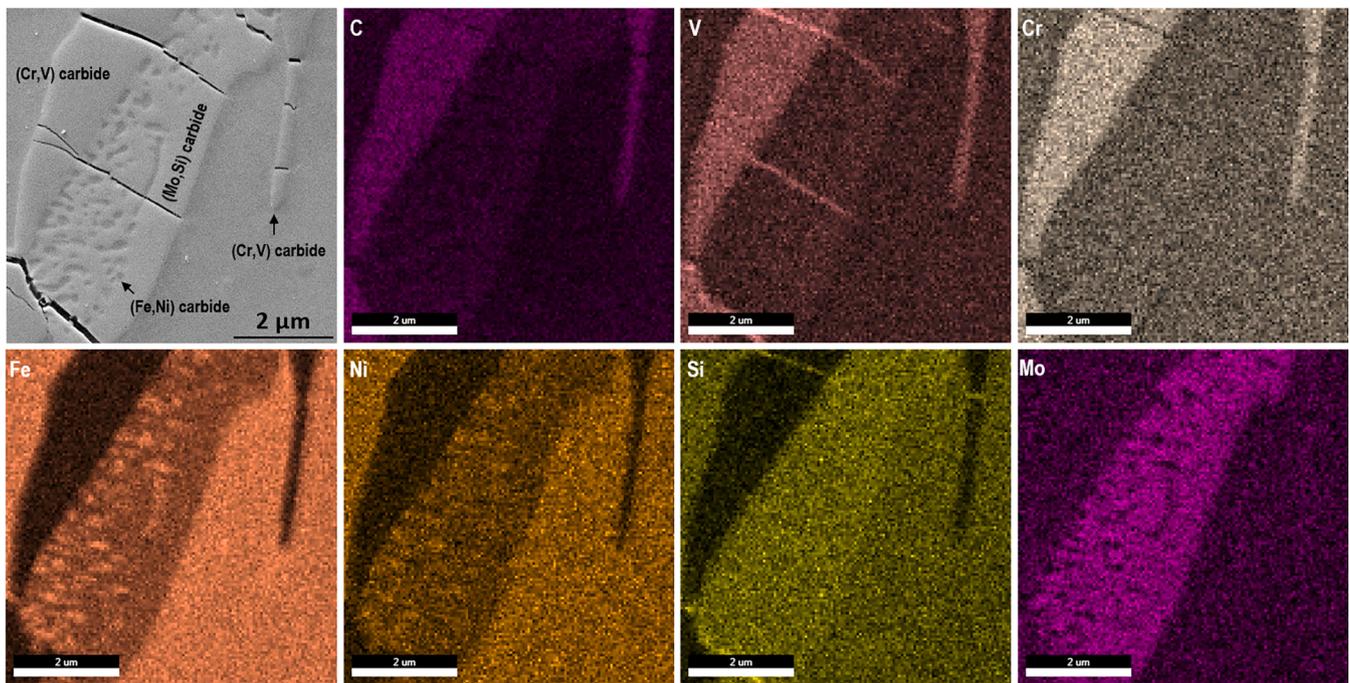
Fig. 8. EDX mappings of the cracked carbides for the area in Fig. 7(e). The chemical compositions of the eutectic and non-eutectic carbides were revealed.

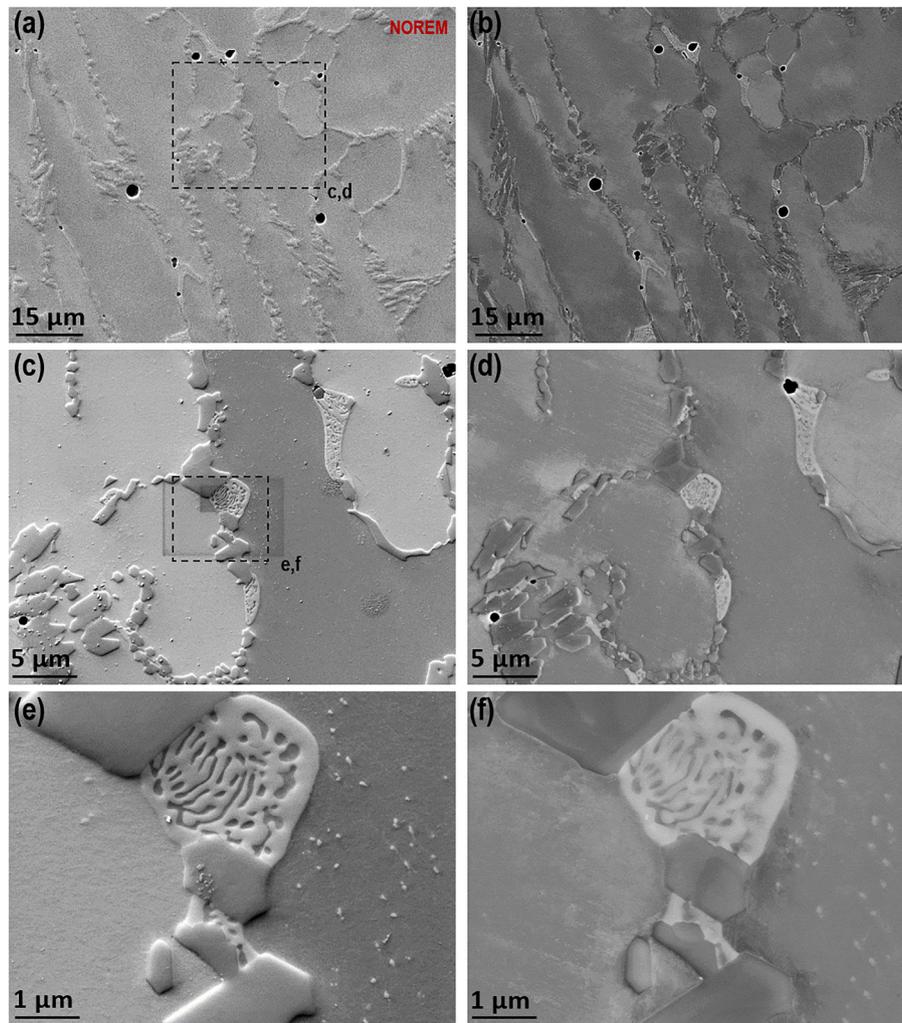
Fig. 9. (a,c,e) low kV SE images and (b,d,f) BSE images of the same areas close to the HAZ of the NOREM 02 hardfacing-base material fusion boundary. The area investigated was shown in Fig. 6(a). ID cavities were observed.

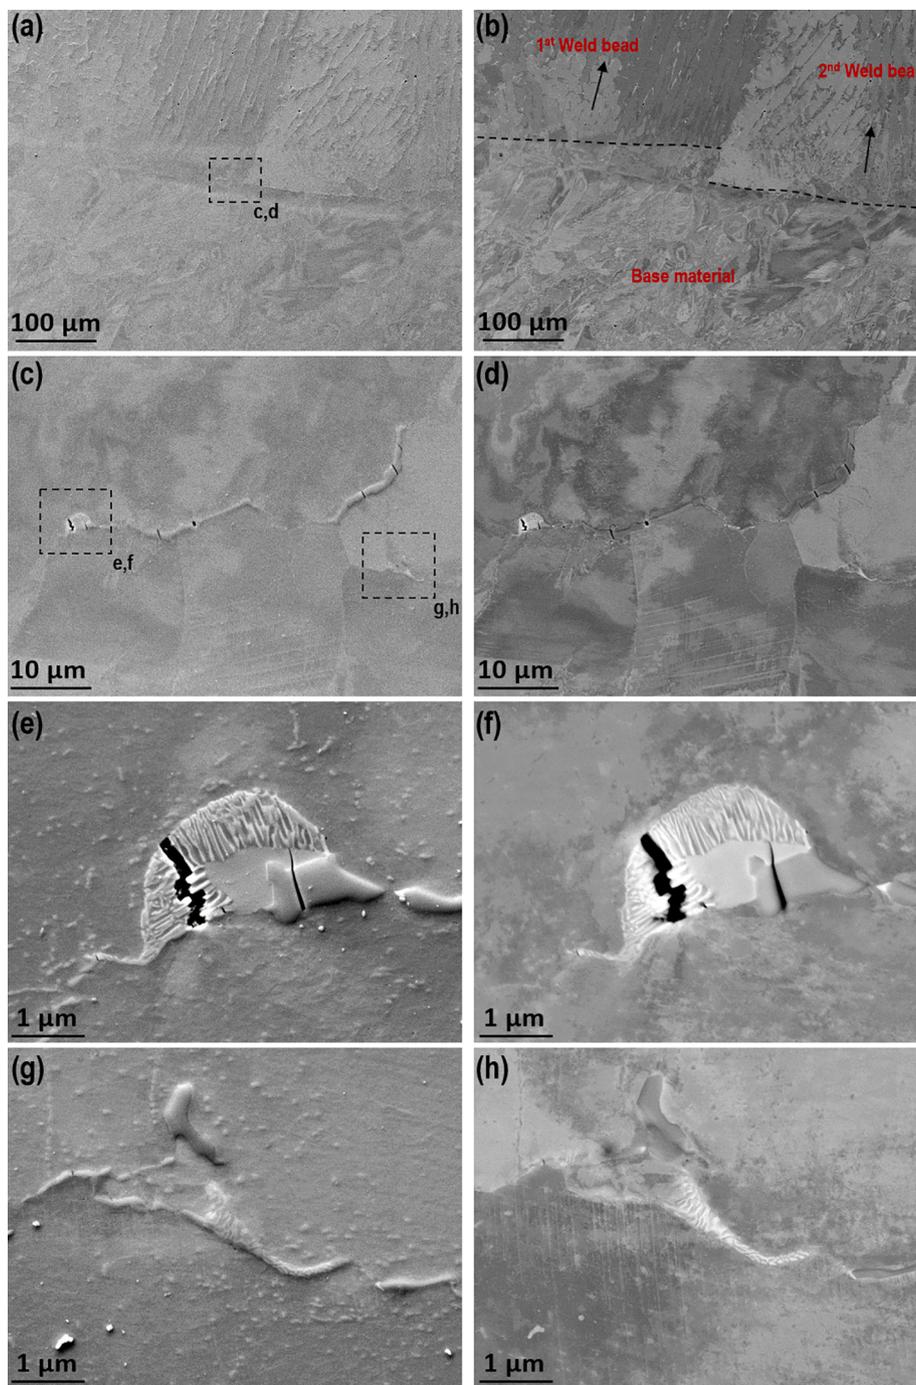
**Fig. 10.** (a,c,e,g) low kV SE images and (b,d,f,h) BSE images of the same areas at the triple joint location of two weld beads in the NOREM 02 hardfacing-base material fusion boundary. The images revealed cracked carbide and iron phase lamella.
