## Long-term investigations of dynamic behavior of a pre-stressed concrete ballasted railway bridge

# Long-term investigations of dynamic behavior of a pre-stressed concrete ballasted railway bridge

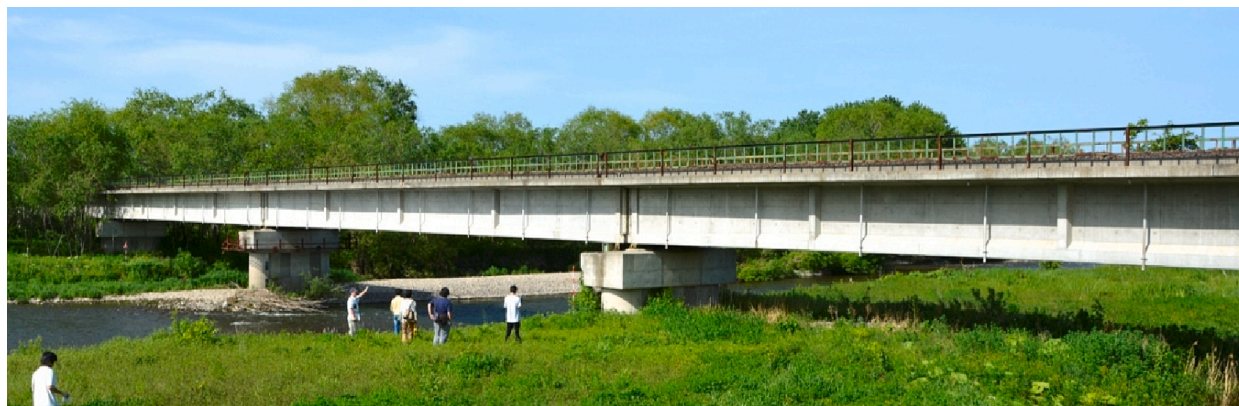
Fig. 1. The investigated bridge.

The ballasted bridge investigated in this study is a 5-span pre-stressed concrete beam bridge in Kitami City, Hokkaido, Japan. The bridge's construction was finalized in 1976. Kitami City and Ikeda County were connected by the bridge. Fig. 1 depicts a lateral perspective of the bridge's three spans, and Fig. 2 displays a general drawing of the bridge. For each span, the span length is 31.3 m, and the length of the deck is 32.02 m. The total length of the bridge is 158.8 m.

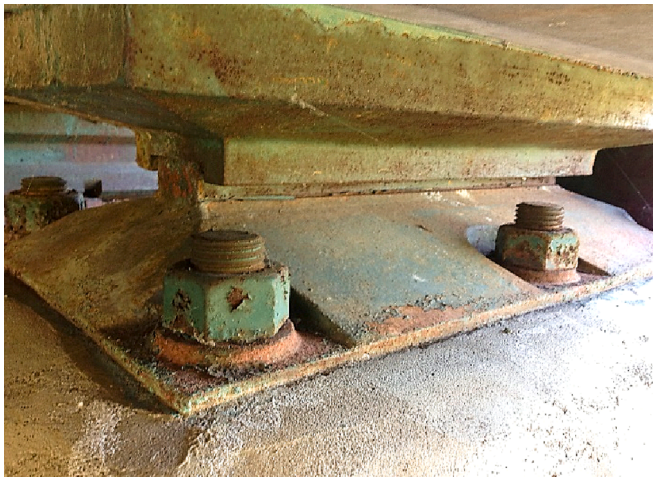
Fig. 4. Line-bearing support.

According to the terrain under the bridge, the three piers on the Ikeda side are taller than the pier on the Kitami side, as shown in Fig. 2. The superstructure of the bridge is supported at the two ends of each girder by the line-bearing supports shown in Fig. 4. Line-bearing support is a type of classical bridge support used in Japan. Technically, it allows the bridge to rotate and move in both longitudinal and vertical directions. However, in actual cases, owing to the high self-weight, vertical movement is generally not considered. Freedom of longitudinal movement meets the requirement of expansion caused by temperature change.

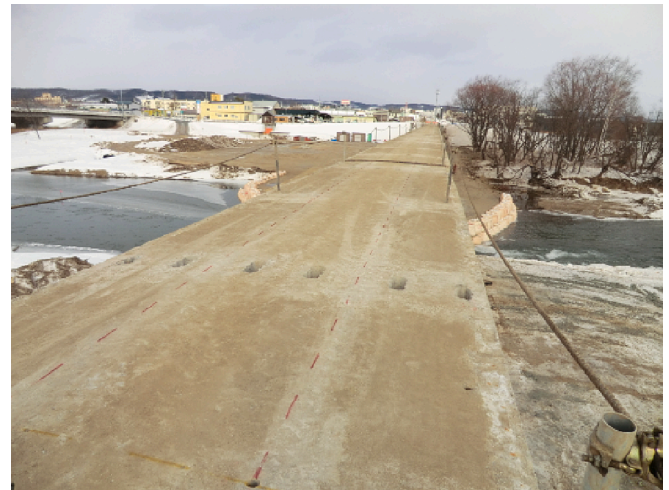
Fig. 6. Bridge under destruction.

A series of vibration studies were conducted from November 2015 to December 2017 to evaluate the dynamic characteristics of the bridge. Table 1 displays the experimental timetable and the ballast state in each experiment. Multiple vibration tests were performed on each individual span in all the experiments. The first eight experiments (No. 1 - No. 8) in Table 1 were carried out on the bridge without a sleeper or track, as indicated in Fig. 5. The final experiment (No. 9) was carried out when the bridge was under deconstruction, and it had no sleeper, track, ballast, ballast stopper, walkway, or handrail. Hoisting holes were also drilled in the slab. The final state of the bridge in the last experiment can be viewed in Figs. 6–7.

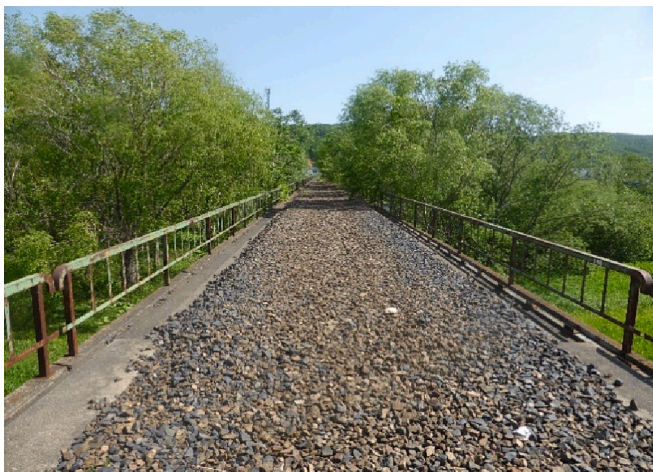
Fig. 5. Evenly distributed ballasts on the bridge.

As illustrated in Fig. 5, the ballasts were uniformly distributed on the slab of all five spans. The sleepers and rails had been removed for several years because the bridge was out of operation. The ballasts, ballast stoppers, walkways, and handrails were removed in the final step before the bridge was completely deconstructed, as shown in Fig. 6. Several holes were drilled on the slabs to lift the bridge's superstructure during deconstruction, as shown in Fig. 7.

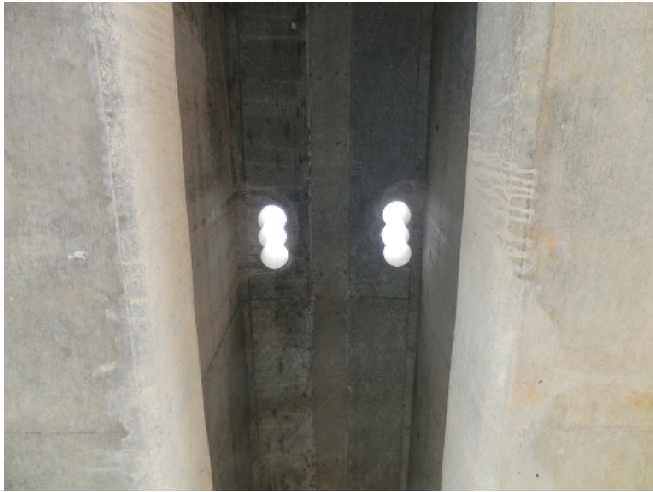
Fig. 7. Holes on the slab for lifting.

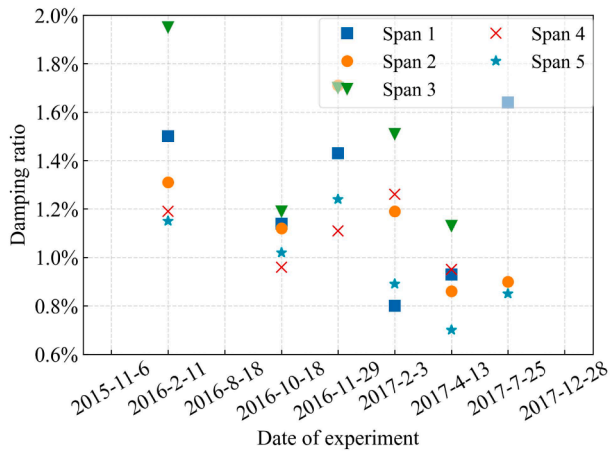
Fig. 13. Identified damping ratios of the five spans.

For the damping ratios shown in Fig. 13, through a general view, no clear regularity could be found within these data. The damping ratios did not show any apparent trend as the natural frequencies. The damping ratios varied independently from the seasonal change. One of the possible reasons for this phenomenon could be the high complexity of the ballasts. The differences between the ballasts lead to the different spaces and interaction mechanisms between ballasts which would directly affect the moisture content, fiction, and stickiness of the ballasts. Furthermore, with the onset of ice material in winter, the ballasts can be frozen, leading to more complex material properties. To sum up, all the mentioned factors can differ the amount of the absorbed and

damped vibration energy, leading to different identified damping ratios. For the last experiment (No. 9), the damping ratios of the 3 lower identified modes (the 1st bending mode, the 1st torsional mode, and the 2nd bending mode) increased obviously, which is far beyond the authors' expectations. Since the ballasts were taken removed, a decrease in the damping ratios was anticipated. The vibration's energy can be absorbed by the ballasts. Lower damping ratios were anticipated because the slab's ability to absorb energy is reduced without the ballasts. One possible reason for the increase in damping ratios is that by removing the subsidiary components of the bridge, the vertical forces on the supports were decreased, leading to lower frictions on the surfaces of the sliding bearing. If there were some motions on the supports, the energy of vibration was consumed in the relative movement of sliding

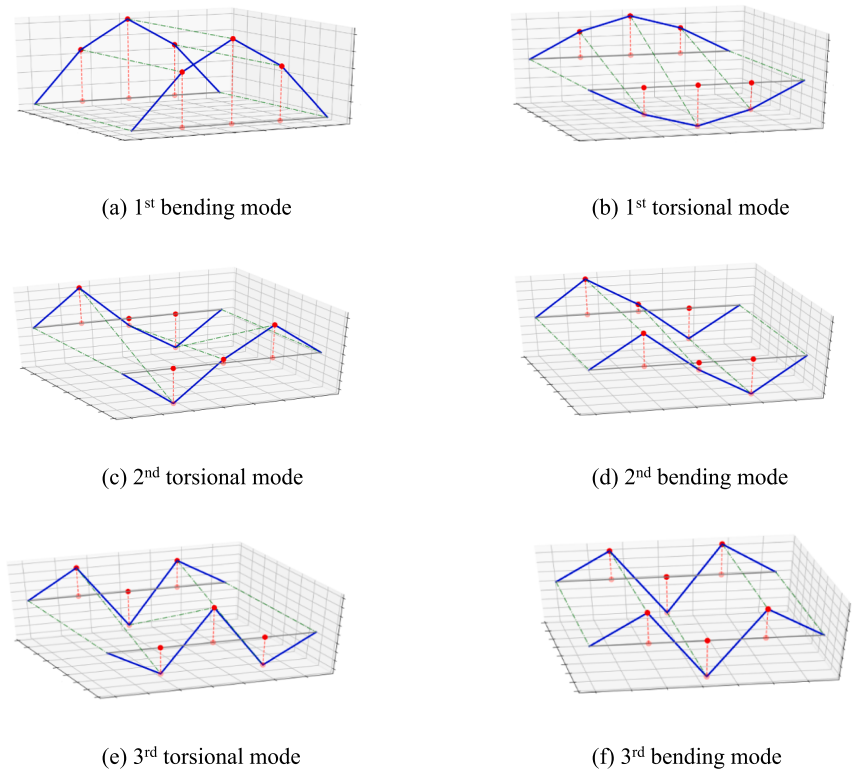
Fig. 14. Identified mode shapes of Span 1 obtained from the No. 4 experiment.

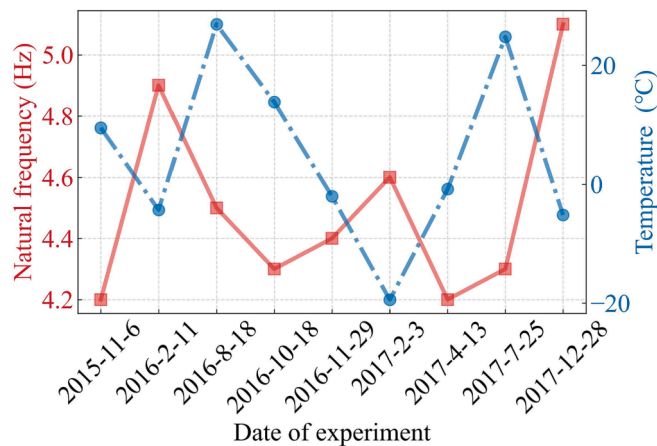
Fig. 15. Correlation of the average temperature of the experimental days and the natural frequency of mode 1 of Span 1.

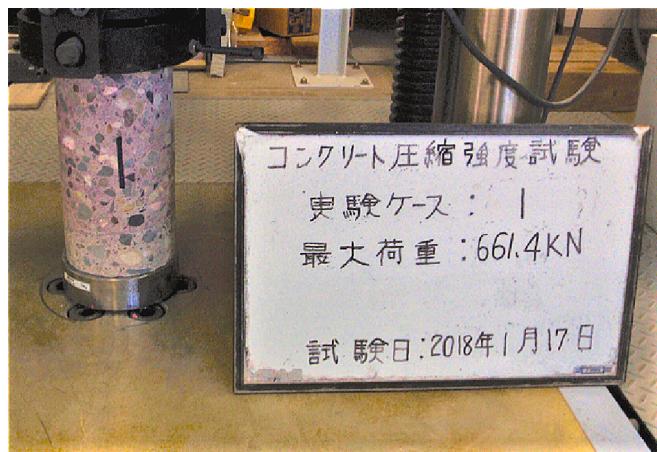
**Fig. 20.** A photo of the compression experiment of concrete sample.

247 and 271 mm. A photo of the compression experiment is shown in Fig. 20.

The results show that the longitudinal compressive strengths of the three test pieces are 37.28 N/mm<sup>2</sup>, 42.13 N/mm<sup>2</sup>, and 39.83 N/mm<sup>2</sup> respectively. The mean longitudinal compressive strength of the three test pieces is 39.7 N/mm<sup>2</sup> with a very low standard deviation of 1.981 N/mm<sup>2</sup>. Compared to the design compression strength of the concrete of 40 N/mm<sup>2</sup>, the results of the sampling investigation show that after
