SHC 2015, International Conference on Solar Heating and Cooling for Buildings and Industry

Performance evaluation of lighting and daylighting retrofits: results from IEA SHC task 50

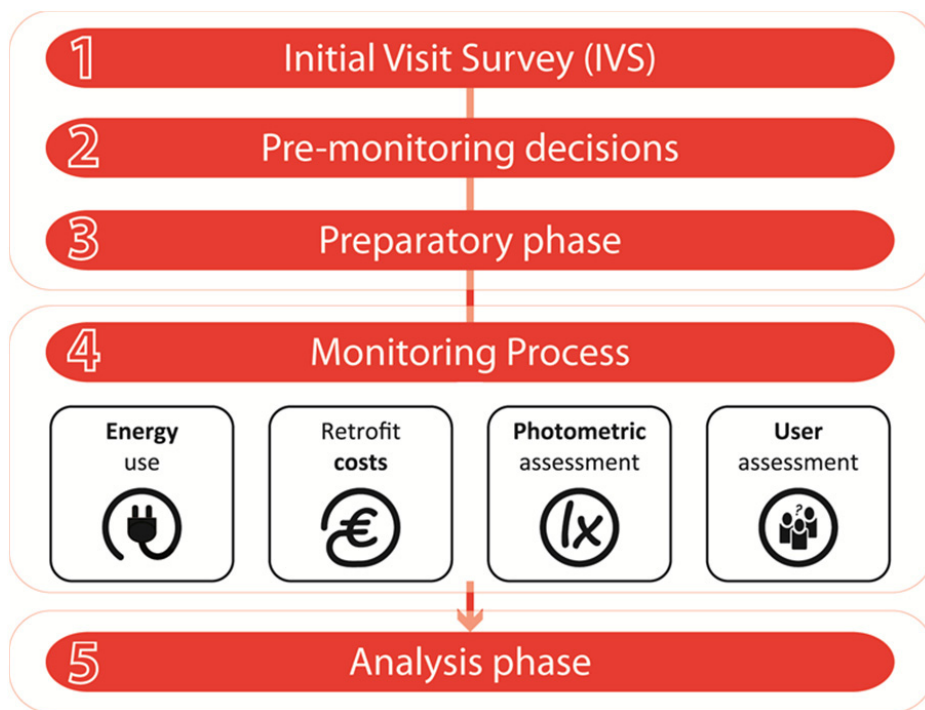
Fig. 2. Structure of the monitoring protocol.

The access to monitored data is crucial to assess whether daylighting or electric lighting systems deliver the anticipated performance in terms of energy efficiency, cost-effectiveness, and lighting quality. The monitoring protocol [1] developed as part of Subtask D is a toolbox for professionals including a five-phase procedure for preparing and conducting the lighting retrofit assessment. After a general introduction, five phases are covered in separate chapters in the monitoring protocol document, which measures four fundamental aspects of a lighting retrofit project (Energy use, Retrofit costs, Photometric assessment, User assessment), as outlined in Fig. 2.

The section about energy use and retrofit costs basically involve the collection of information on costs, the description of daylight/electric lighting systems and, when possible, the measurements of energy consumption. The photometric assessment, which is the most developed part of the protocol, involves measurements of seven key photometric quantities that allow describing lighting conditions and quality, see [2] for details. Finally, the fourth aspect of the protocol called ‘User assessment’ involves subjective assessments via questionnaires and/or interviews with the building occupants.

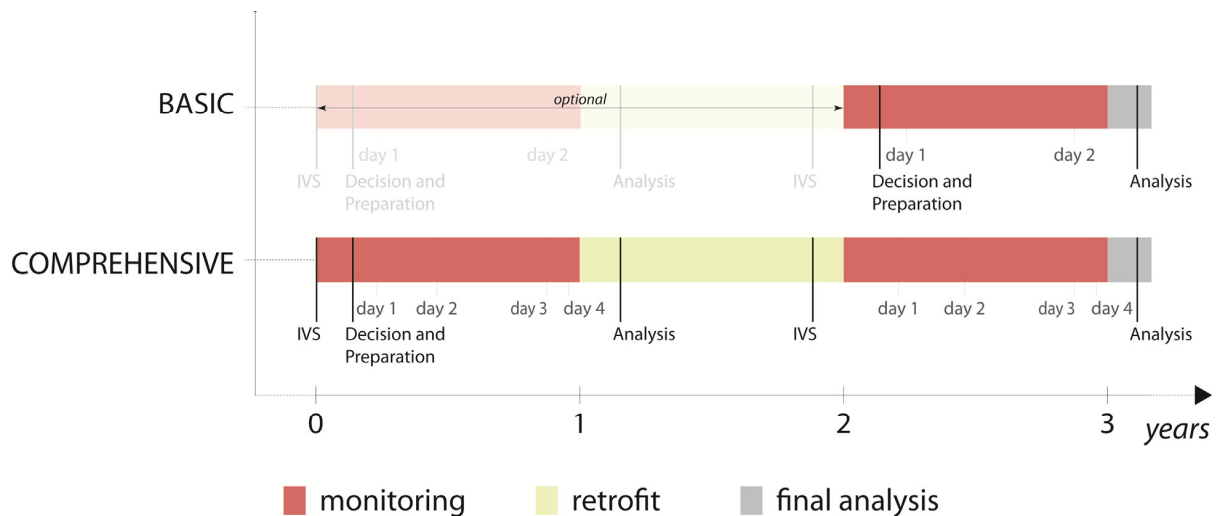
Fig. 3. Timeline for the evaluation for the two different levels of monitoring.

The protocol offers two monitoring levels: 1) a ‘basic’ and 2) a ‘comprehensive’ level. The choice depends on the purpose of monitoring and on practical constraints like the access to the building and the availability of resources. The protocol is developed so that a comprehensive picture of the electric lighting/daylighting performance can be obtained for the conditions before and after renovation (referred to as pre- and post-retrofit in the monitoring protocol document). However, it is possible to use segments of the protocol. For example, in some cases, it is not possible to access the pre-retrofit situation as the building has already been retrofitted. In this case, it is possible to perform the post-retrofit evaluation only and compare the results obtained with typical (benchmark) values for similar types of spaces.

The ‘basic’ level requires a) more limited instrumentation, b) access to the spaces at least in their post-retrofit condition, c) an overcast sky day and clear sky day (close to an equinox) over a one-year period for the actual monitoring, d) approximately one year for the whole evaluation process (Fig. 3). On the other hand, the ‘comprehensive’ level requires a) advanced instrumentation, b) access to the spaces both before and after the retrofit, c) four days per year over a period of two years for the actual monitoring (overcast day, clear skies for an equinox and each solstice), d) approximately three years for the whole evaluation process. Note also that it is possible to mix elements of the basic and comprehensive monitoring procedure to suit the specific needs of the building or monitoring team.

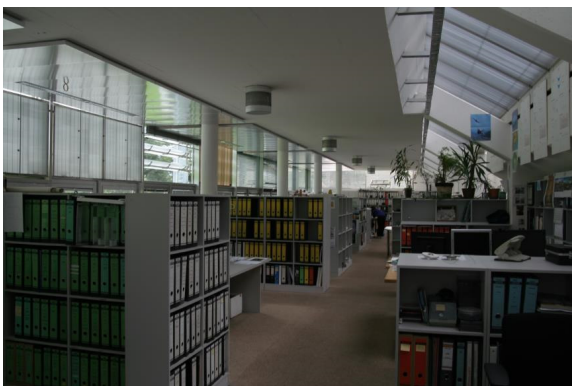
Fig. 4. Pre-retrofit view of Bartenbach R&D Office.

The Bartenbach R&D office is an example of a comprehensive lighting retrofit of an office building (Figs. 4 and 5). Here the daylight solution, the electrical lighting, the lighting control and the interior design of the room have been retrofitted.

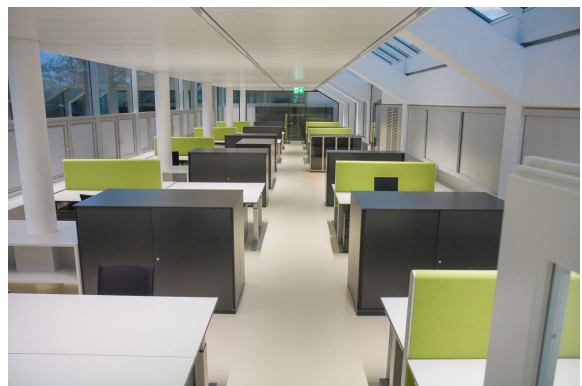
Fig. 5. Post-retrofit view of Bartenbach R&D Office.

- The daylight solution consists of exterior louvers with varying distances between the single slats optimized for the geographical location. An additional screen has been added for luminance control and glare protection. With this combination, the visual link to the exterior is maximized even for sunny conditions.

- The architecture integrated electric lighting solution is an efficient tunable white LED downlight system where the color temperature can vary from 2,200 to 5,000K for dynamic scenarios. The dimmable system provides up to 1250lx in every light color at the work plane to also allow biologically activating light. Independent of the selected light colour, the energy consumption at 500lx workplane illuminance is below 6 W/m².

- In this project, an integrated control for the daylight solution, the electric lighting system, the heating and the ventilation system have also been installed. Occupancy sensors, workplane as well as exterior illuminance sensors, wind speed sensors and temperature sensors feed this holistic control system.

The installed daylighting solution provides a highly daylit building with hardly any need for additional electric lighting during daytime hours. The variable combination of louvers and screens also allows for good solar and glare protection. For the morning and evening hours, the highly flexible electric lighting solution produces dynamic scenarios in an attempt to support the human circadian rhythm at highest energy efficiency. The integrated control reacts to exterior and interior conditions to intelligently combine the daylight and electric lighting solution and provide a pleasant lighting experience.

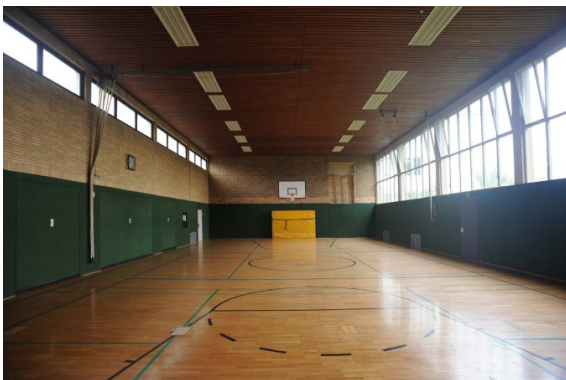
Fig. 6. Small gymnasium before renovation.

The vocational college in Detmold consists of four classroom buildings and two gymnasiums. A classroom in Building 1 and the small gymnasium were selected for monitoring. In the sports hall, the lower part of the glazed facade, which had been masked by a baffle wall, was reopened. This was possible because the gymnasium will only be used for gymnastics after renovation, but no longer for ball games. After renovation, the gymnasium provides a view and the window-to-floor area ratio was increased by 20 percent. Since the new frames are thinner in relation to the old frames, the glazing-to-floor area ratio increased by 38 percent. However, since the sports hall had single glazing before renovation and is glazed after renovation with triple glazing with a significant area of light diffusing glass (Figs. 6 and 7), the visual transmittance of the glass was reduced by 43 percent. In total the efficient window-to-floor area ratio decreased by 22 percent. After renovation, the daylight factor in the centre of the floor space accounted for 2.4 percent. New LED-lighting replaces the fluorescent lighting installed before renovation.

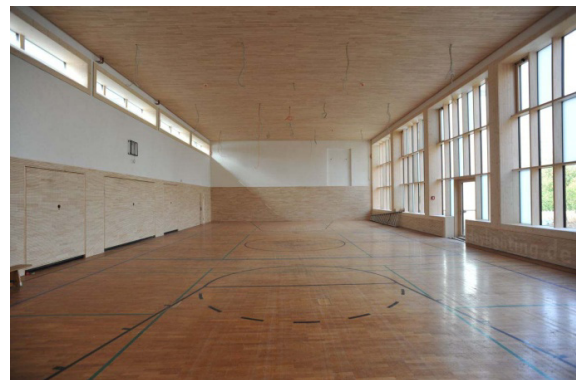
Fig. 7. Small gymnasium after renovation.
