Published in:
Materials and Corrosion : Werkstoffe und Korrosion

Hydrogen embrittlement of nodular cast iron

Ferritic nodular cast iron, intended for use as the material for inserts of canisters for long-term geological disposal of spent nuclear fuel, was studied for hydrogen sensitivity. In the canisters, the insert provides the mechanical strength against external loads. Hydrogen was charged from 0.1 N H₂SO₄ solution in free-corrosion tests and under controlled cathodic potential. Hydrogen uptake and trapping were then measured using thermal desorption spectroscopy. The hydrogen desorption rate after hydrogen charging manifests two distinct peaks. Plastic deformation during hydrogen charging increases the hydrogen uptake considerably. Hydrogen reduces the elongation to fracture and time to fracture in slow strain rate testing and constant load testing (CLT), respectively. Especially, the strain rate in CLT is dramatically increased. The appearance of hydrogen-induced cracking in the ferrite phase changes from ductile dimple fracture to brittle cleavage fracture due to hydrogen charging, which initiates from the interphases of the graphite nodules. The results are discussed in t

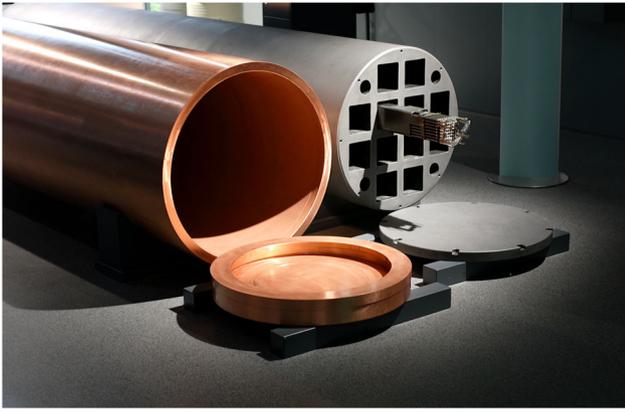
FIGURE 1 KBS-3 canister. Copper shell and lid on the left and cast iron insert and steel lid of the insert on the right. Posiva Oy [Color figure can be viewed at wileyonlinelibrary.com]

In the KBS-3 method of long-term geological disposal of spent nuclear fuel, the load-bearing inserts of the canisters are intended to be manufactured from ferritic nodular ductile cast iron (DCI) EN 1563 grade EN-GJS-400-15U^[1–3] (Figure 1). Recent studies of hydrogen effects on the mechanical performance of DCI have shown a remarkable sensitivity to hydrogen in the form of hydrogen embrittlement and hydrogen-enhanced creep.^[4] There are some possible internal sources of hydrogen in the canister

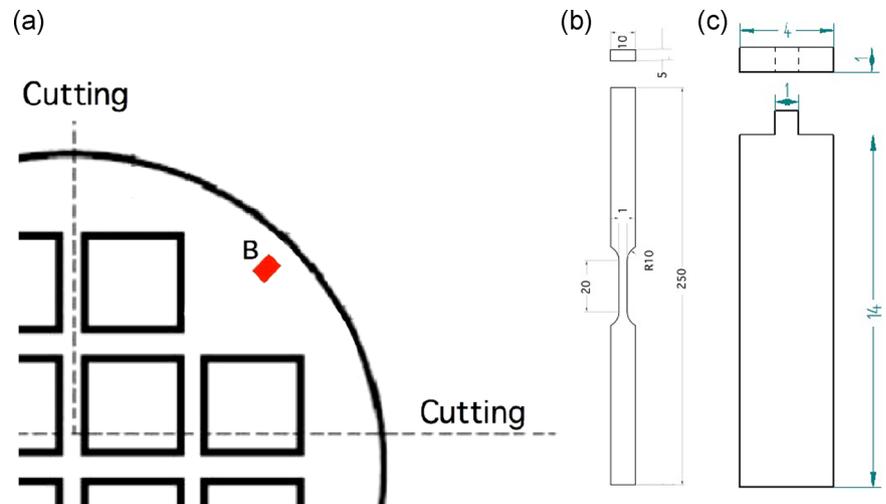
FIGURE 2 (a) The location of billet from which the samples were cut, marked with B, (b) tensile specimen geometry, and (c) thermal desorption spectroscopy sample geometry [Color figure can be viewed at wileyonlinelibrary.com]

The effects of hydrogen on the graphite morphology and mechanical performance of ferritic nodular cast iron grade EN-GJS-400-15U were studied. The chemical composition of the studied DCI is shown in Table 1. Casting I73 produced by Posiva Oy, Finland, was cut as shown in Figure 2. A block of the material was cut from the location marked with red

square (B) for manufacturing the specimens for tensile testing and hydrogen charging. The samples were cut from near the surface of the casting and from the depth of ~40 mm, using electro-discharge machining (EDM). Two types of specimens were made, that is, tensile specimens according to the geometry shown in Figure 2b and TDS samples shown in Figure 2c. Both specimens were mechanically ground to remove the EDM-affected surface layer. The gauge section of the tensile specimens was mechanically polished, finishing with 2,500 grit emery paper without lubrication. The TDS samples were polished up to 2,500 grit emery paper using common wet grinding and polishing techniques. After CLTs, the TDS samples were cut immediately after terminating the tensile test from the gauge part of the tensile specimens and polished using the emery papers.

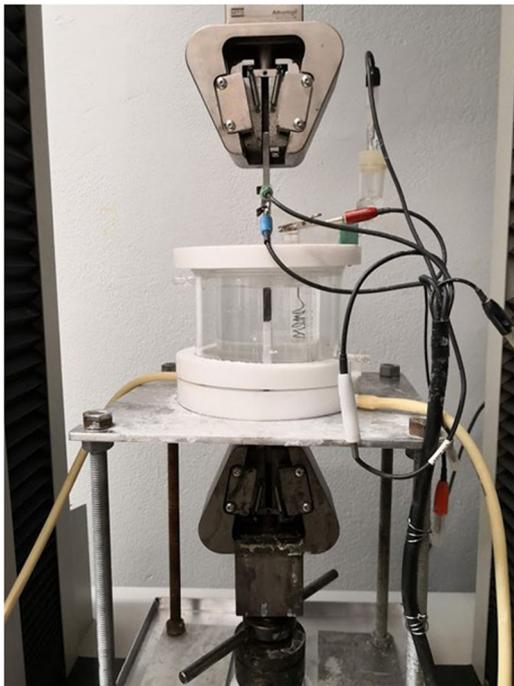
FIGURE 3 The tensile testing system consisting of a 35 kN MTS desktop machine with an electrochemical cell and Gamry potentiostat [Color figure can be viewed at wileyonlinelibrary.com]

The tensile specimens were studied with SSRT and CLT in air and under continuous hydrogen charging with controlled electrochemical potential. The testing system consists of a 35 kN MTS desktop tensile testing machine equipped with a three-electrode electrochemical cell with Hg/Hg₂SO₄ reference and Pt counter electrodes and a Gamry potentiostat for controlled hydrogen charging. The test set-up is shown in Figure 3. Electrochemical hydrogen charging was performed at a controlled cathodic potential of –0.85 V from 0.1 N H₂SO₄ solution with added 10 mg/L thiourea. Each hydrogen charged tensile test was preceded by 1 hr precharging to uniformly saturate the specimen with hydrogen before loading. Only the gauge parts of the tensile specimens were exposed to the environment by insulating the rest of the immersed specimen with polytetrafluoroethylene (PTFE) tape. The total volume of the solution was about 1,600 cm³ and the pumping rate was 2 cm³/s circulating between the test cell and the conditioning container, which held the extra solution.

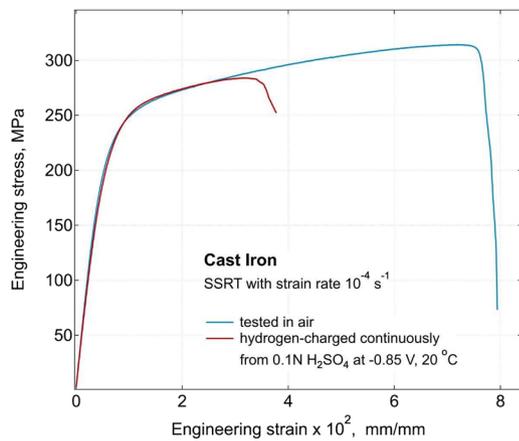
FIGURE 4 Slow strain rate tensile testing (SSRT) stress–strain curves in the air (blue) and under continuous hydrogen charging (red) tested at room temperature [Color figure can be viewed at wileyonlinelibrary.com]

Typical stress–strain curves obtained in SSRT are shown in Figure 4 and strain versus time plots obtained in CLT in Figure 5. As in the previous study,^[4] the DCI's mechanical properties show a remarkable reduction under hydrogen charging. The ultimate tensile strength of the material was markedly reduced in the SSRT test under hydrogen charging and the elongation to fracture was halved.

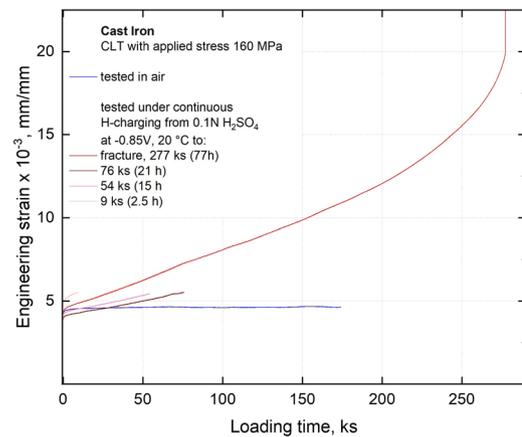
FIGURE 5 Strain versus time curves in constant load testing (CLT) in the air (blue) and under continuous hydrogen charging (shades of red) tested at room temperature [Color figure can be viewed at wileyonlinelibrary.com]

The behavior of the DCI was more closely examined using CLTs (Figure 5). Most CLT tests were interrupted before failure to study the evolution of the material's

deformation and crack initiation in constant loading under hydrogen charging by examining the changes in the graphite nodules and ferrite matrix of the material. When the specimen was kept at a constant applied stress of 160 MPa in air, the specimen did not show any remarkable creep strain during the test period of several days. However, when repeating the test under continuous hydrogen charging, the specimen elongated at an accelerating rate leading to eventual fracture. There was a noticeable scatter in the strain rates of different tests. The scatter is, however, understandable due to several factors: the comparatively small gauge size of the tensile specimens means that the effects of any discontinuities in the microstructure are enhanced. In other words, the fraction and size of graphite nodules in relation to the size of the cross-section of the specimen and their location with respect to the edges of the specimen bring random variations to the experiment. For instance, if a graphite nodule is located at or close to the edge of the specimen, it causes stress concentration at the edge, leading possibly to cracking in that location.

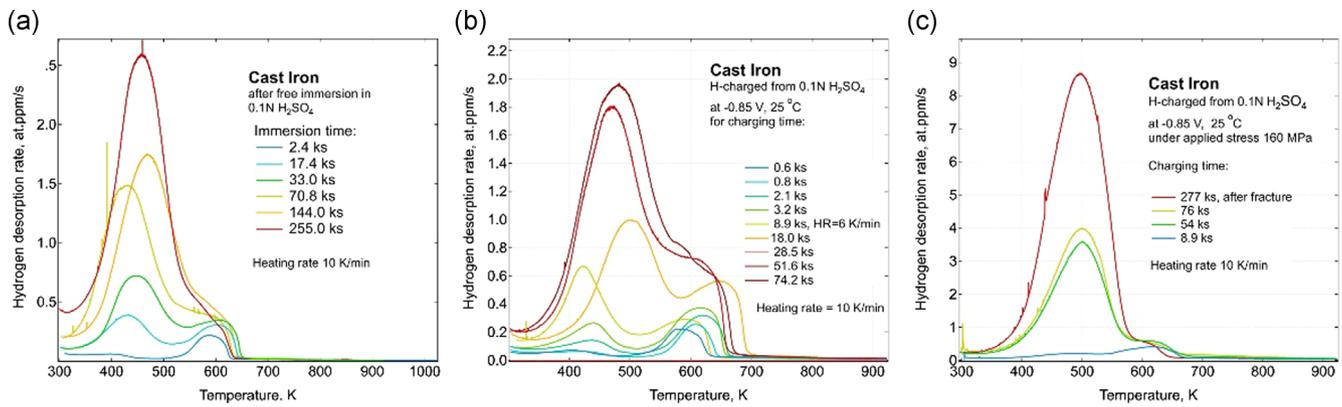
FIGURE 6 The characteristic peaks of hydrogen desorption from ductile cast iron in different test conditions. (a) After free immersion in 0.1 N H₂SO₄ solution for different immersion times. (b) After electrochemical hydrogen charging for different times. (c) Measured from the gauge section of constant load testing specimens after interrupted testing under electrochemical charging [Color figure can be viewed at wileyonlinelibrary.com]

In this study, the DCI shows two distinct peaks of hydrogen thermal desorption. Figure 6a shows the hydrogen desorption peaks when the sample is immersed freely in 0.1 N H₂SO₄ solution without external mechanical loading or applied electrochemical potential. The immersion time affects significantly the location and magnitude of the peak correlating with the amount of trapped hydrogen in the sample. The TDS curve for immersion time of 2,400 s (40 min), for instance, shows how hydrogen absorption mostly manifests as a 600 K peak. The longer immersion times result in the saturation of this high-temperature peak, the desorption rate being about 0.4 at ppm/s. As the immersion time is increased, the magnitude of the low-temperature peak at 450 K keeps increasing. This means that an increasing amount of hydrogen is being trapped in this trapping site.

Figure 6b shows similar behavior to the free-immersion tests for the specimens tested with the external electrochemical potential control for hydrogen charging. The high-temperature peak reaches a similar saturation level of 0.4 at ppm/s, after which the low-temperature trapping site is gradually activated. The amount of trapped hydrogen increases with charging time, reaching a similar level as in the free-immersion tests. With the introduction of the external

Figure 6c shows TDS curves obtained after CLTs under continuous hydrogen charging. Again, the high-temperature peak is saturated and the low-temperature peak gradually increases. However, now under both tensile loading and electrochemical hydrogen charging, the low-temperature peak increases markedly more as compared to the unloaded conditions. Thus, it can be concluded that an external tensile loading causes the formation of effective trapping sites which are responsible for the increase of hydrogen uptake.

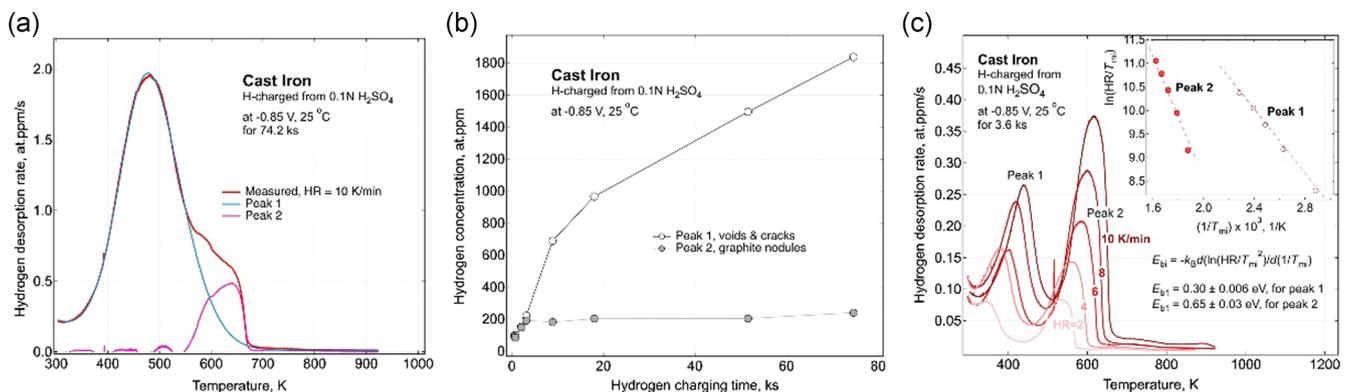
FIGURE 7 The characteristics of thermal desorption spectroscopy (TDS) curves. (a) The decomposition of measured TDS curve into two peaks, (b) the amount of trapped hydrogen as a function of electrochemical charging time, and (c) activation analysis for both components of the peak [Color figure can be viewed at wileyonlinelibrary.com]

Assuming that the desorption peaks can be approximated with Gaussian functions, the measured complex TDS peaks were decomposed into two components as shown in Figure 7a. Applying the decomposition procedure to the TDS peaks measured for the samples with different electrochemical charging times, one can obtain dependencies of the hydrogen concentration

corresponding to each component versus charging time as shown in Figure 7b. As the charging time increases, the amount of hydrogen corresponding to the high-temperature peak remains the same, but it increases with time for the low-temperature peak. The closed nature of these peaks is examined more closely in Section 4. Using the Kissinger procedure^[13,14] for activation analysis of both peak temperature positions versus the heating rate of TDS measurement as shown in Figure 7c, the trapping energy for these peaks can be found to be 0.30 ± 0.006 and 0.65 ± 0.03 eV, most likely corresponding with the ferrite matrix and the graphite nodules, respectively.

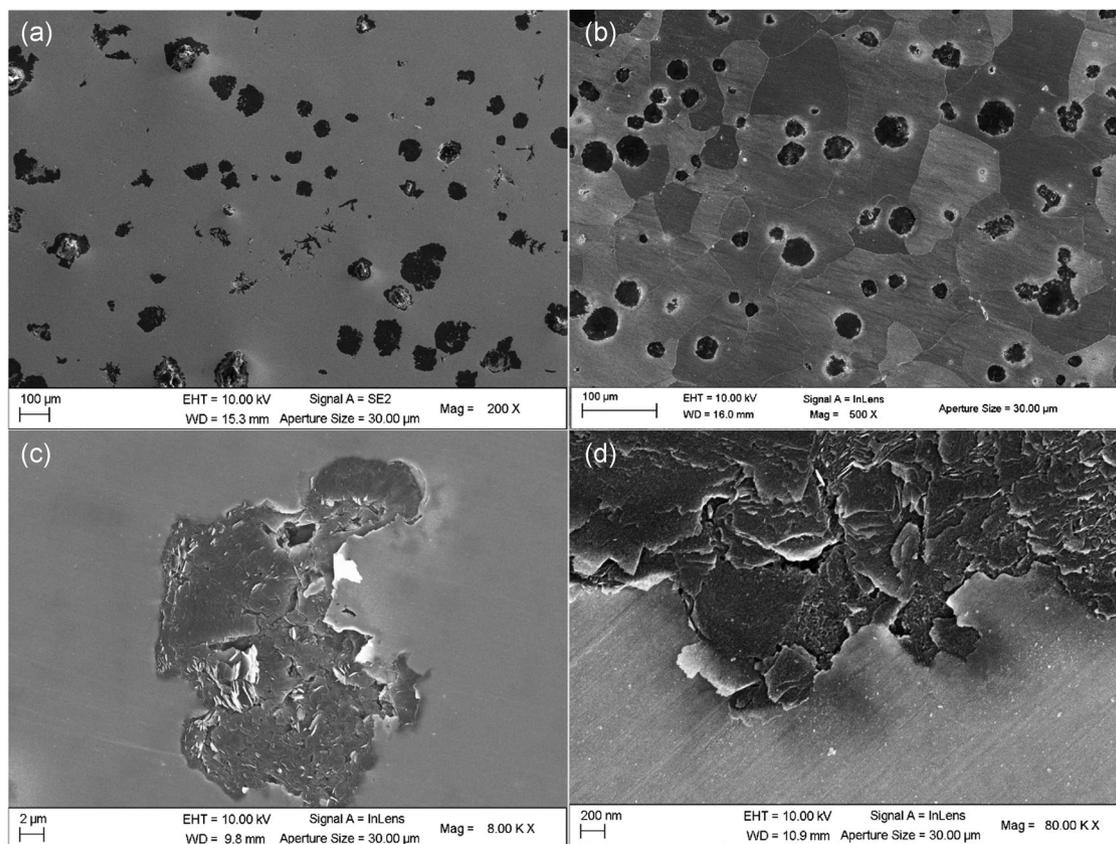
FIGURE 8 (a) General view of microstructure of as-received ductile cast iron cut from near casting surface and (b) after etching in 2% nital solution. (c) A graphite nodule and (d) the graphite nodule/ferrite matrix interface before hydrogen charging

Typical microstructures of the studied DCI are shown in Figure 8. The material consists of a ferritic matrix with dispersed graphite nodules. The graphite is mostly

nodular with somewhat uneven distribution of nodules related most likely to the segregation of alloying elements during solidification. All nodules are of type V and type VI according to EN ISO-945-1:2018. The volume fraction of the graphite nodules is about 0.056. The average nodule size in the studied part of the cast iron insert is about $44.5 \mu\text{m}$, and the volume density of the graphite nodules is $6.31 \times 10^{12} \text{m}^{-3}$. The spheroidal graphite nodules have a layered flaked structure and incoherent graphite/ferrite interface (Figure 8c,d). The grain size of the ferrite matrix is about $78 \mu\text{m}$ and a very small amount of pearlite is present (<5%).

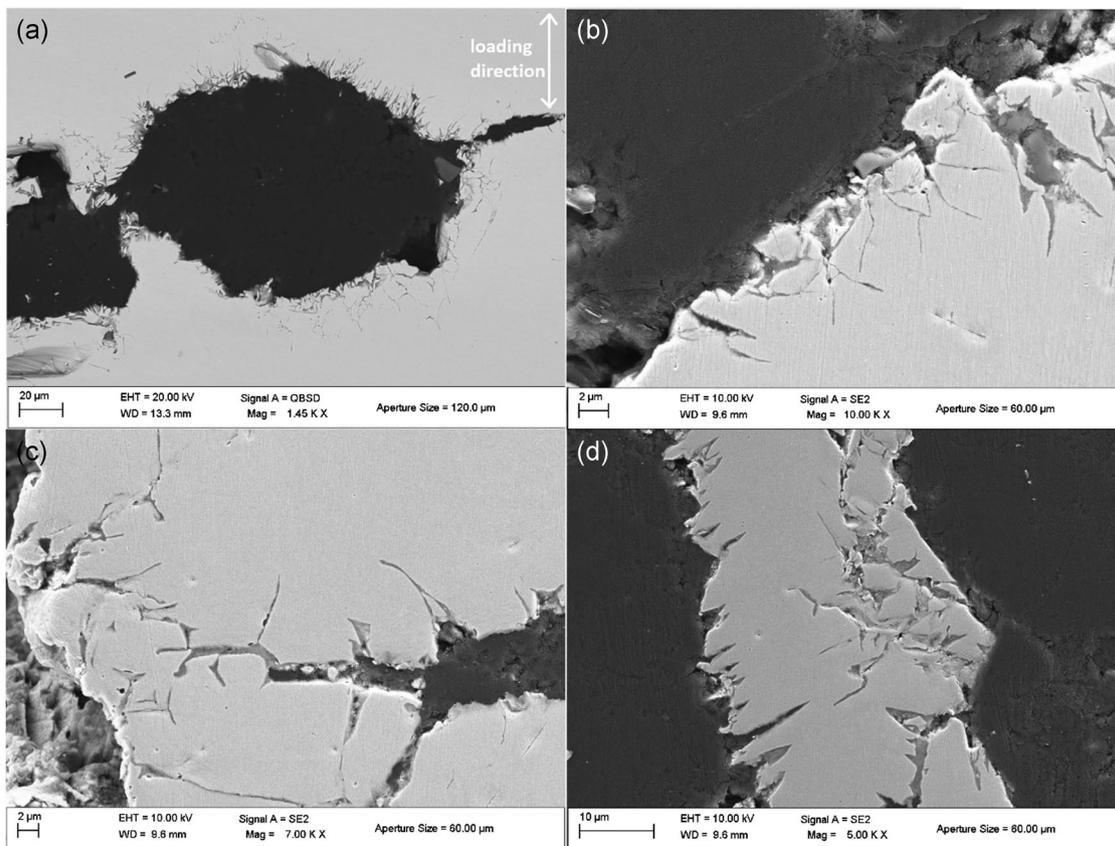
FIGURE 9 Graphite nodules of constant load testing tensile specimen cut from location B. Tested up to fracture (loading time 238 ks/66 hr). (a) The general appearance of cracking around a nodule, (b) close-up of cracking at nodule/matrix interface, and (c and d) linking between adjacent graphite nodules by brittle cleavage cracking

The graphite nodules are affected by hydrogen charging (Figure 9a), and especially, the graphite nodule/ferrite matrix interfaces exhibit multiple small cracks in the ferrite matrix formed under hydrogen charging (Figure 9b–d). Cracking at the interface of the graphite nodules and eventual linkage of cracking between the graphite nodules was not observed in the as-supplied DCI (Figure 8). Only under hydrogen charging and with increasing charging time or introduction of tensile loading, microcracking at graphite nodule/ferrite matrix interfaces appears in increasing numbers, and the cracks grow and connect forming a series of larger step-wise brittle cracks in the material.

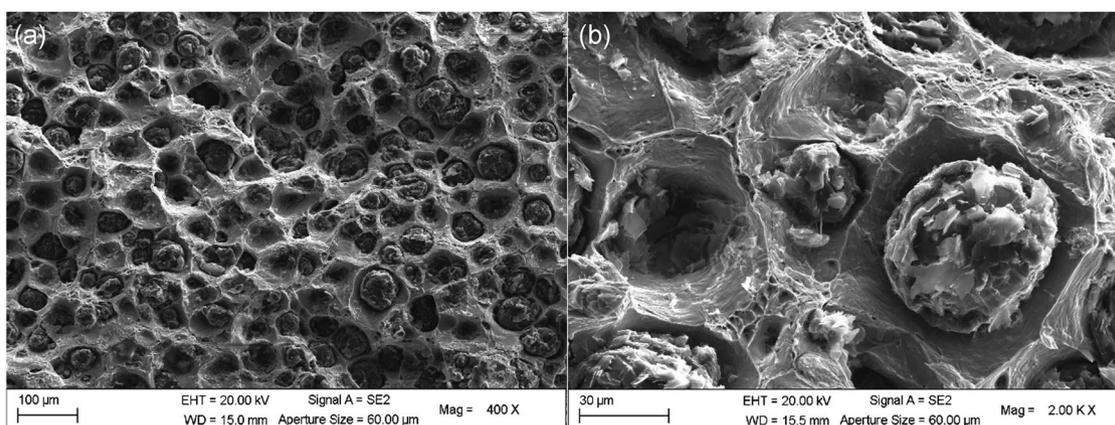
FIGURE 10 The fracture surface of slow strain rate tensile testing specimen loaded in the air showing ductile fracture with large cavities around graphite nodules and small dimples in ferrite ligaments

The fracture surface of an SSRT specimen tested in the air is shown in Figure 10. It exhibits the typical ductile fracture characteristics in the form of large cavities around the graphite nodules and small dimples in the ligaments, as is expected of the DCI tested in the air (elongation to fracture 8%). With the uptake of hydrogen under constant load, however, the ligaments between the large cavities show brittle cleavage fracture facets as shown in Figure 11a,b. The cleavage fracture occurs in the ferrite between the graphite nodules. Large cavities are also left by the graphite nodules in the ferrite matrix. In the large cavities, the interface between the graphite nodules and the ferrite matrix becomes visible showing a faceted surface structure (Figure 11c,d). Energy-dispersive X-ray spectroscopy analysis of the faceted cavity surfaces shows only the presence of iron in the spectrum indicating an interfacial detachment of the graphite nodules during tensile testing.

graphite nodules (Figure 11a,b). In the air without hydrogen (Figure 10), ductile fracture occurs forming small dimples in the ferrite ligaments typical for a ductile material such as DCI. It is of great significance that the fracture behavior of DCI changes markedly in the presence of hydrogen. Hydrogen diffuses freely through ferrite, but the graphite nodules can uptake the available hydrogen and become saturated. The hydrogen build-up and resulting internal gas pressure may eventually cause the graphite nodules to detach from the ferrite matrix. This introduces cracks in the microstructure and leads to the initiation of brittle cleavage fracture.

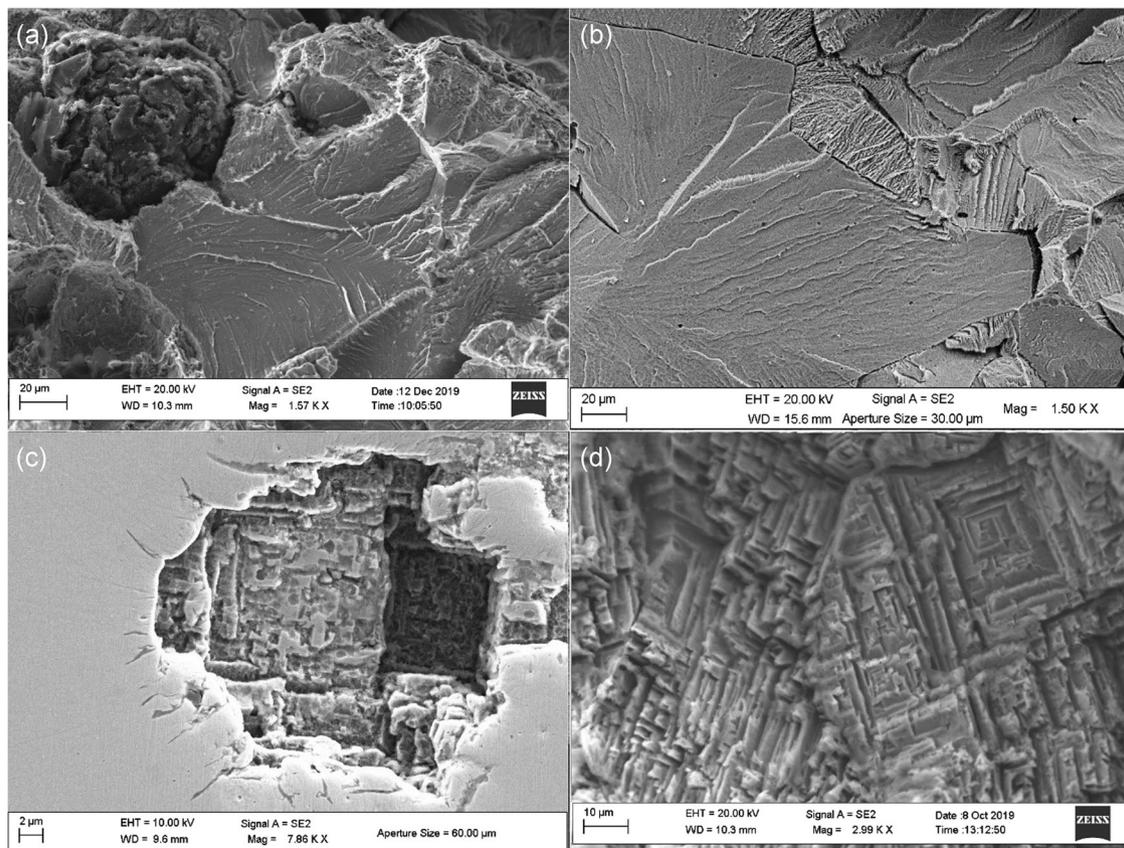
FIGURE 11 Hydrogen charged constant load testing specimens. (a) General view of the fracture surface and (b) a close-up of brittle cleavage fracture facets in ferrite ligaments. (c) Side view of polished specimen cross-section surface showing multiple small brittle cracks around a cavity left by a detached graphite nodule and (d) a close-up of the surface of the cavity

The CLT and SSRT tests show that under continuous hydrogen charging the mechanical properties of DCI are markedly reduced compared with performance in the air showing similar behavior as in the previous study.^[4] Fractography after CLT shows the separation of graphite nodules from the ferrite matrix with the faceted interface of the cavities and cleavage fracture in ferrite between the
