## Natural weathering of soft- and hardwoods modified by contact and flame charring methods

*Published in:*  
European Journal of Wood and Wood Products

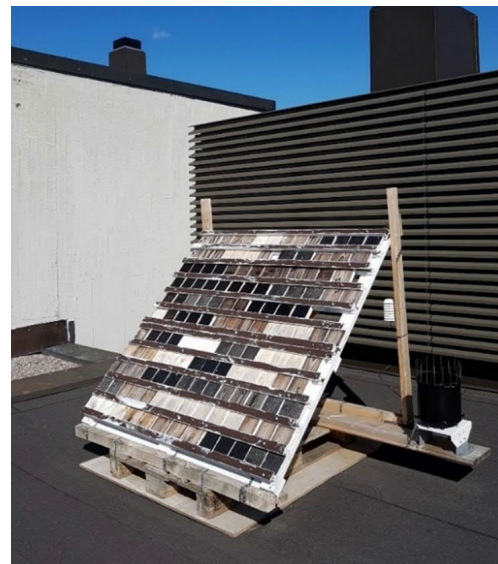
**Fig. 1** Left: Relative humidity (%), monthly rainfall (mm) and averages of monthly temperature (°C); Right: The weathering rack after three months of weathering in September 2020

The relative humidity, average monthly temperature and cumulative rainfall logged on site are shown in Fig. 1. Monthly average temperatures ranged from  $-6.9$  to  $17.1$  °C, with a low in February and high in June. The winter had an average monthly snow cover of 150–284 mm between January and March, during which time the rainfall measuring bucket was blocked with snow. For this period, the bottom rows of samples were also blanketed with wind-blown piles of snow. No visually detectable differences dependent on the placing were seen between the rows, thus this detail was omitted from the further analysis.

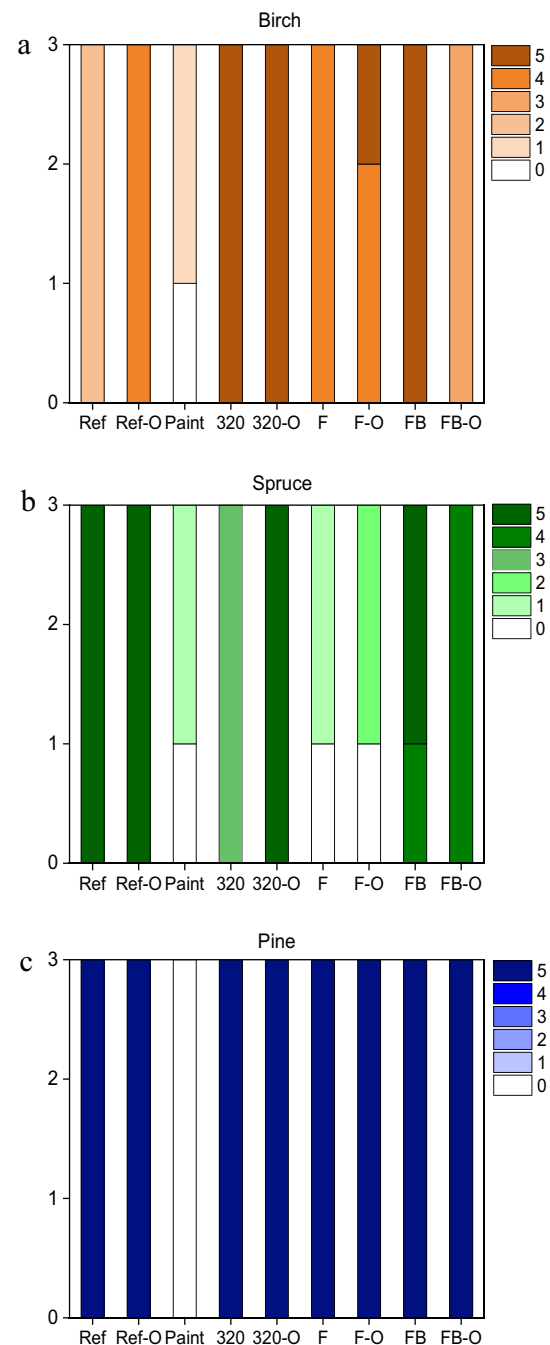
**Fig. 2** Surface cracking evaluated visually on a scale of 0–5, where 0 = no defects, and 5 = dense pattern of defects on weathered samples, with the number of samples on y-axis; Birch (a), spruce (b), and pine (c)

The pine samples cracked heavily almost regardless of modification—only the painted references showed negligible cracking. The material used was mature pine sapwood with a density of about 590 kg/m<sup>3</sup>. This is above the usually quoted range for Finnish-grown Scots pine (370–550 kg/m<sup>3</sup>; Puuinfo 2020). The total number of cracks was about the same as for weathered spruce, but they were deeper: some of the samples had cracked half-way through the entire specimen (Fig. 3). Thick boards are recommended for exterior claddings, and the basic recommendation in Finland is minimum 23 mm (RT 82-10829 2004). The higher mass helps reduce moisture-driven dimensional changes as the moisture has a larger volume to distribute over. Thickness was therefore prioritized when choosing boards for this experiment. Although higher density woods tend to erode slower than lower density woods (Sell and Feist 1986), Sjökvist et al. (2019) reported that high-density spruce wood suffered from more cracks, and the sorption differences between low- and high-density samples were more connected to the coating performance. Because the painted pine references remained intact, it may be concluded that the wood was not too dense for outside use, rather too dense for one-sided charring. It is likely the dense material accumulated more stresses during modification, which then released during weathering and resulted in severe cracking. One-sided charring creates sharp temperature and moisture gradients causing strong shrinkage and swelling stresses and, consequently, microcracking of the wood. These microcracks then easily transform into macrocracks due to cyclic drying and wetting and concomitant contraction and swelling. Contact charring attempts to avoid some of these problems by reducing the modification temperature and prolonging the modification time, but it seems this slower regime does not serve to reduce the cracking but rather increases it. Moreover, thermally modified wood has been reported to crack, even more than unmodified wood, when exposed to cyclic humidity conditions, despite the lower hydrophilicity (Altgen et al. 2017). This is likely a result of the more brittle nature of the wood. Additionally, existing microcracks caused by wood anisotropy, annual ring structure,

Birch exhibited a higher total number of cracks (Table S1), but they were generally shallower than those in the two softwoods. However, several birch samples had severe internal cracks visible from the transverse ends (data

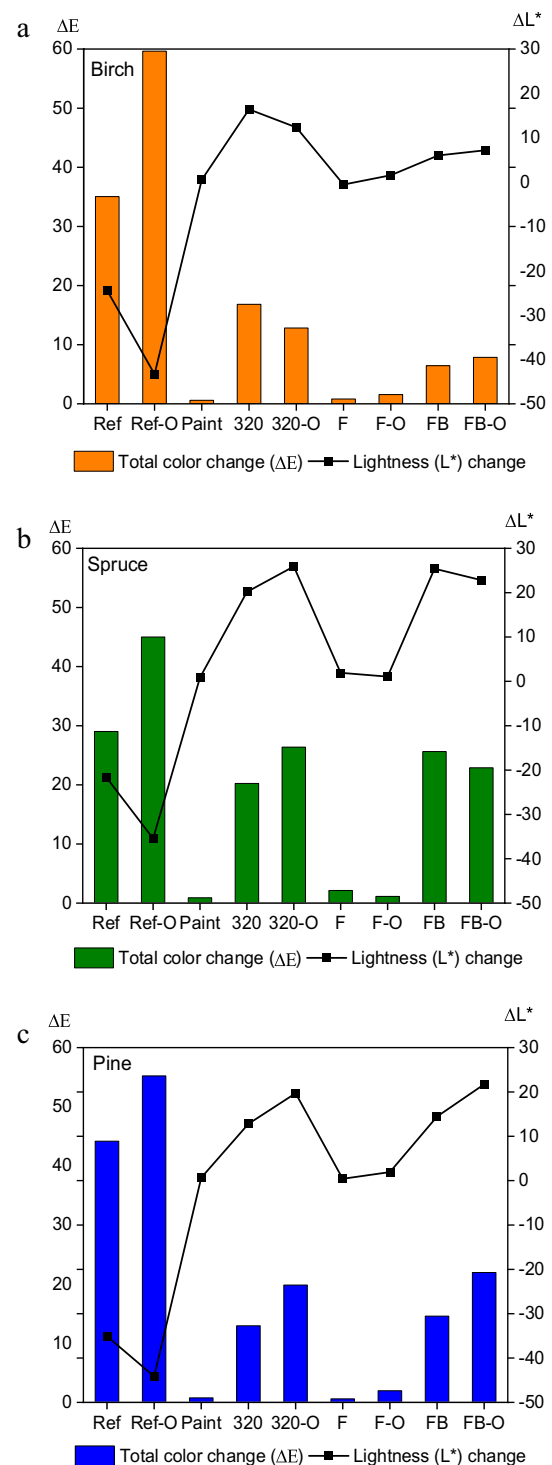
**Fig. 4** Total color change ( $\Delta E$ ) and change in lightness ( $L^*$ ) after natural weathering of birch (a), spruce (b), and pine (c)

All reference samples turned from beige to gray during the exposure. The oiled references were darker in color, some of the oiled birch references had even turned black from extensive weathering and molding. Contact charred samples retained their dark color in the latewood sections, but not in earlywood sections—the overall color change  $\Delta E$  was in the range 13–26 (Fig. 4). As mentioned, the point values were averaged and no separation between early- and latewood was made other than in visual evaluation. This was due to the fact that it was impossible to separate the different wood types in flame charred samples (and contact charred birch). The  $L^*$ ,  $a^*$  and  $b^*$  values increased, i.e., these surfaces became lighter and more red and yellow. Modified birch and pine samples showed less total color change than spruce, but the color change was less than for references in all cases. Flame charred samples remained black with relatively little flaking. Some of the original sheen was lost, but otherwise the samples showed little change in appearance during the weathering period. Color measurements verify the observation, with  $\Delta E$  remaining below 2.1 in all cases. Oiling somewhat dulls the sheen but brings out a bluish hue on the char surfaces at certain viewing angles, which was visible still after 1 year.  $L^*$  is the most sensitive and easily visualized parameter for wood surface quality during wood thermal modification, as well as weathering. Lightening of the color is related to degradation of lignin and extractives, that bring out the light-colored cellulose (Huang et al. 2012). The increase in  $L^*$  (Fig. 4) was seen in all samples but only a very small difference was measured for painted, F and F–O samples (all species). Flame charred and brushed samples (FB and FB–O) of spruce and pine went through similar change in appearance to the contact charred samples: the latewood sections remained dark, but earlywood sections were badly weathered (Fig. 5). Gray tones were detected and  $\Delta E$  was of similar magnitude to those of contact charred samples. Birch FB samples showed less changes. This is related to the

char layer properties, as the surface of this denser material is less prone to abrasion and was less affected by brushing. Therefore, more black char remained on the surface instead of the thermally modified transition layer that was revealed

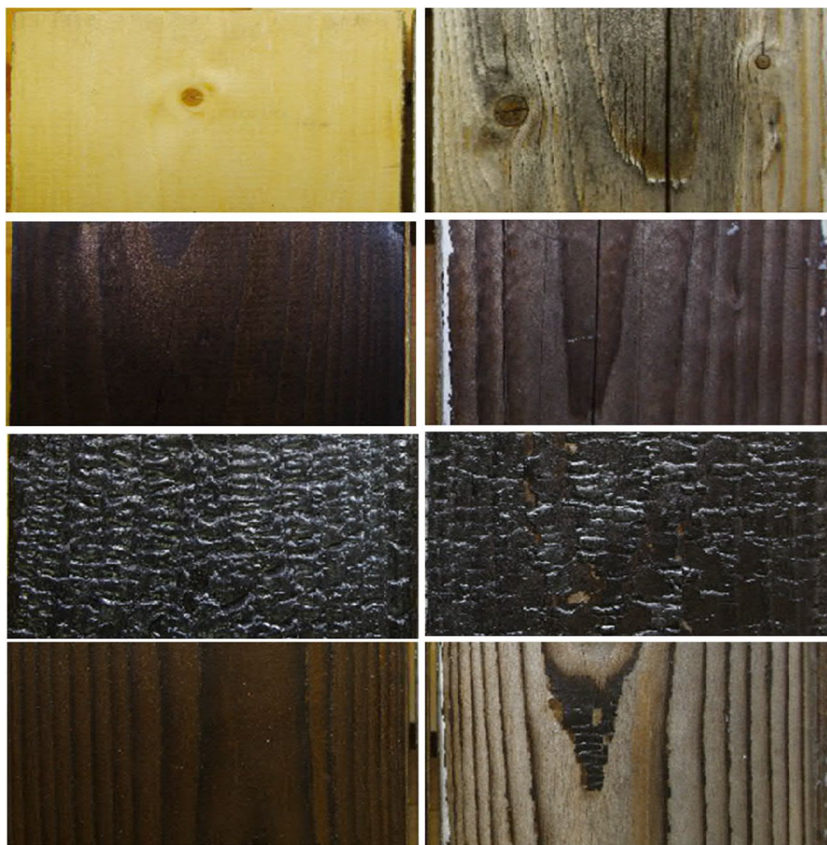
**Fig. 5** A selection of inside stored spruce references (left) and weathered specimens (right). From top to bottom: unmodified reference (Ref), contact charred (320), flame charred (F), flame charred and brushed (FB)

in softwoods. The char layer obviously protects the wood effectively against weathering damage, again highlighting the relevance of char layer thickness. All in all, the modified birch samples exhibited lowest values of  $\Delta E$ . This suggests that birch also benefited from the contact charring, though it is possible that mold affected the darker surfaces. To reveal the effect of mold, the modified samples should be examined further, preferably by chemical methods. One-way ANOVA showed that all groups (modifications) differed from each other both before and after the weathering. Further post hoc testing was applied to color values measured from modified surfaces (excluding Ref and Ref-O). The  $Q$  critical value was significant between modifications on all species with some differences: For spruce, the oiling did not affect color changes. For pine, the P320  $L^*$  did not differ from FB and FB-O, meaning that in terms of lightness values the contact charring was equal to flame charring combined with brushing. Oiling did, however, affect the other relations ( $a^*$  and  $b^*$ ). For birch, all modifications differed from each other significantly in terms of color values after weathering. Between species (within modification), the one-way ANOVA showed significant differences after weathering between all modifications except for paint ( $L^*$  and  $a^*$ ), and between 320-O, F, FB and FB-O ( $b^*$ ). The painted surface was thus unchanged during weathering, and contact charring combined with oiling experienced similar

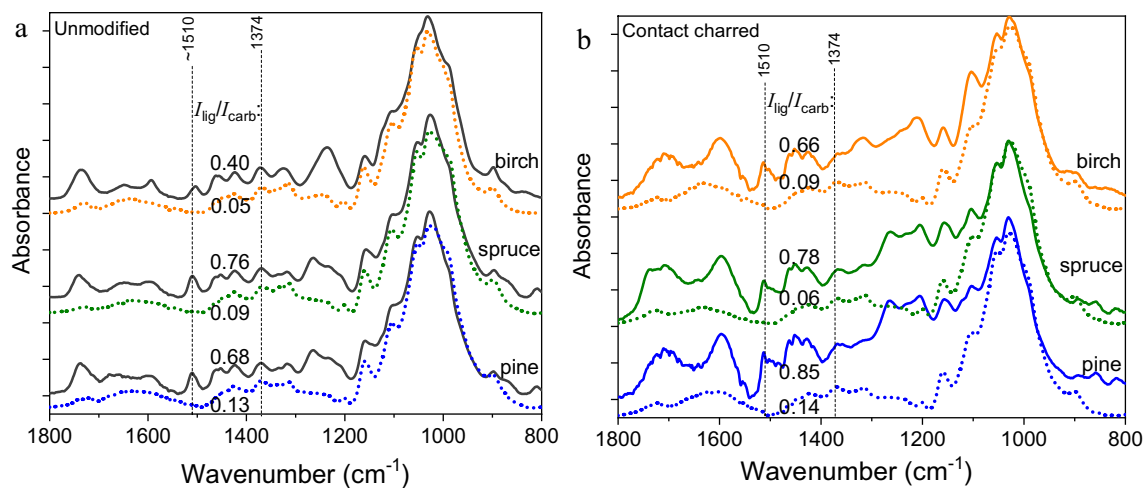
**Fig. 6** Infrared spectra of unmodified (a) and contact charred birch, spruce and pine wood (b). Solid line stands for samples before weathering and dotted line for samples after weathering

Chemical changes in the wood surfaces of unmodified and contact charred samples were assessed by FTIR (Fig. 6). However, the method was found to be unsuitable for flame charring modification due to the high degree of carbonization, which made calculation of peak ratios impossible. In this case, Raman spectroscopy was used (Fig. 7). Contact

In general, all the examined wood species undergo similar changes during the modifications (Fig. S3 in Supplementary Information). The carbohydrate peaks at around 1734, 1375, 1158, and 898  $\text{cm}^{-1}$  degrade and diminish, while the lignin reference peaks at around 1510, 1462, 1269/1330 and 1225/1122  $\text{cm}^{-1}$  (softwood/hardwood, Pandey and Pitman 2004) intensify. To reach a self-normalization allowing a reasonable comparison among species, avoiding effects such as sample preparation, a ratio of intensities between lignin aromatic band against holocellulose ( $I_{\text{lig}}/I_{\text{carb}}$ ) was assessed. As can be observed in Fig. 6a, the unmodified samples of pine and spruce presented a higher  $I_{\text{lig}}/I_{\text{carb}}$  ratio compared to birch wood. This higher ratio is in fact expected for softwoods (Barker and Owen 1999). The  $I_{\text{lig}}/I_{\text{carb}}$  ratio of contact charred samples, before weathering (Fig. 6b), increased when compared to its unmodified form before weathering (Fig. 6a), mostly due to the degradation of carbohydrates as a consequence of the charring treatment. This observation is less evident for spruce wood. The difference is small but is possibly connected to the higher amounts of extractives in pine, that may again increase the charring rate and therefore degradation of components especially at the lower end of the temperature range. In the unmodified weathered samples (Fig. 6a), the  $I_{\text{lig}}/I_{\text{carb}}$  ratio is near zero for all species, indicating heavy degradation of lignin during natural weathering. In the contact charred weathered samples (Fig. 6b), it is possible to observe a similar pattern, with  $I_{\text{lig}}/I_{\text{carb}}$  ratio reaching zero and indicating extensive deterioration of lignin. In both cases, the  $I_{\text{lig}}/I_{\text{carb}}$  ratio for pine after weathering is slightly higher than the other two species, meaning that pine may be more resistant to weathering. This can be related to its slightly higher amount of lignin and higher density (Sell and Feist 1986; Sandberg 1999).

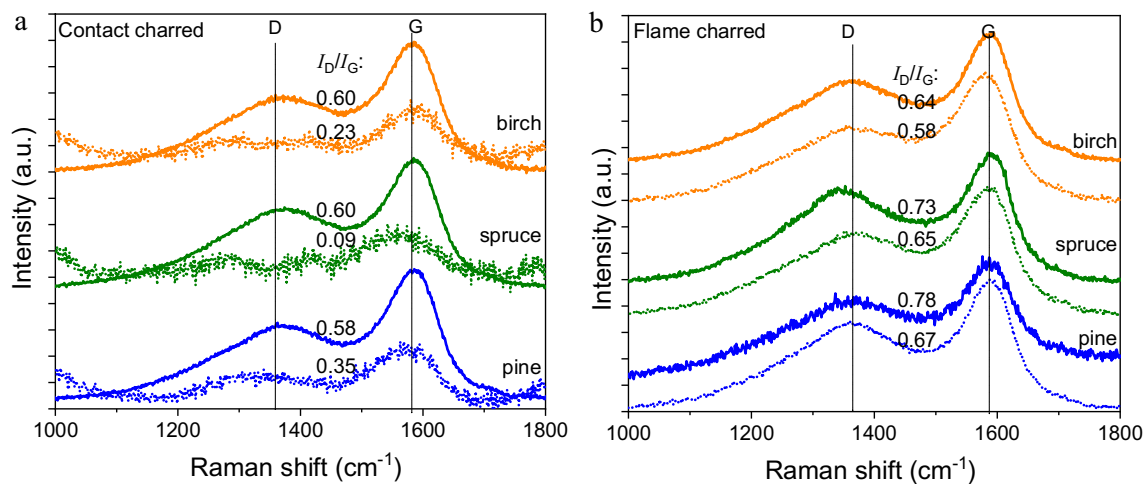
**Fig. 7** Raman spectra from the surface of contact-charred wood (a) and flame charred (b), before weathering (solid line) and after weathering (dotted line)

Raman spectroscopy allowed for a more detailed comparison between contact and flame charring treatments, where analysis of the *D* and *G* bands further elucidated the compositional changes. These bands are the most prominent signals and commonly investigated in carbon materials (Bengtsson et al. 2020). The intensity ratio of *D* and *G* ( $I_D/I_G$ ) can provide information about the carbon structure of the material, where *G* is known as the graphite band with a vibrational frequency at  $\sim 1580 \text{ cm}^{-1}$  due to the  $\text{sp}^2$  bonded carbon in planar sheets, and *D* ( $\sim 1350 \text{ cm}^{-1}$ ) is known as a defect-induced band indicating the presence of some disorder. Thus, comparing the  $I_D/I_G$  values between contact (Fig. 7a) and flame (Fig. 7b) charred samples, before weathering

(solid lines), it is possible to observe ratios of 7, 22 and 50% higher in flame charring for birch, spruce and pine, respectively. This is mostly associated with a higher intensity of the defect-induced *D* band, as *G* band presented similar shape and intensities in both treatments (Fig. S4 in Supplementary Information). These values infer a higher graphitization of flame-charred samples. In fact, when analyzing the modified samples after weathering, the *D* and *G* intensities almost disappear for contact charred samples (except for pine, supporting the observations of higher weathering resistance from FTIR, Fig. 6), while the flame-charred samples presented only a slight decrease (9, 11 and 14% for birch, spruce and pine, respectively) in the intensities after weathering. These results confirm a strong surface change after flame charring, conserved after weathering, similarly for all species.
