A humidity-induced novel failure mechanism in power semiconductor diodes

J. Leppänen [a],[*], G. Ross [b], V. Vuorinen [b], J. Ingman [a], J. Jormanainen [a], M. Paulasto-Kröckel [b]

[a] *ABB Drives, Finland*
[b] *Aalto University, Finland*

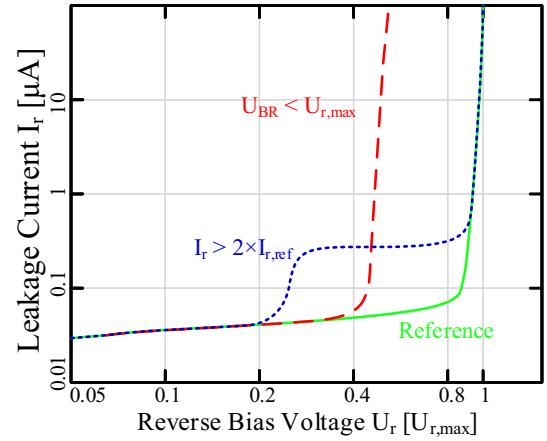
Based on earlier studies [7,10,11], there are two electrical deterioration modes expected during the test described in Fig. 1. The failure behavior is reported to be seen either as an increasing leakage current or as a premature voltage breakdown when compared with the reference curve tracer measurements done prior to the H3TRB test [9,17].

Fig. 1. The reverse bias leakage characteristic curve (the green solid line) shows the reference reverse voltage blocking characteristics of a nominal device, (the red dashed line) shows a decreased breakdown voltage and (the blue dotted line) shows a premature increase of the leakage current. (For interpretation of the references to colour in this figure legend, the reader is referred to the web version of this article.)

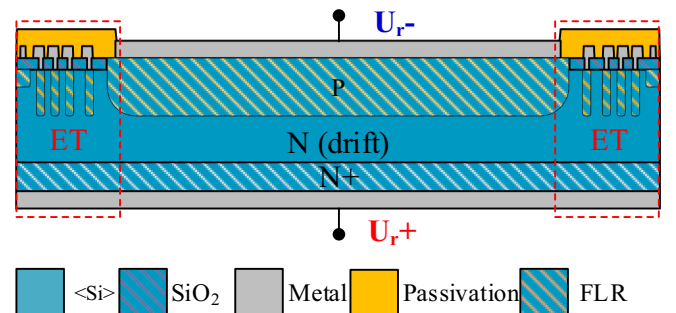
semiconductor device is arranged as pictured in Fig. 2 for a simple power semiconductor diode using field limiting ring (FLR) edge termination (ET) structures [18,19].

It is crucial to remember the direction of the electric field gradient in reverse bias conditions when considering possible failure mechanisms, for example electrochemical corrosion (EC) and associated migration directions, based on the actual ionic species in question. In Fig. 2 it is demonstrated that the top electrode (U_r-) is equivalent to the P-side (anode) and the bottom electrode (U_r+) is the N-side cathode in a diode configuration when reversely biased [18]. Similar devices are used either as an anti-parallel diode in buck/boost converter topologies and also in different rectifying bridge topologies [20,21].

Fig. 2. A power semiconductor diode reverse biased with its ET structures based on FLRs (red dashed boxes). (For interpretation of the references to colour in this figure legend, the reader is referred to the web version of this article.)

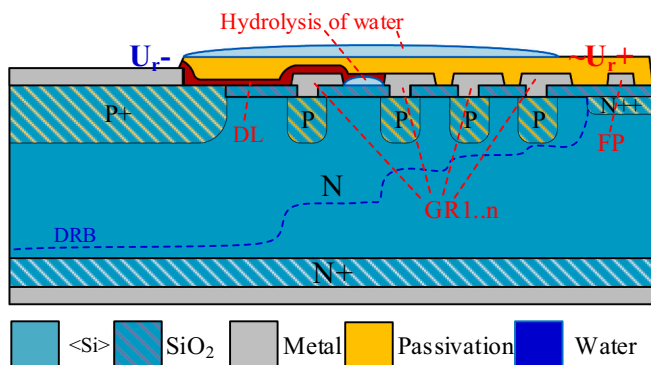
Fig. 3. Moisture can agglomerate onto the surface of the passivation or enter the area between two GRs or FPs due to the delamination (DL) of the passivation (shown in dark red), as described in [7,14,17]. (For interpretation of the references to colour in this figure legend, the reader is referred to the web version of this article.)

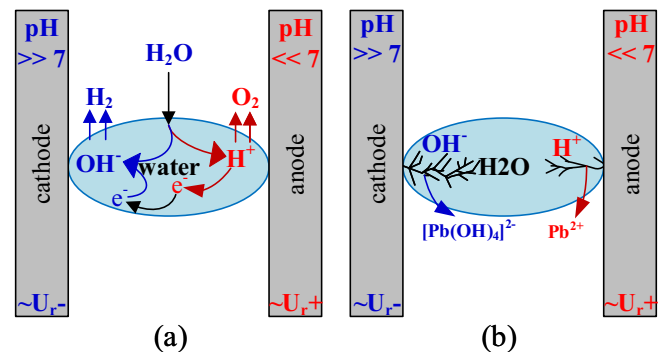
At the anode, according to Eq. (1), it is suggested that the pH $\ll$ 7, and respectively, at the cathode, according to Eqs. (2a) and (2b), the pH $\gg$ 7 (i.e. a large pH gradient exists between the anode and the cathode) [28,29]. These facts arise from the accumulation of OH^- ions at the cathode and H^+ ions at the anode side, as summarised in Fig. 4a.

The pH gradient can be associated with the ECM of metallic species, as described with Cu, Ag [7], Sn [28,29], and Pb [30]. Fig. 4b shows a basic example of the ECM process of positive metal ions from anode to cathode and the forming of a dendritic structure based on the dissolution of M^{n+} in a low pH solution [31]:

Fig. 4. Hydrolysis (a) leads into a large pH gradient [7,23] between cathode-anode electrodes forming an electrolytic cell, which can lead into (b) the ECM of some metallic species, e.g. Cu, Ag, Al, Pb, forming a dendrite between cathode and anode [7,30].

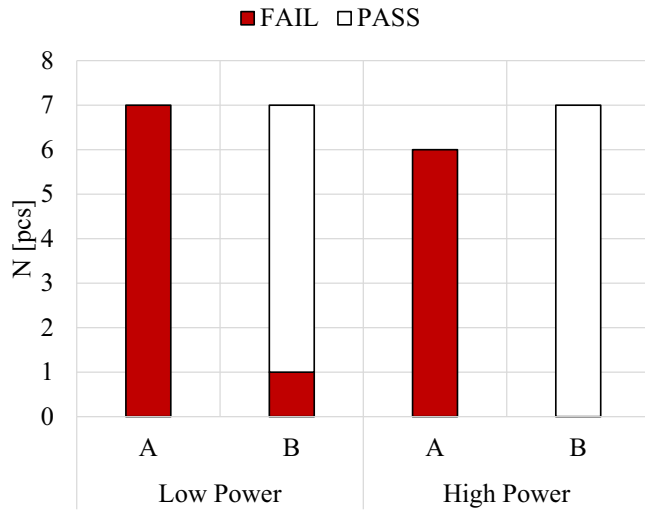
Based on the in situ monitoring during the H3TRB-HVDC test, all booster modules from vendor A failed between 900 and 1200 h due to a short circuit while their competing counterparts from vendor B with a passivation based on polyimide (PI) survived the test with only a single failure, as can be seen in Fig. 5. A single booster module from vendor A (high power) was removed from the statistics since it was mechanically damaged during the preparation of the test.

Fig. 5. A summary of the H3TRB test results after 1200 h based on in situ leakage monitoring with $I_r > 2 \times I_{r,\text{ref}}$ as a failure criterion for booster modules used in 50 kW (low) and 60 kW (high) power converters.

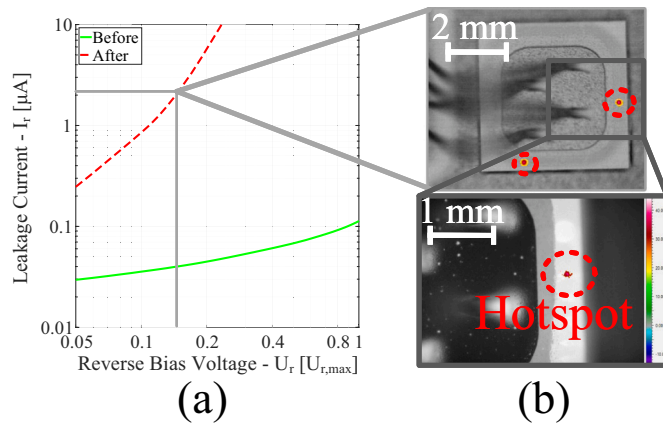
The failures were detected by in situ leakage current monitoring and the associated channel power supply was cut manually shortly afterwards. After the test was completed, an electrical characterisation was made for all samples with a curve tracer, as shown in Fig. 6a.

Fig. 6. Device characterisation with (a) a curve tracer showing increased leakage currents and (b) LiT localising the thermal hotspots (the red dashed circles) when biased with $U_r \approx 200$ V (the gray solid line). (For interpretation of the references to colour in this figure legend, the reader is referred to the web version of this article.)

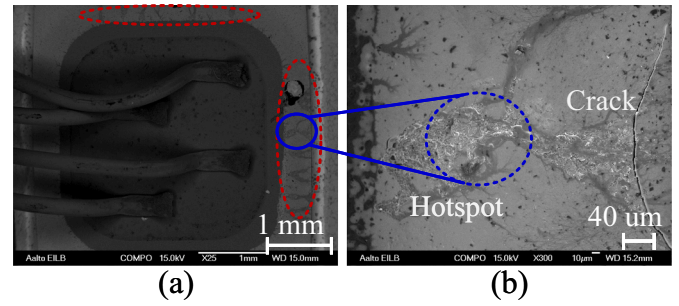
Majority of the failures had short circuit when characterised with the curve tracer. However, four failed samples were only showing major deterioration in leakage characteristics. These failed samples showed visually detectable treelike structures on diode edge termination structures when inspected with optical microscope. It was assumed that these four samples were in earlier stage of the same failure mechanism as most of the failures. Therefore, these four modules were determined to be less damaged and suitable candidates for further failure analysis. After this LiT was used to localise the failure into a single chip, as shown in Fig. 6b. LiT analysis revealed no thermal hotspots in any of the transistor chips (i.e. IGBT or MOSFET) in parallel with the diodes during the test; however, the results consistently showed thermal hotspots on top of the diode chips, both in low- and high-power variants from vendor A. *superior* robustness of IGBT and MOSFET chips could be explained by their different edge termination topologies associated with polyimide passivation. An SEM was used to analyse the hotspot location identified by the LiT analysis in Fig. 6. The SEM analysis (see Fig. 7) revealed that the edge termination region was filled with multiple treelike or dendritic structures, generally spanning out in the direction of the electric field gradient.

Fig. 7. A top view SEM image shows treelike structures growing (a) all over (the red dotted circles) the top of the glass-passivated diode edge termination while (b) the localised hotspot (the blue dotted circle) shows possible remnants of a highly deformed treelike structure with a visible crack in the glass. (For interpretation of the references to colour in this figure legend, the reader is referred to the web version of this article.)

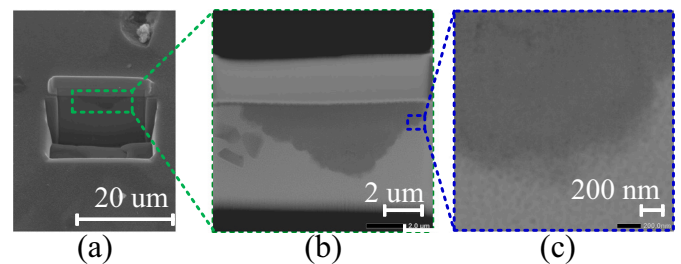
In regions where treelike structures had grown long enough to cause a local short circuit there were local changes (i.e. cracks in glass passivation and changes in the glass surface morphology). These changes were not observed on shorter treelike structures, which indicate that the changes in morphology and cracks were collateral damage possibly caused by local thermomechanical stresses due to the excess leakage current densities. It became evident that some of the treelike structures seemed to expand over the entire passivation, to the edge of the chip. Generally, the longer structures showed obvious surface deformation of the glass passivation, probably due to the excess leakage power flowing through the structures. However, some of the dendritic structures were much shorter and did not contain any obvious deformation. Further investigation of one of the shorter dendrites after a cross-section (an X-section) was made with a focused ion beam (FIB) revealed that the analysed structure was growing inside the glass passivation, as can be seen in Fig. 8a.

A STEM also confirmed that the dark field (DF) image shows that the dendrite bears no crystalline structure (see Fig. 8b–c), thus, the structure is amorphous, similar to the rest of the glass passivation. The lack of (single or poly-) crystallinity in the treelike structure is contradictory to the failure mechanisms described in the related literature (i.e. ECM of metallic species) [30]. Furthermore, in a recent article the dendrites were described as growing on top of the passivation film rather than inside the solid [7]. The glass passivation showed no signs of porosity and the amorphous treelike structures seemed to be part of the same bulk material.

Fig. 8. A FIB X-section shows (a) the treelike structure growing inside the glass rather than on top of it in an SEM image, (b) a lamella made from the X-section shows no inter-boundary phases and (c) the structure is confirmed to be amorphous in a dark field STEM image of the lamella.

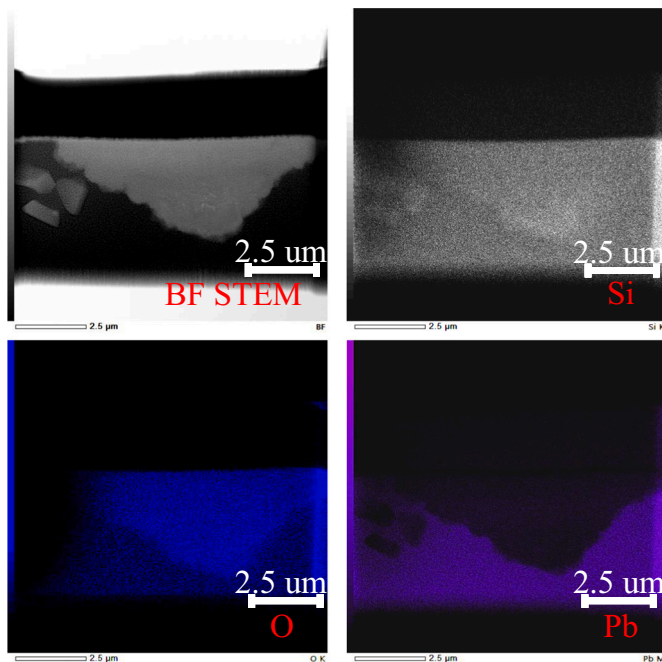
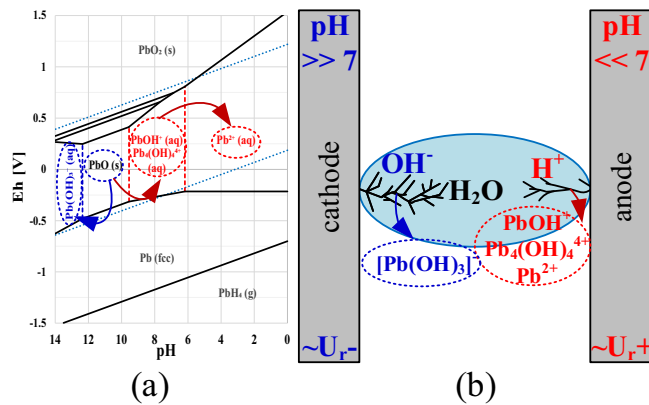
Lead monoxide (PbO) is known to be amphoteric, but its Pourbaix (Eh-pH) diagram in moderate concentration H_2O-PbO system is not described in any of the common databases [45,46]. Instead, lead dioxide (PbO_2) is often described [41,45]; however, in [46] lead monoxide was already considered in mild conditions and found to be soluble in alkalic solution. Based on thermodynamic calculations of a moderate PbO (10^{-3} mol/l) concentration in [42], an Eh-pH diagram of an H_2O-PbO system is recreated in Fig. 11a, which is used to emphasise that, in principle, PbO can be immune in range from moderately to highly alkalic solution [42].

However, contradictory to [42], it is suggested in [47] that the stabile region of PbO (s) is shifted closer to the neutral pH and it could also dissolve directly in Pb^{2+}(aq) [46,47]. Nevertheless, the two-phase dissolving process of lead oxide may be responsible for the lower thickness of the secondary (reverse) treelike structures witnessed in Fig. 10b on the anode side. However, there could also be other anodic processes involved in lead glass leaching. Therefore, on the anodic side, a two-phase process maybe involved (see Fig. 11a–b) with the growth of reverse trees, starting with the dissolving of lead oxide into lead hydroxides near neutral pH via the process described in Eqs. (4a) and (4b)

Fig. 11. The EC of lead oxide as described in (a) Pourbaix diagrams of lead oxide (PbO) in a moderate (10^{-3} mol/l) electrolytic aqueous solution at room temperature [42], which acts as a basis for (b) bi-directional water treeing, which can cause localised leaching (e.g. of lead electrochemical corrosion products) [31,42,45].
