*Published in:*  
Nuclear Materials and Energy

## Study of cracking and microstructure in Co-free valve seat hardfacing

This study is based on the investigations of one cracked NPP swing check valve plug. This work aims to investigate the potential cause of the through-the-thickness cracking of the hardfacing deposit made from

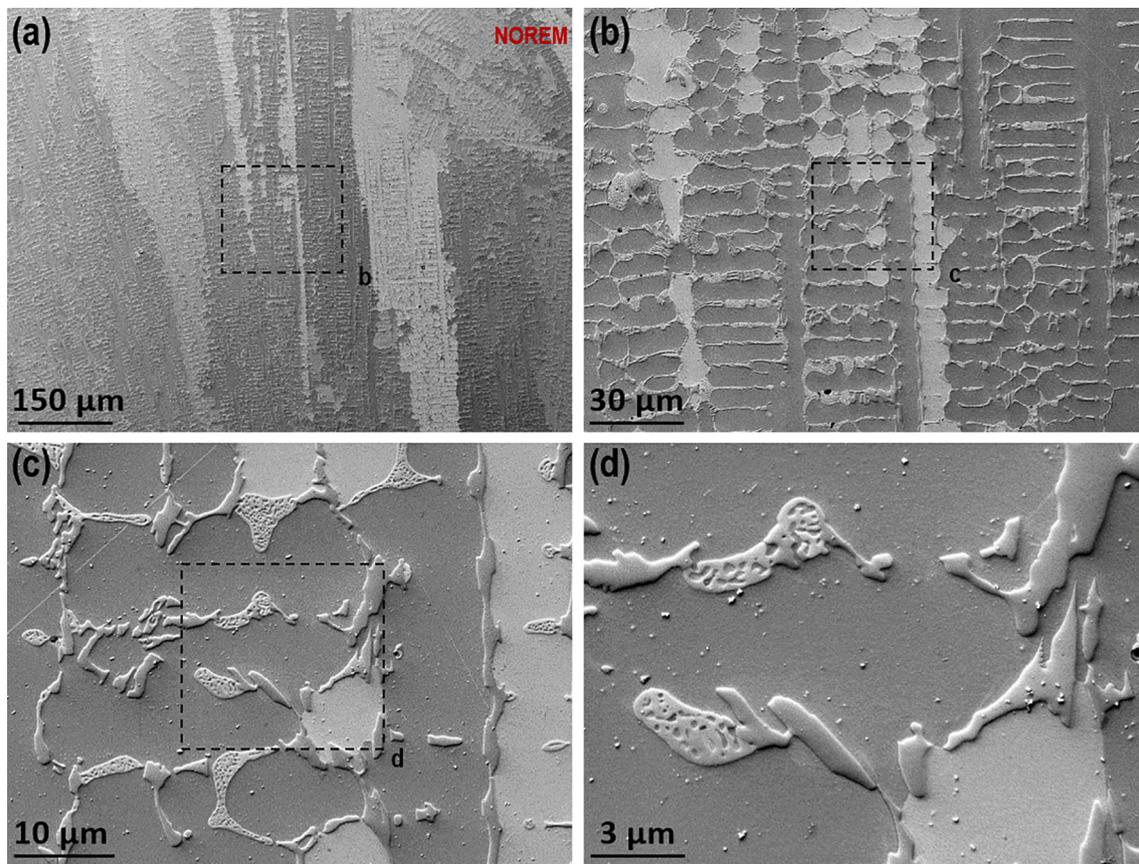
The microstructure of representative intact NOREM 02 hardfacing material was comprehensively investigated from Fig. 11 to Fig. 14. The typical microstructure of solid-solution strengthened NOREM 02 hardfacing material consists of a dendritic austenitic matrix with ID network of carbides with M7C3 type (with very limited fraction of M23C6 type). Eutectic complex carbides rich in Fe-Mn-Ni and Mo-V-Si and non-eutectic carbides rich in Cr-V were found (Fig. 12). The chemical composition of the carbides varied slightly from the intact area to the

Fig. 11. (a-d) low kV SE images of the NOREM 02 hardfacing microstructure from a location far away from the main cracking. The austenitic dendrites were  $\sim 10 \mu\text{m}$  in size.

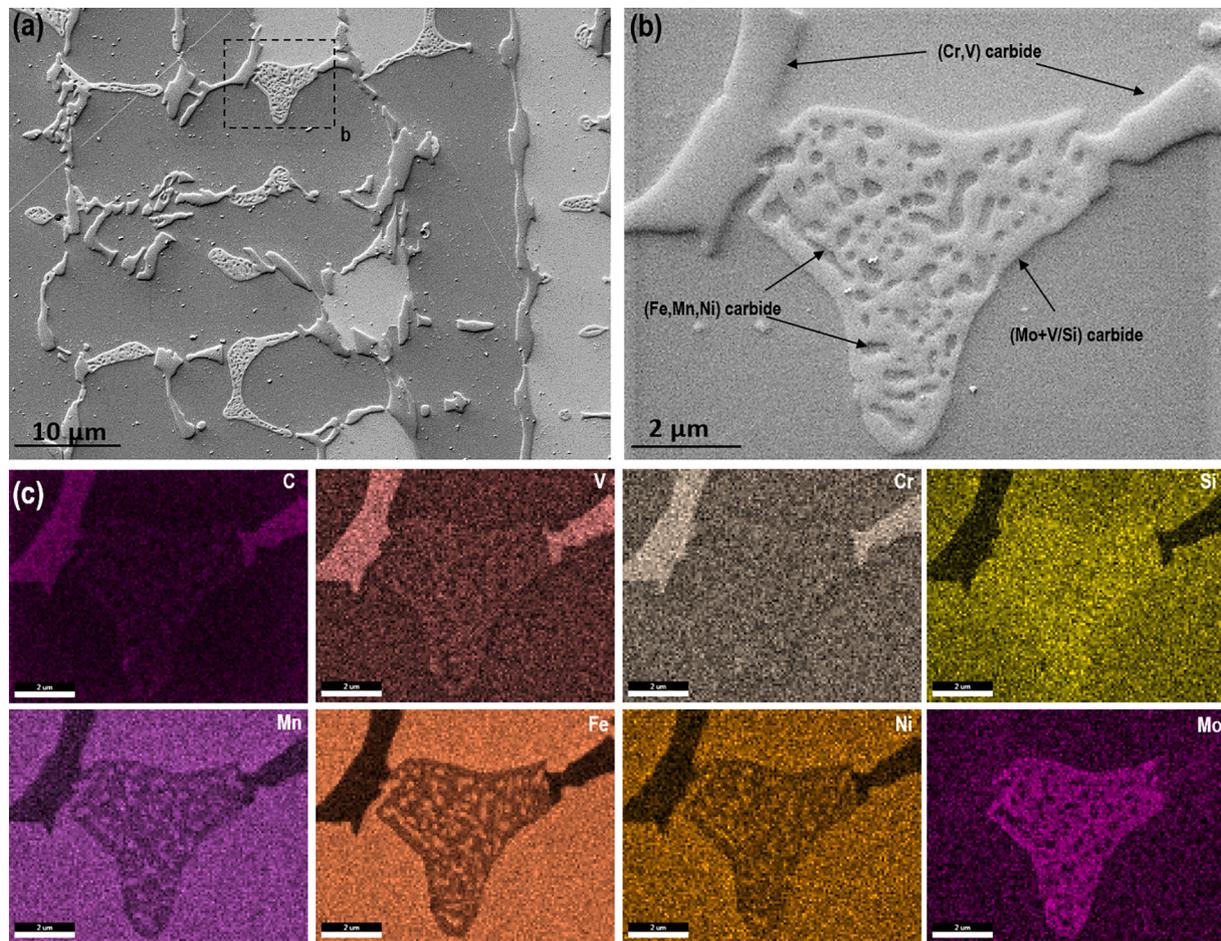
Fig. 12. (a-b) low kV SE images and (c) EDX mapping of the area in b.

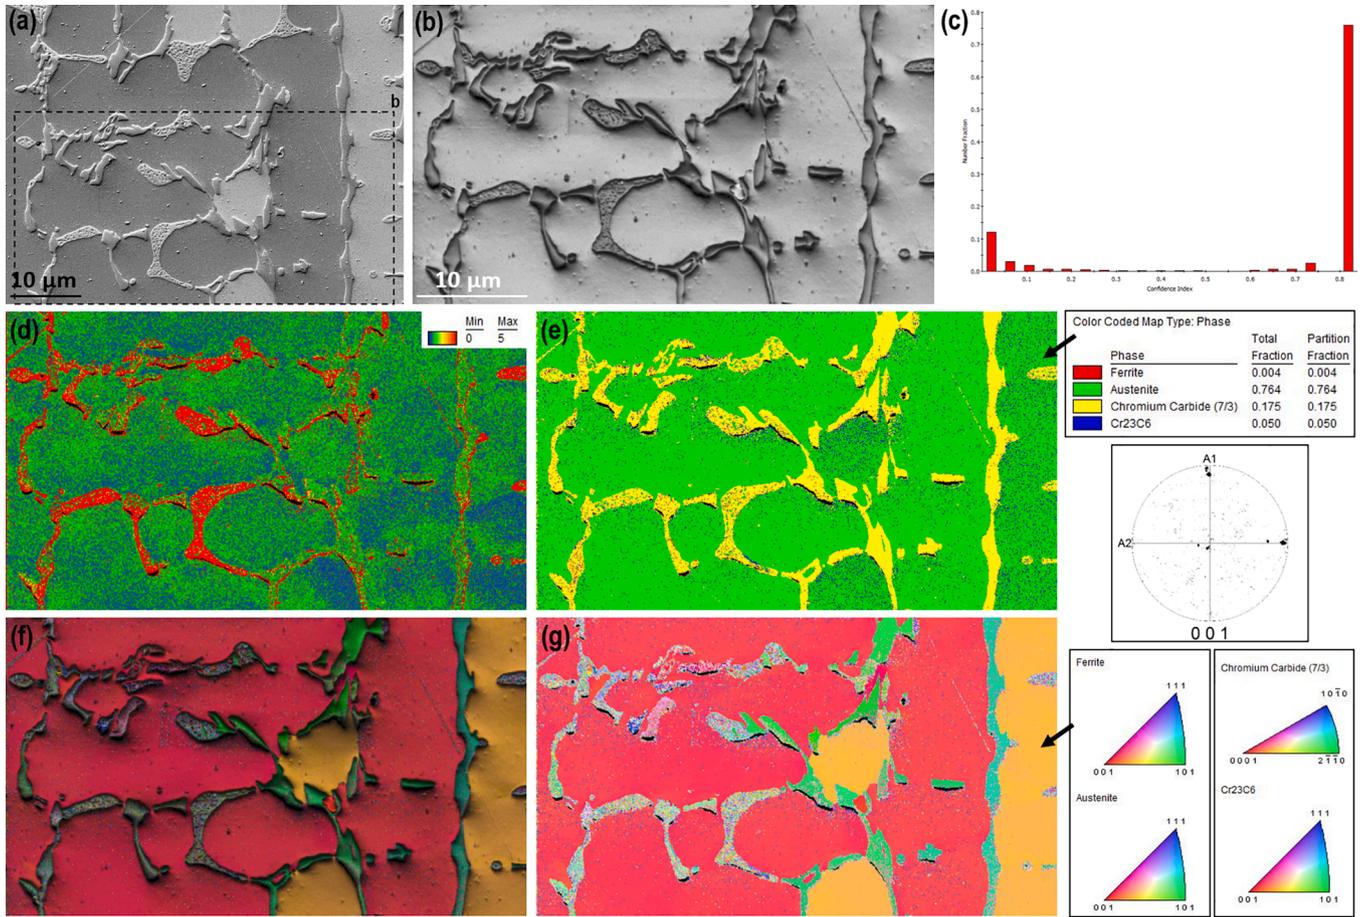
Fig. 13. (a) low kV SE image, (b) IQ image, (c) correlation of number fraction with coincidence index, (d) KAM map, (e) phase map, (f) IQ + IPF and (g) IPF image.

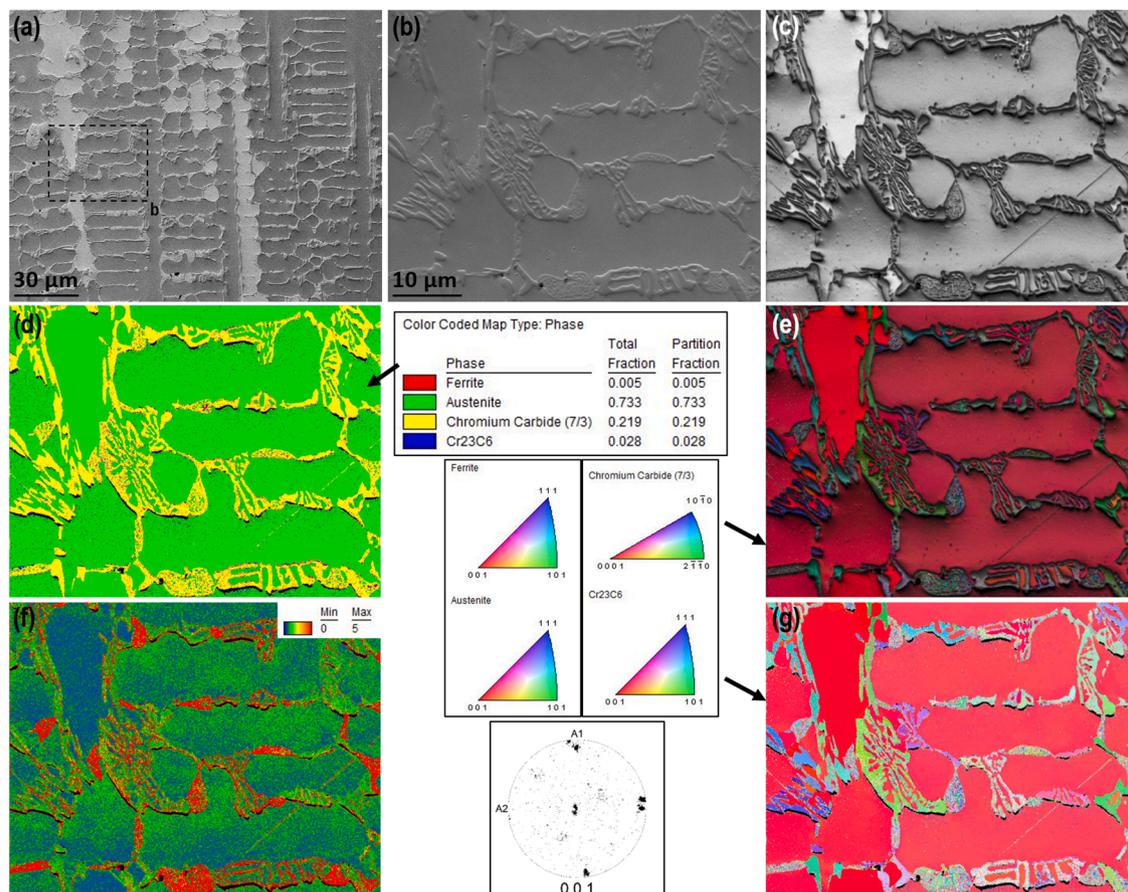
Fig. 14. (a) low kV SE image, (b) high kV SE image, (c) IQ image, (d) phase map, (e) IQ + IPF, (f) KAM map and (g) IPF image. (b-g) are from the area with inset in (a).
