Savolainen, Panu; Seppänen, Liisa; Laine, Laura; Huttunen, Marko; Aakala, Tuomas  
**Revealing the Innovations in Late Medieval Roof Structures of Finland**

INTERNATIONAL JOURNAL OF WOOD CULTURE

# Revealing the Innovations in Late Medieval Roof Structures of Finland

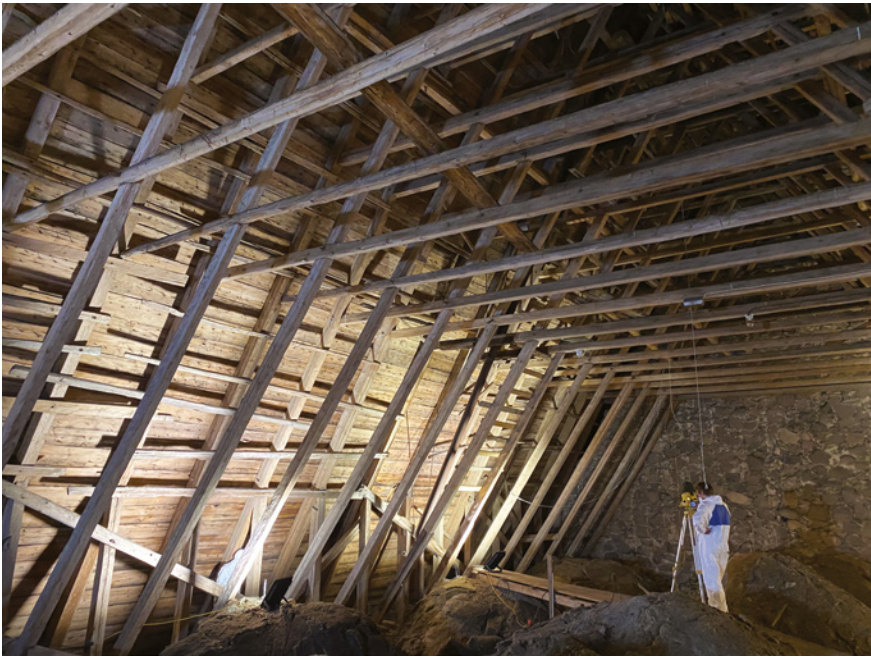
FIGURE 5 The roof structure of Pyhtää church (1461–1462d)  
PHOTO: PANU SAVOLAINEN

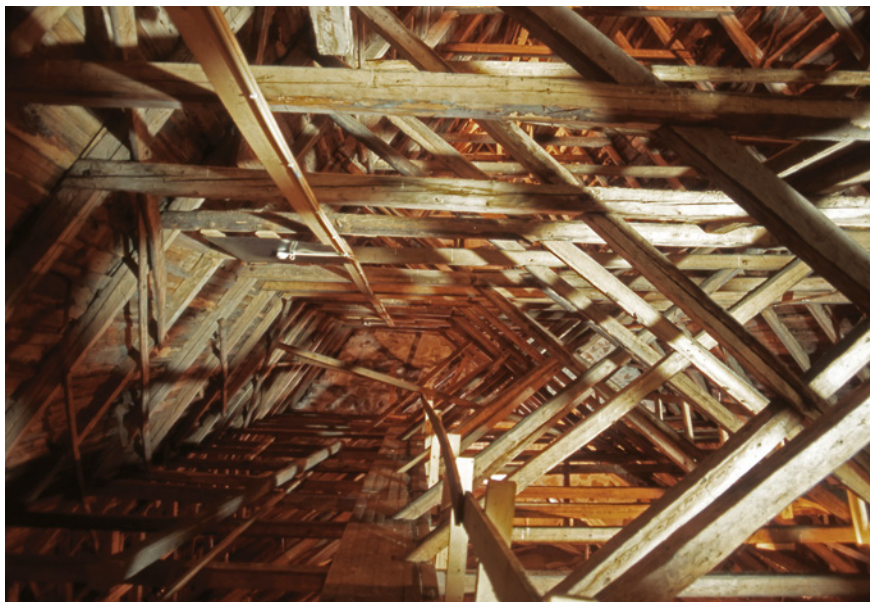
FIGURE 6 The roof structure of Pernaja church (1440d, 1452–1453d)  
PHOTO: LIVADY

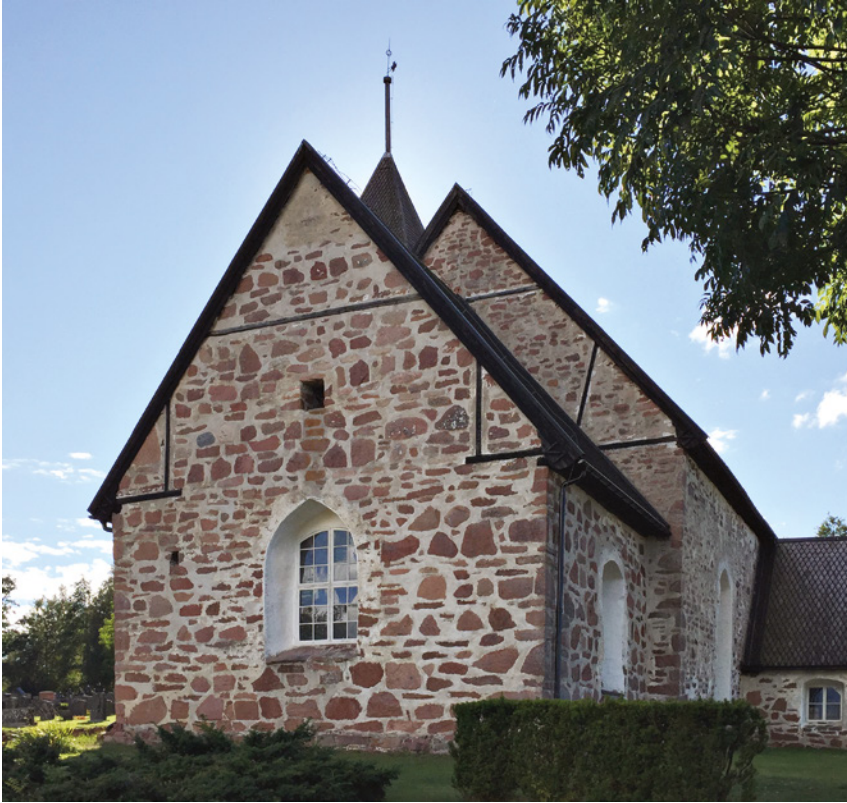
FIGURE 7 Hammarland church with both tie beam truss and rafter foot truss visible in the gables

The Hammarland Church on Åland islands is exceptional because the preserved roof constructions from the 15th century comprise both tie beam trusses and rafter foot trusses without tie beams. The nave of the church was built in the beginning of the 14th century (Hiekkanen 2014), but after the fire, the roof construction was rebuilt around 1440d according to dendrochronological data (Ringbom & Renner 1995). The construction of the nave in the 1440s is a tie beam structure (Figs 7–8). For some reason, the roof of the chancel was erected only later, in the 1460s. The roof of the chancel is a rafter-foot structure without a tie beam. Dendrochronological dating (Ringbom & Renner 1995) indicates that the timber was felled in 1465d.
