## Repairing of exit-hole in dissimilar Al-Mg friction stir welding: process and microstructural pattern

*Published in:*  
Manufacturing Letters

**Keywords:** exit-hole; friction stir welding; microstructure; repairing; welding

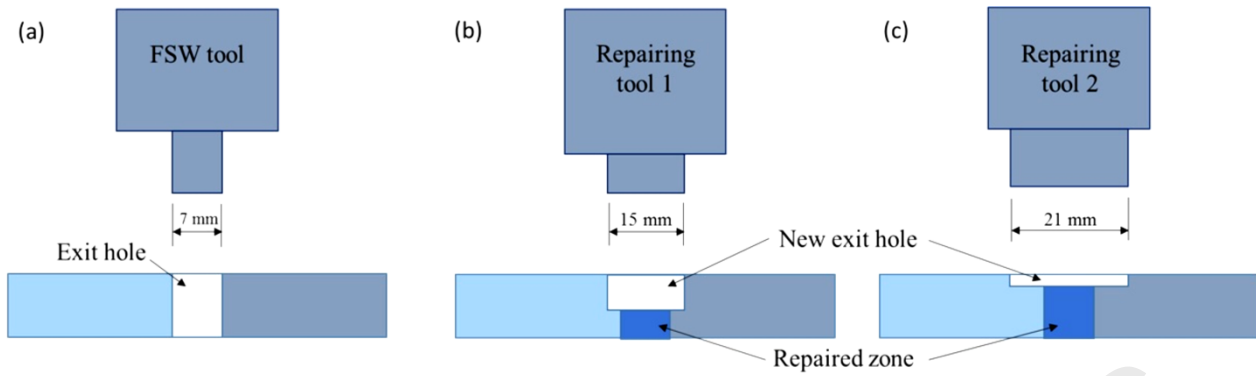
Fig. 1 Process: (a) FSW exit-hole, (b) Repairing phase 1, and (c) Repairing phase 2

Dissimilar FSW was performed on 6061 Aluminum alloy and AZ31B magnesium alloy as per process conditions of Mehta et al. [17]. Fig: 1 shows novel procedure to repair exit-hole of dissimilar FSW. The exit-hole of Al-Mg weld was repaired by two non-consumable probe less tools. In this work, the best set of process parameters was used after feasibility experiments. The repairing tools were plunged with rotational speed of 1070 rpm and plunge rate of 3 mm/min in both cases. The tool diameter was kept bigger than exit-hole diameter so that the bottom surface of tool makes contact with surface of workpiece that in turn fills the cavity of exit-hole by material deformation and subsequent vertical movement. Two different tools were designed in order to fill 6 mm deep cavity of exit-hole as shown in Fig: 1 (b) and (c), which were having their diameters as 15 mm and 21 mm respectively. A new exit-hole was left after two stages of aforementioned repairing, which was having around 1 mm depth and 21 mm width. This new exit-hole can be further settled with grinding and finishing operations.

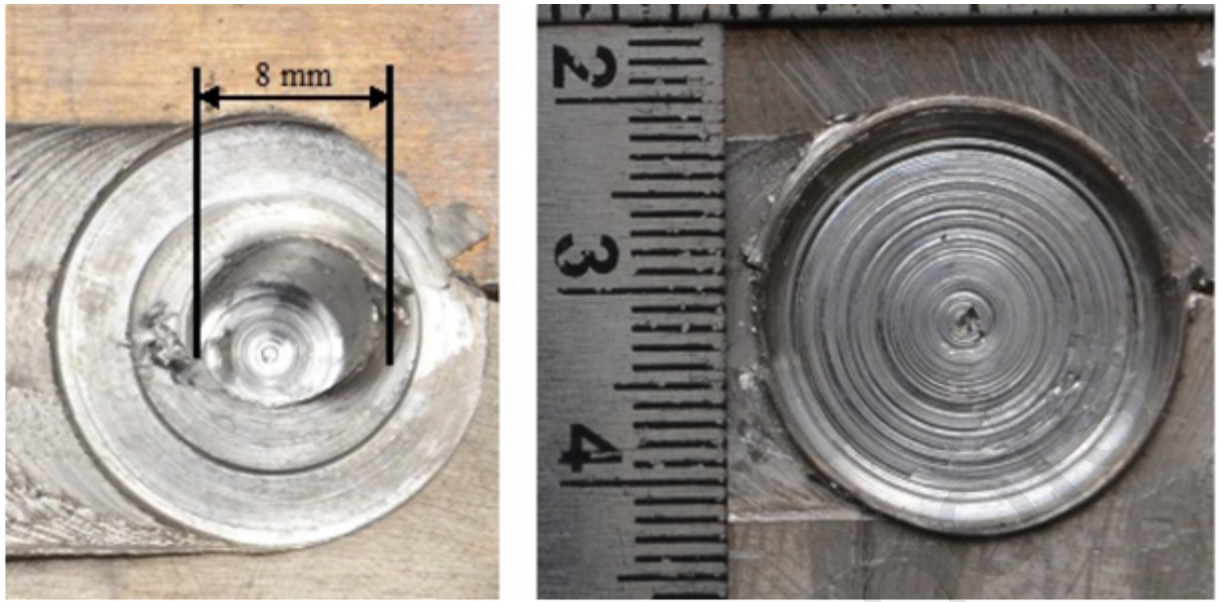
Fig: 2 Surface morphologies of (a) exit-hole and (b) repaired zone

Fig: 2 shows surface of exit-hole before and after its repairing. It can be seen from surface inspection that a deep cavity of exit-hole is satisfactorily repaired without any surface defects. Fig: 2 (b) is showing new exit-hole having its large width of 21 mm and very small depth of around 1 mm. This was further processed by grinding and finishing.

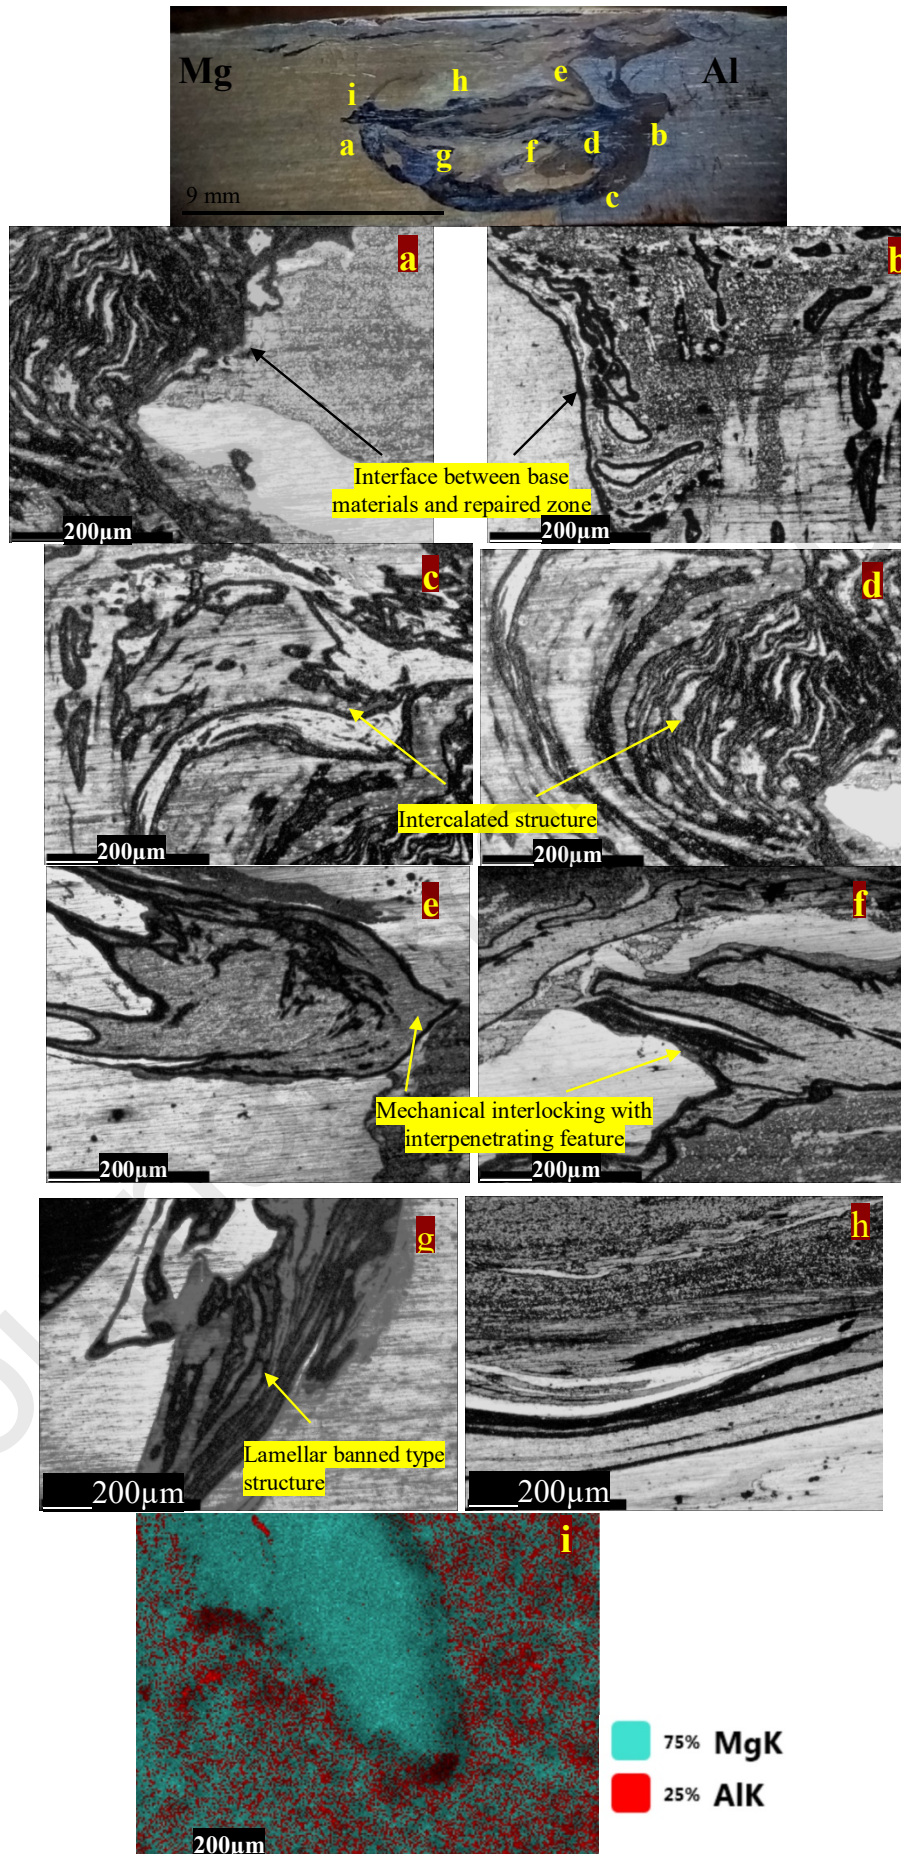
Fig: 3 Material mixing and microstructures of dissimilar Al-Mg exit-hole repaired portion

Fig: 3 shows material mixing and microstructures of exit-hole repaired portion. It can be seen that the material mixing is very complex and unique considering Al-Mg welding. The bottom portion in the vertical cross section can be observed more complex as revealed by different features. There was no severe grain refinement observed unlike stir zone of FSW (refer Fig: 4) as stirring was not present and heat input was not adequate that induce grain growth after severe plastic deformation. The repaired zone of exit-hole was consists of interpenetrating features and lamellar structure, which was recommended as desirable structures of Al-Mg FSW [18]. It is suggested that combined action of rotation and forging resulted a drastic crushing action of workpiece material beneath the tool surface caused by plastic deformation. This in turn directed a deformed material towards bottom portion when tool: 1 was subjected. Intriguing features of intercalated banned type structures can be observed in the bottom portion. The intercalated microstructure of Al-Mg repaired zone was caused by distinct deformability behavior of Al and Mg and severe deformation during forging and swirling of Al and Mg. The vortexes and swirling were caused due to rotation and axial pressure that in turn resulted in helical material movement in axial direction. Due to this the lamellar type strips of Al and Mg were observed. These structures are consisted of large Al and Mg solid solution particles along with its reaction layers

of intermetallic compounds (IMCs). The diffusion layer with formation of IMCs (with phases of  $\text{Al}_3\text{Mg}_2$  and  $\text{Al}_{12}\text{Mg}_{17}$ ) and Al-Mg and Mg-Al solid solutions in the stir zone were identified in the same sample [17]. Similar phases can be expected in the repaired zone with solid state diffusion and constructional liquation mechanisms. These type of diffusion layers are usually found at reaction zones where the elements of Al and Mg are interacted. The amount of deformation was less in case of tool: 1 compare to tool: 2 as tool: 1 was having smaller diameter than tool: 2. In case of tool: 2, the same phenomenon of material mixing in vertical direction may have resulted with larger heat input. However, the top portion filled in repaired zone was without such complex features as larger diameter may have allowed more intermixing than bottom portion (as can be evidenced from Fig: 3 (a, b, c, d, f and g)). The intermixing of Al and Mg was evidenced by elemental mapping as can be seen from Fig: 3 (i) performed in between top and bottom portion of repaired exit-hole. The microstructures also reveal that the joining mechanisms were like mechanical interlocking with tortuous interfaces of Al and Mg particles with intermixed structure and matrix of Al and Mg at different portions along with obvious chemical bonding of IMCs (phases of  $\text{Al}_3\text{Mg}_2$  and  $\text{Al}_{12}\text{Mg}_{17}$  are expected based on stir zone studies [17]).

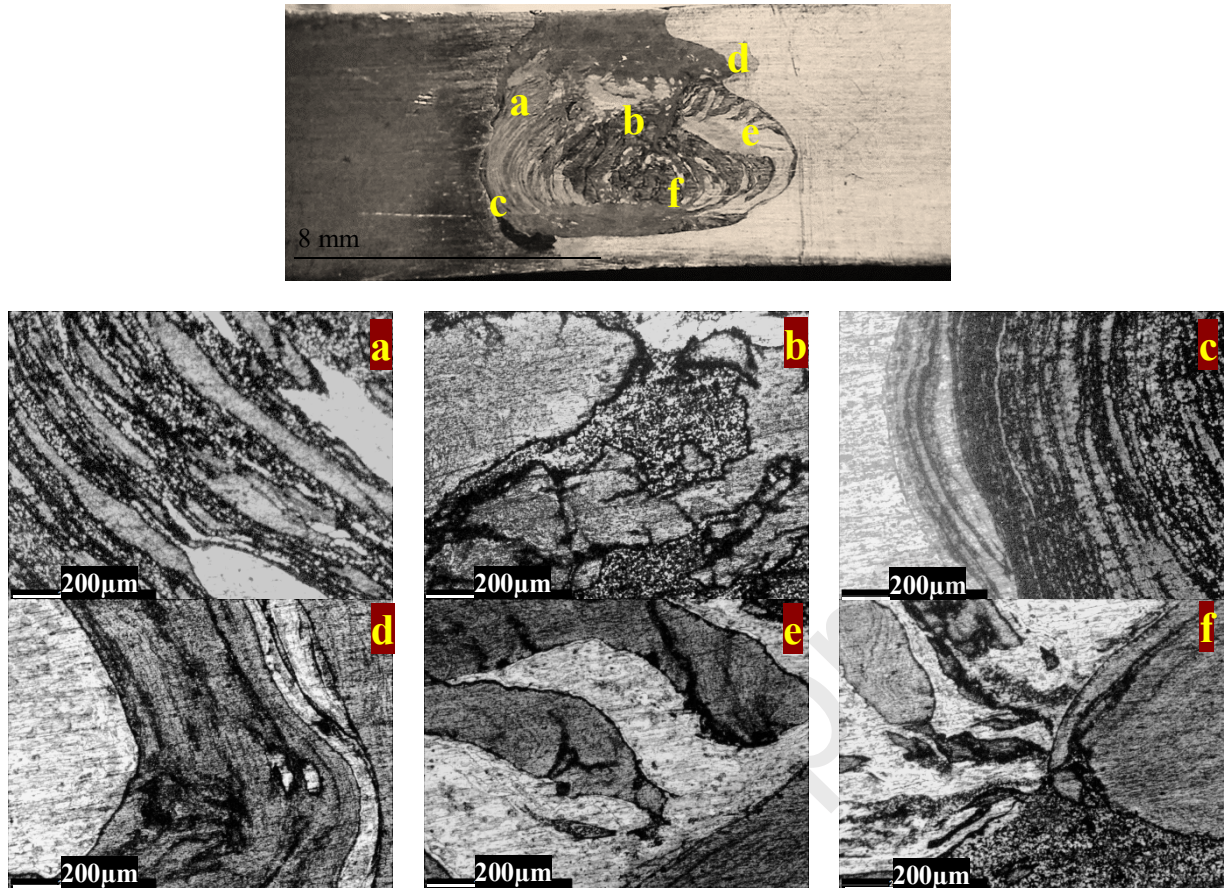
Fig: 4 Microstructural features of dissimilar Al-Mg friction stir welded stir zone

Besides, Fig: 4 shows microstructural features of the stir zone of Al-Mg FSW. Dissimilar materials Al and Mg are mixed together due to stirring action followed by material movement like onion rings that typically found in FSW. Obvious interface between Al-stir zone-Mg are distinguishable [Fig: 4 (a, c, d and e)] with each other, and also different than the repaired zone. Intercalated lamellar structure can be found at many instances in Fig: 4, however, totally different than repaired zone of Fig: 3. Localized stirring led to small size detachment of both the materials that are mixed after intense swirling action with stretched grains in the direction of stirring action [Fig: 4 (a, c and d)]. Variations in deformation behavior lead to different sized detachments of both the materials [Fig: 4 (b, e and f)] that are intermixed after swirling, forging and movement in transverse direction.
