# Experimental Study on Seismic Performance of Precast Columns Repaired with CFRP Fabrics

**Abstract:** Earthquakes worldwide highlight the seismic vulnerability of reinforced concrete (RC) bridge columns. RC bridges are likely to collapse or lose service function due to damage to the bridge columns from strong earthquakes. Rapid repair of RC bridge columns is of great significance for maintaining traffic lines for emergency rescue work after earthquakes. In this study, an improved rapid repair method was developed to restore the bearing capacity of a damaged precast column after earthquake damage. A cyclic loading test was performed to simulate the seismic loading. The original column and the repaired column were both tested. The test results showed that the bearing capacity of the repaired columns was increased by 8%, and the energy dissipation capacity was 53% higher than that of the original column. The ductility decreased because the test for the repaired specimen ended in advance. The initial stiffness of the repaired columns was reduced, but the stiffness was significantly developed in the later loading stage. The rapid repair method proposed in this study exhibited an exce

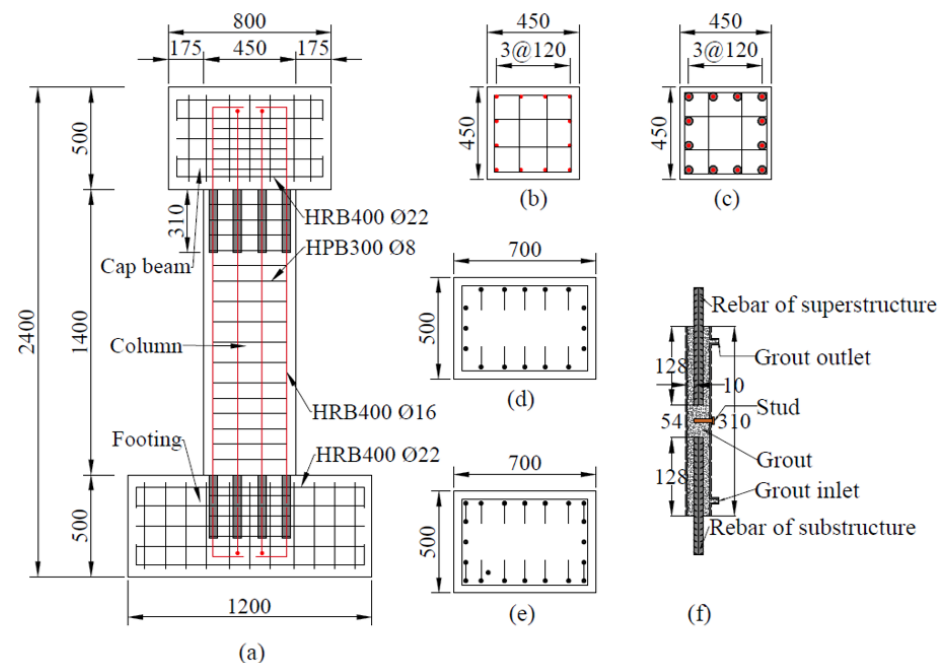
**Figure 1.** Details of the specimen: (a) precast column with grouted sleeve connections; (b) cross section of the column; (c) cross section of the column with grouted sleeve connections; (d) cross section of the cap beam; (e) cross section of the footing; (f) details of the grouted sleeve.

In order to study the effect of repair with CFRP fabrics on damaged precast columns after earthquakes, a precast column with grouted sleeve connections was designed and tested under cyclic loading. Figure 1 shows the details of the specimen. The specimen used in this test represents a typical precast bridge column. The specimen was divided into three components: the cap beam, the column, and the footing. The column had a height of 1400 mm and a cross section of 450 mm × 450 mm. The aspect ratio of the column was about 3:1. The cap beam had dimensions of 800 mm × 700 mm × 500 mm, and the footing had dimensions of 1200 mm × 700 mm × 500 mm. The reinforcement ratio of the column was 1.19%. The column was longitudinally reinforced by 12-Φ16 HRB400

(hot-rolled ribbed bars with a nominal yield strength of 400 MPa) rebars and transversely reinforced by  $\Phi 8$  HPB300 (hot-rolled plain bars with a nominal yield strength of 300 MPa) stirrups. The center-to-center spacing of the stirrups was 100 mm in the non-strengthened area and 75 mm in the strengthened area. The cap beam and the footing were reinforced by  $\Phi 22$  HRB400 rebars, thereby ensuring their failure would occur later than that of the column under vertical and lateral loads. At the cap beam and the footing, longitudinal rebars that extended 150 mm were lap spliced. The grouted sleeve had a height of 310 mm, an inner diameter of 36 mm, and an outer diameter of 42 mm, as shown in Figure 1f. Ultra-high-performance concrete (UHPC) grout material was applied to the grouted sleeve to connect the longitudinal rebars.

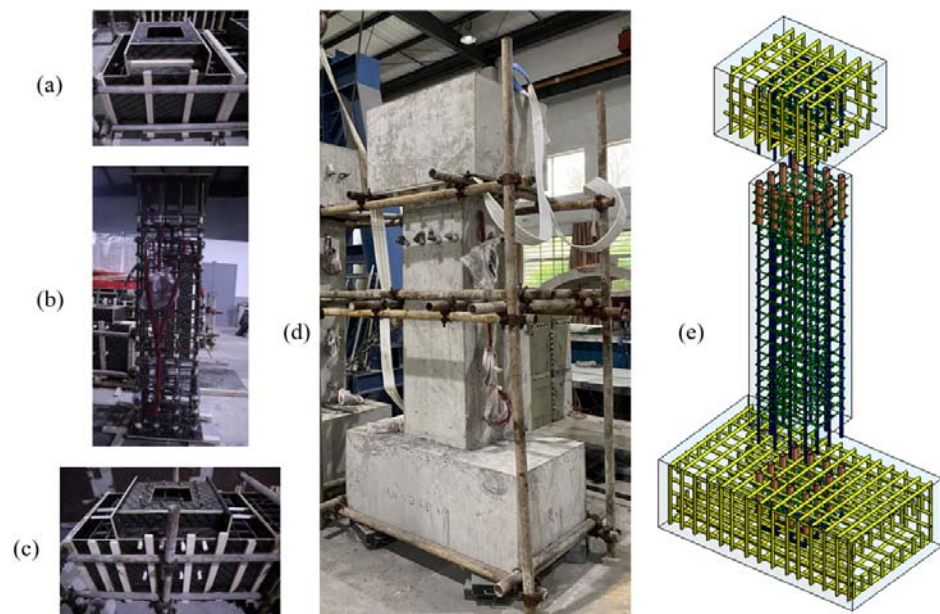
**Figure 2.** Construction of the precast column with grouted sleeve connections: (a) cap beam; (b) column; (c) footing; (d) assembling; (e) 3D model of the precast column.

Unlike the construction of the cast-in-place column, the components of the precast column were prefabricated individually and then assembled, as shown in Figure 2. All components were cured for 28 days before assembly. During the assembling process, cement mortar was poured on the surface of the joint at first. Then, rebars were inserted into the grouted sleeve in different components, and the UHPC grout material was pressed into the grouted sleeves to connect the precast components. The specimen was taken to the cyclic loading test after another 28 days of curing until the grout material reached enough strength.

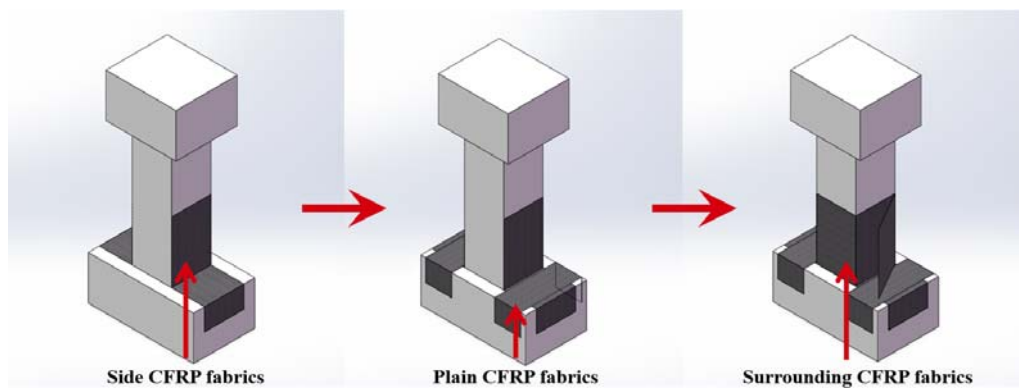
Figure 3. Repair design for the damaged precast column with CFRP fabrics.

After the loading test for the original precast column, the test device was removed, and a repair design was proposed. The design philosophy of the repair for the damaged precast column was to rehabilitate the displacement capacity and strength of the original precast column. Different from the traditional CFRP-confined column design which applies the CFRP fabrics to surround the column [25], side and plain CFRP fabrics were added to the design presented in this paper, as shown in Figure 3. The side CFRP fabrics were applied on the bending surface of the column at first. The flexure behavior of the precast column was enhanced in this way. It is worth noticing that the side CFRP fabrics extend from the column to the footing, thereby strengthening the critical interface of the precast column. Then, the plain CFRP fabrics were applied on the footing to enhance the adhesion of the side CFRP fabrics. Finally, the surrounding CFRP fabrics were applied to the column. The surrounding CFRP fabrics were revealed to improve the mechanical performance of the concrete in the plastic hinge region, including its compressive strength, durability, and ductility [32]. Different fabrics were placed at 0/90 angles in the stack area. The CFRP-confined area was within the height of 700 mm above the column–footing interface, and three layers of the CFRP fabrics were used in each step.

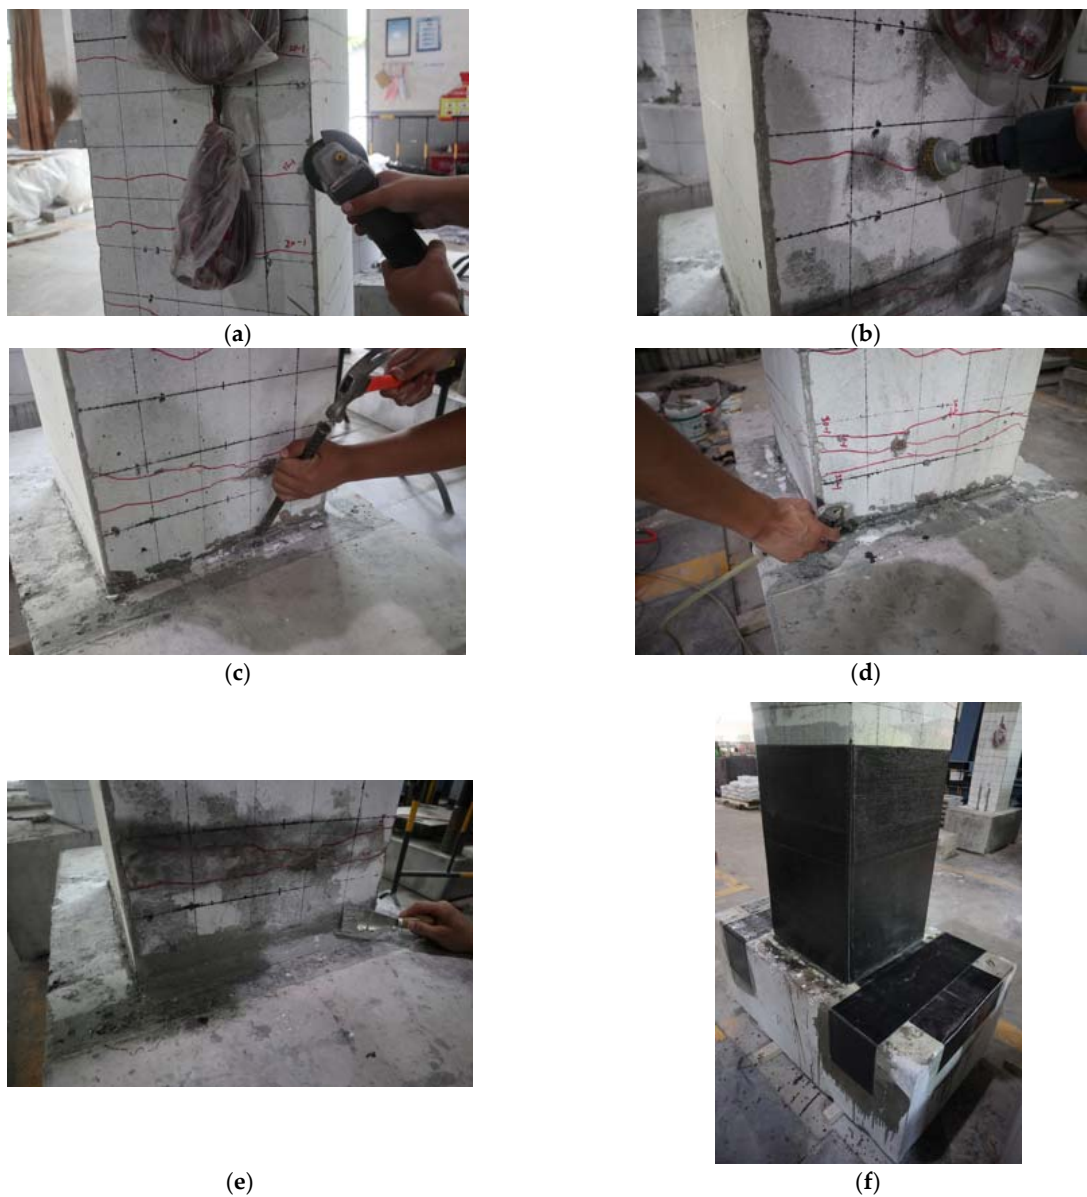
Figure 4. Repair procedures: (a) rounding the corner; (b) roughing the surface; (c) removing the spalling concrete; (d) cleaning the surface; (e) filling the crack and the corner of the column-footing interface; (f) applying the CFRP fabrics.

The repair consisted of the following procedures recommended by CECS 146: 2003 [33], as shown in Figure 4: (a) The sharp corner of the column under the CFRP fabrics was rounded to a radius of 20 mm. The rounded corner prevented the CFRP fabrics from stress concentrations. (b) The surface of the damaged precast column was roughed using an electric metal brush to enhance adhesion to the CFRP fabrics. (c) The spalling concrete in the plastic hinge region was removed using a chisel. (d) The surface of the specimen was cleaned using compressed air. (e) The broken concrete was refilled with epoxy. The corner between the column–footing interface was filled with epoxy to a radius of 20 mm. (f) The CFRP fabrics were applied to the specimen as designed.

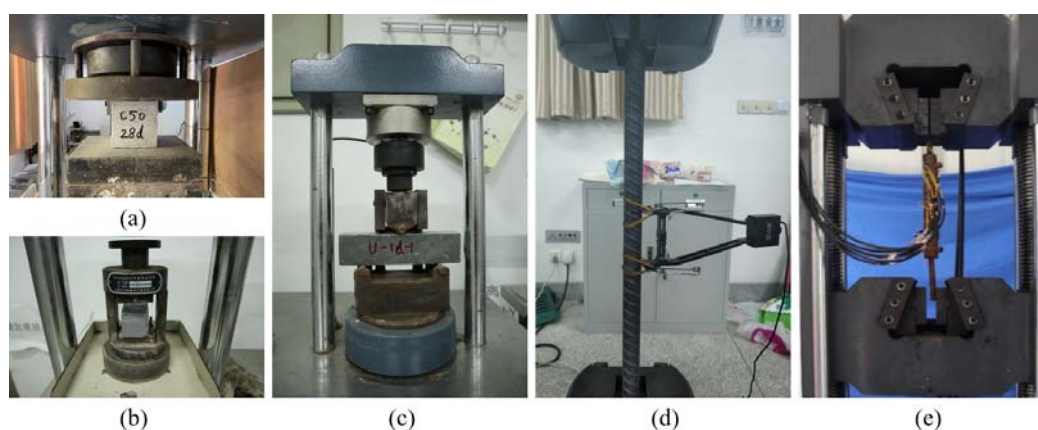
**Figure 5.** Mechanical property tests: (a) concrete; (b,c) grout; (d) rebars; (e) grouted sleeve.

All the mechanical properties tests for materials are exhibited in Figure 5.

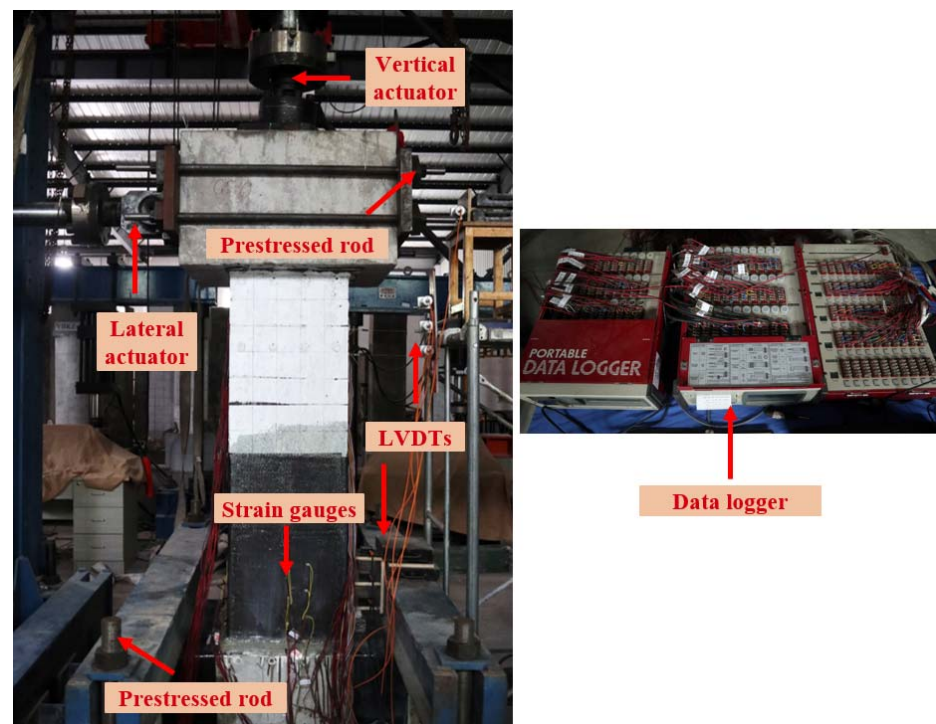
Figure 6. Test step and instrumentation.

Figure 6 shows the test device for the specimen. A 1000 kN servo-hydraulic vertical actuator was used to apply constant axial pressure on the top of the specimen. The axial pressure was 7% of the specimen's compressive bearing capacity. A 500 kN servo-hydraulic lateral actuator was used to apply cyclic displacement-control load. The footing was anchored to the ground by the prestressed rod, and the cap beam was anchored with the

Both the vertical actuator and lateral actuator were instrumented with load cells and displacement transformers. The load and displacement data of the actuators were recorded and fed back to control the actuators. Seven linear variable displacement transformers (LVDTs) were instrumented to record the lateral displacements along the height of the specimen. Three LVDTs were spaced 100 mm above the column–footing interface. Another three LVDTs were spaced 100 mm below the cap beam–footing interface. An additional LVDT was installed on the middle height of the cap beam to check the lateral displacement of the actuator. Six strain gauges were used to record the strain of the CFRP fabrics. They were installed on the CFRP fabrics on two perpendicular surfaces. All the measured data were collected by the data logger (TDS-530), as shown in Figure 6.

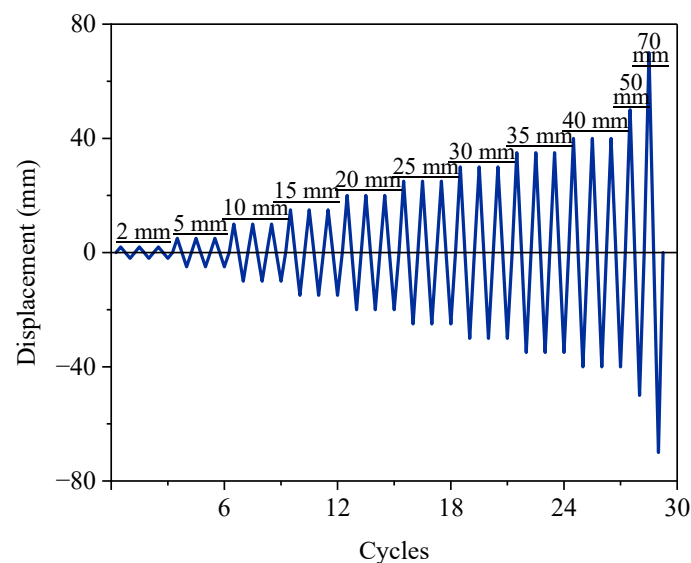
Figure 7. The protocol of the cyclic displacement-control load.

lateral actuator by the prestressed rod as well. The protocol of the cyclic displacement-control load is shown in Figure 7. Three cycles at each displacement level were conducted until 40 mm. The precast column suffered significant plastic damage at large displacement levels, so one cycle was conducted on the specimen in subsequent displacement levels. During the cyclic loading test on the original precast column, the test ended when the lateral load decreased to 85% of the peak load at a displacement of 66.67 mm. To compare the repaired precast column with the original column, the loading protocol for the repaired specimen was the same as that of the original column, and the test ended after one cycle at the displacement level of 70 mm. The experimental conditions of the tested specimens are shown in Table 3.

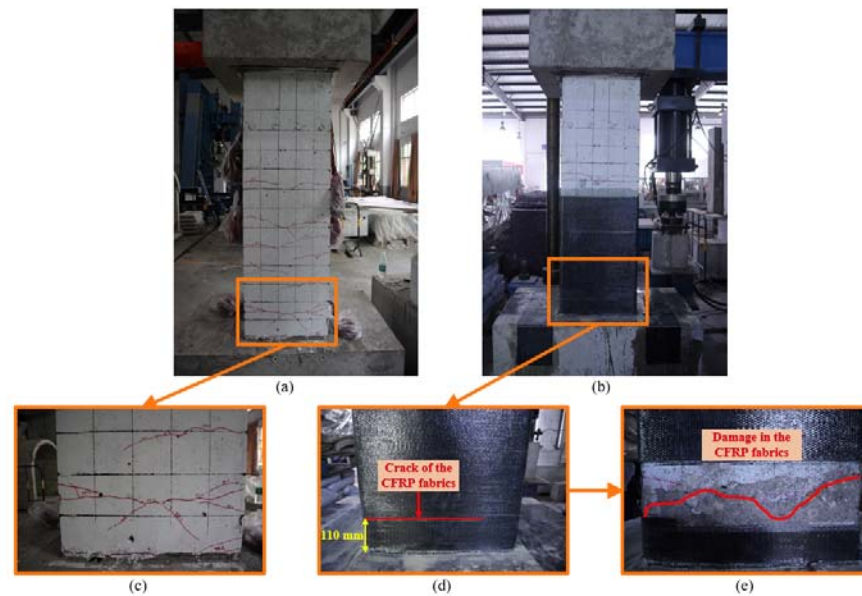
**Figure 8.** Damage of tested specimens: (a) original specimen; (b) repaired specimen; (c) crack details for the original specimen; (d,e) crack details for the repaired specimen.

During the cyclic loading test for the original precast column, the specimen exhibited typical flexure–shear damage progression, as shown in Figure 8a. The initial crack appeared about 150 mm and 300 mm above the column–footing interface at the first displacement cycle of 10 mm. Then, evenly distributed flexural cracks appeared within 900 mm above the column–footing interface until 25 mm cycles. The cracks gradually extended and penetrated with the increase in loading cycles. Spalling of concrete was found at displacement cycles of 30 mm and 35 mm. Spalling of concrete concentrated at the corners of the bottom of the column due to the stress concentration here [34]. The cyclic loading test ended when the precast column researched its ultimate capacity at the displacement level of 66.67 mm. The largest crack appeared at the column–footing interface, which was proposed to be a critical interface for the precast column with grouted sleeve connections [35]. Nonetheless, the width of cracks was less than 1 mm during the cyclic loading test for the original precast column.

To compare the damage between the original specimen and the repaired specimen, the CFRP fabrics were peeled off within the debonding area, as shown in Figure 8e. It was found that the protective layer suffered serious damage. The main crack formed at the height of about 150 mm above the column-footing interface. The position of the main crack is the same as that of the initial crack of the original specimen when compared with Figure 8c. Although the column concrete was damaged severely, the bearing capacity was rehabilitated by repair with the CFRP fabrics. The CFRP fabrics also prevented the concrete from spalling.

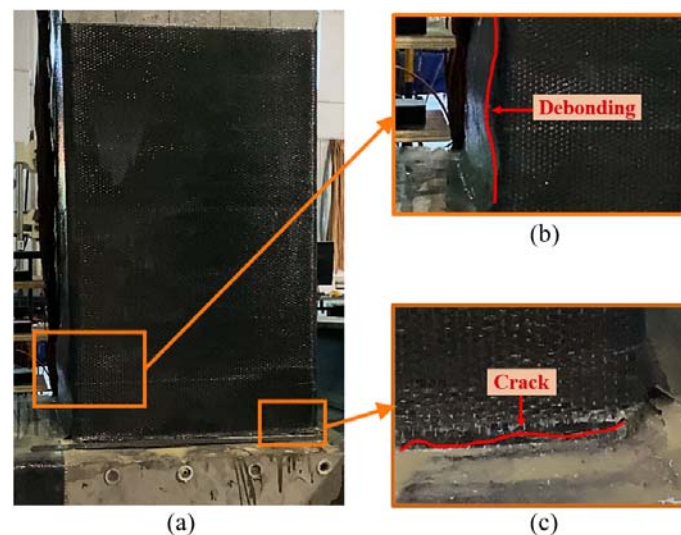
**Figure 9.** Damage at the displacement level of 70 mm for the repaired specimen: (a) damage for the repaired specimen; (b) debonding of the CFRP fabrics; (c) crack at the column-footing interface.

During the cyclic loading test for the repaired precast column, concrete cracks could not be recorded within the wrap of the CFRP fabrics. Localized debonding was found on the CFRP fabrics within 400 mm above the column–footing interface after the displacement cycles of 15 mm, as shown in Figure 9b. The most significant debonding is 110 mm above the column–footing interface where the CFRP fabrics experienced stress concentration, as shown in Figure 8d. Corresponding to the debonding, a crack formed on the CFRP sheet at the same height, as shown in Figure 8d. It should be noted that a crack could be found at the column–footing interface, as shown in Figure 9c. The width of this crack is larger than that of the crack of the original specimen, but still less than 2 mm. The side fabrics limited the deformation at the column–footing interface.

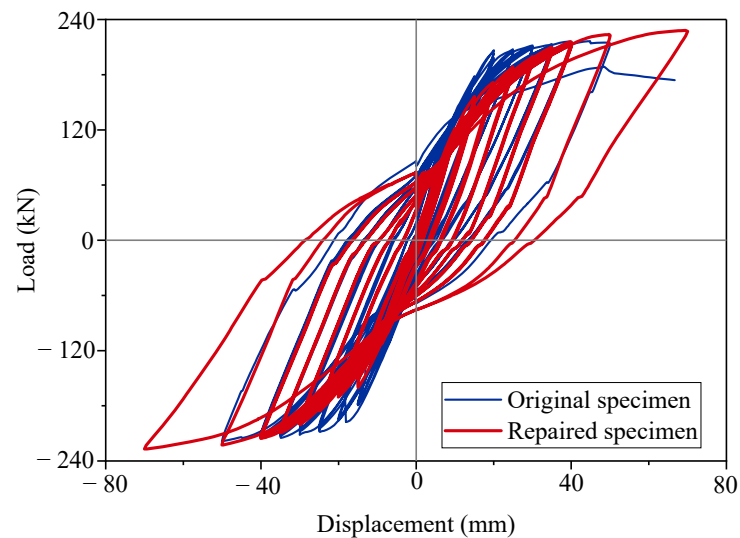
Figure 10. Load–displacement curves.

The load–displacement curves reflect the hysteric behavior of the columns under cyclic loading tests. A comparison of the load–displacement curves is shown in Figure 10. The skeleton curves were used to determine the critical characteristics of the seismic performance of the precast columns. The skeleton curves were obtained from the envelope

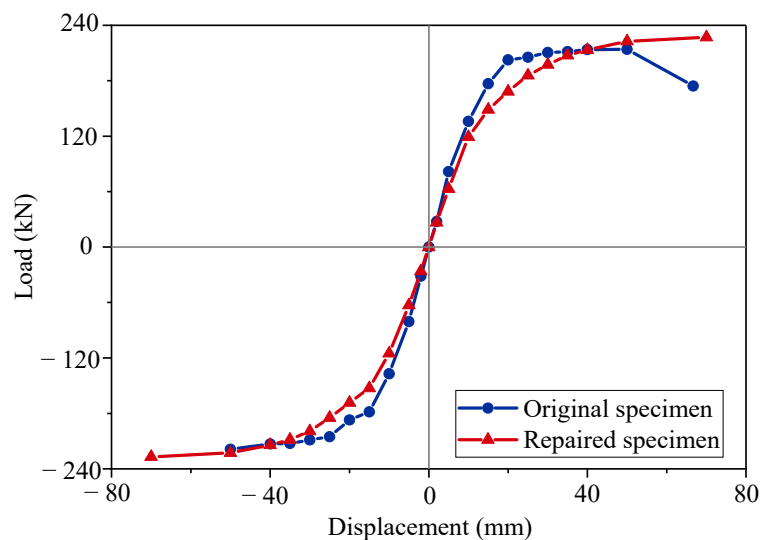
Figure 11. Skeleton curves.

of the load–displacement curves, as shown in Figure 11. Both columns exhibited the pinching effect on the shape of curves as typical reinforcement columns. The original specimen reached the peak point with a peak load ( $F_p$ ) of 213.93 kN and a peak displacement ( $\Delta_p$ ) of 40.1 mm. The repaired specimen had an 8% larger peak load of 227.09 kN at the displacement level of 70 mm. The ultimate strength ( $F_u$ ) was 174.19 kN for the original specimen, and the related ultimate displacement ( $\Delta_u$ ) was 66.67 mm. The ultimate point was the same as the peak point for the repaired specimen. For the repaired specimen, the cyclic loading test ended in advance at the same displacement cycle as the original specimen. The repaired specimen was not at its actual ultimate state, and the actual ultimate displacement should be larger than 70 mm.

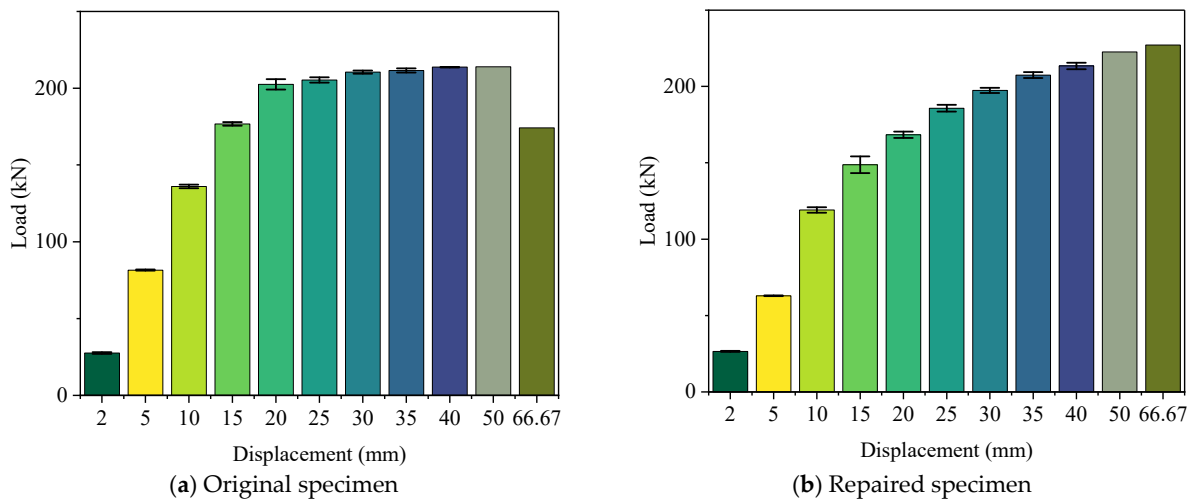
**Figure 12.** The standard deviation for the peak loads at each displacement level: (a) standard deviation of the original specimen; (b) standard deviation of the repaired specimen.

It is worth noticing that there were three loading cycles at each displacement level until 40 mm, while there was only one load value at each displacement level shown in Figure 12. The loads in the skeleton curves were the average values of three cycles at each displacement level. In this case, a statistical analysis was conducted, and the standard deviation results are shown in Figure 12.

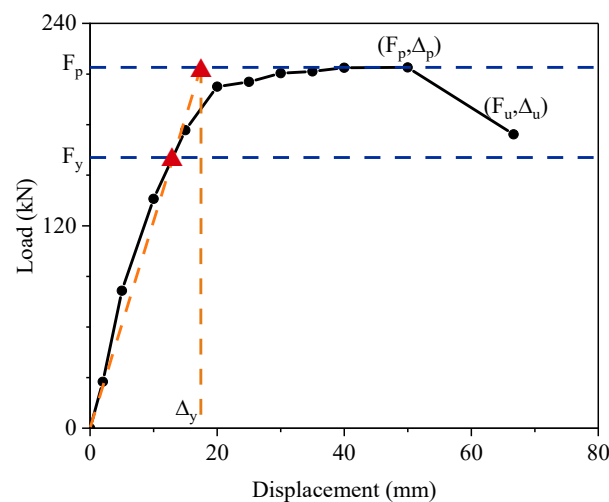
**Figure 13.** Determination of the yield point according to the Park [38] method.

The yield point was determined by the Park [38] method, which is the method most commonly used to calculate the yield point for reinforcement columns. The principle of the method is shown in Figure 13. The yield load ( $F_y$ ) was  $0.75 F_p$ . Two horizontal lines were drawn at the heights of  $F_p$  and  $F_y$ . Then, a line was drawn passing the zero point and the intersection point of the skeleton curve and horizontal line  $F_y$ . This line intersected the horizontal line  $F_p$ , and the abscissa of the intersection point is the yield displacement ( $\Delta_y$ ). The ductility coefficient ( $\mu$ ) is calculated according to Equation (1):

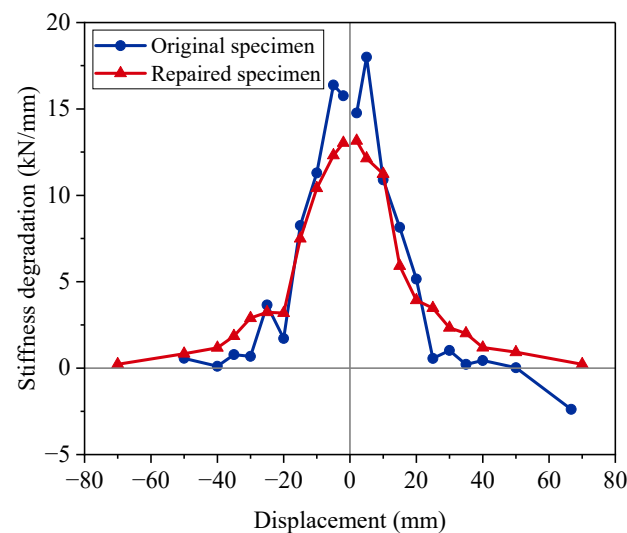
**Figure 14.** Stiffness degradation.

The stiffness degradation is known as the decrease rate of the bearing capacity [39]. The stiffness degradation for the tested specimens is shown in Figure 14. The stiffness degradation curves were almost symmetrical with minor differences. The construction deviation and material anisotropy contributed to the differences [40]. In the first two displacement levels, the stiffness degradation of the original specimen was much greater than that of the repaired specimen. The maximum error reached 48% at the positive displacement level of 5 mm. For the original specimen, the damage progression for the concrete column developed fast at the primary stage of loading. For the repaired specimen, the concrete was still in a state of low strength with damage. Repair restored the strength of the column by supplementing its strength, rather than helping the original materials regain strength. At the displacement level of 25 mm, the repaired specimen exhibited a decreasing trend in the rate of stiffness degradation, and its stiffness degradation remained larger than the original specimen later. It was indicated that the CFRP fabrics began to exhibit rehabilitation ability. The stiffness degradation of the original specimen was close to 0 at the displacement level of 35 mm. This result showed that the original specimen nearly reached the peak bearing capacity state. The repaired specimen closed to the peak state at the displacement level of 70 mm, which doubled the displacement. The comparison confirmed that the repaired specimen had remaining ductility.

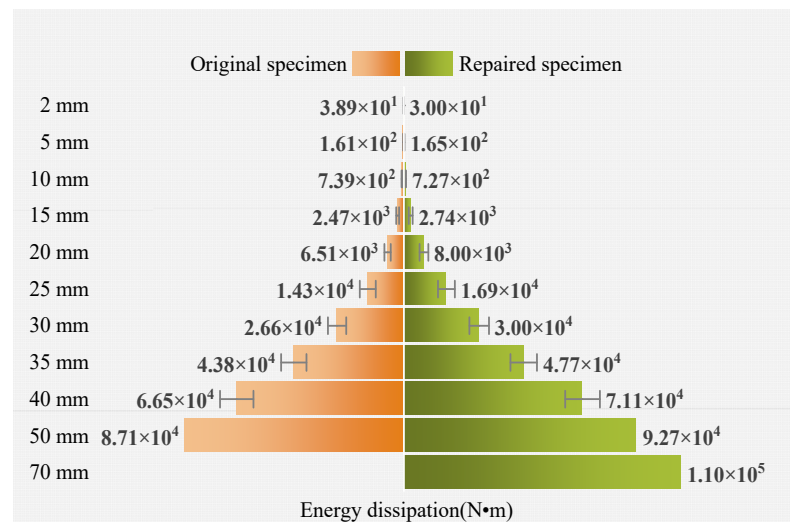
Figure 15. Comparison of energy dissipation at different displacement levels.

Figure 15 shows the energy dissipation at different displacement levels. The data from 2 mm to 40 mm were the average values of three cycles. The standard deviation was also calculated, as shown in Figure 15. The energy dissipation for the original specimen at the displacement level of 66.67 mm could not be calculated because it was not a whole cycle. The repaired specimen showed a similar energy dissipation ability to the original specimen in the first three displacement levels. In the later loading stage, the repaired specimen exhibited better energy dissipation ability. At the displacement cycle of 50 mm, the repaired specimen dissipated  $9.27 \times 10^4$  N · m of energy. This value was  $5.6 \times 10^3$  N · m more than that of the original specimen. The energy dissipation ability had not been restored in small displacement levels. However, this ability was significantly strengthened in large displacement levels.

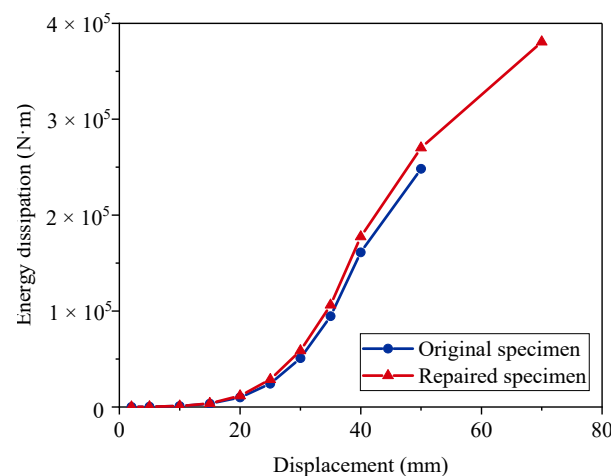
Figure 16. Cumulative energy dissipation.

Figure 16 shows the cumulative energy dissipation. The repaired specimen showed superior energy dissipation ability. The repaired specimen achieved a total energy dissipation of  $3.80 \times 10^5$  N · m. As the original specimen ended the loading test at the displacement level of 66.67 mm, it was only able to dissipate  $2.48 \times 10^5$  N · m of energy.

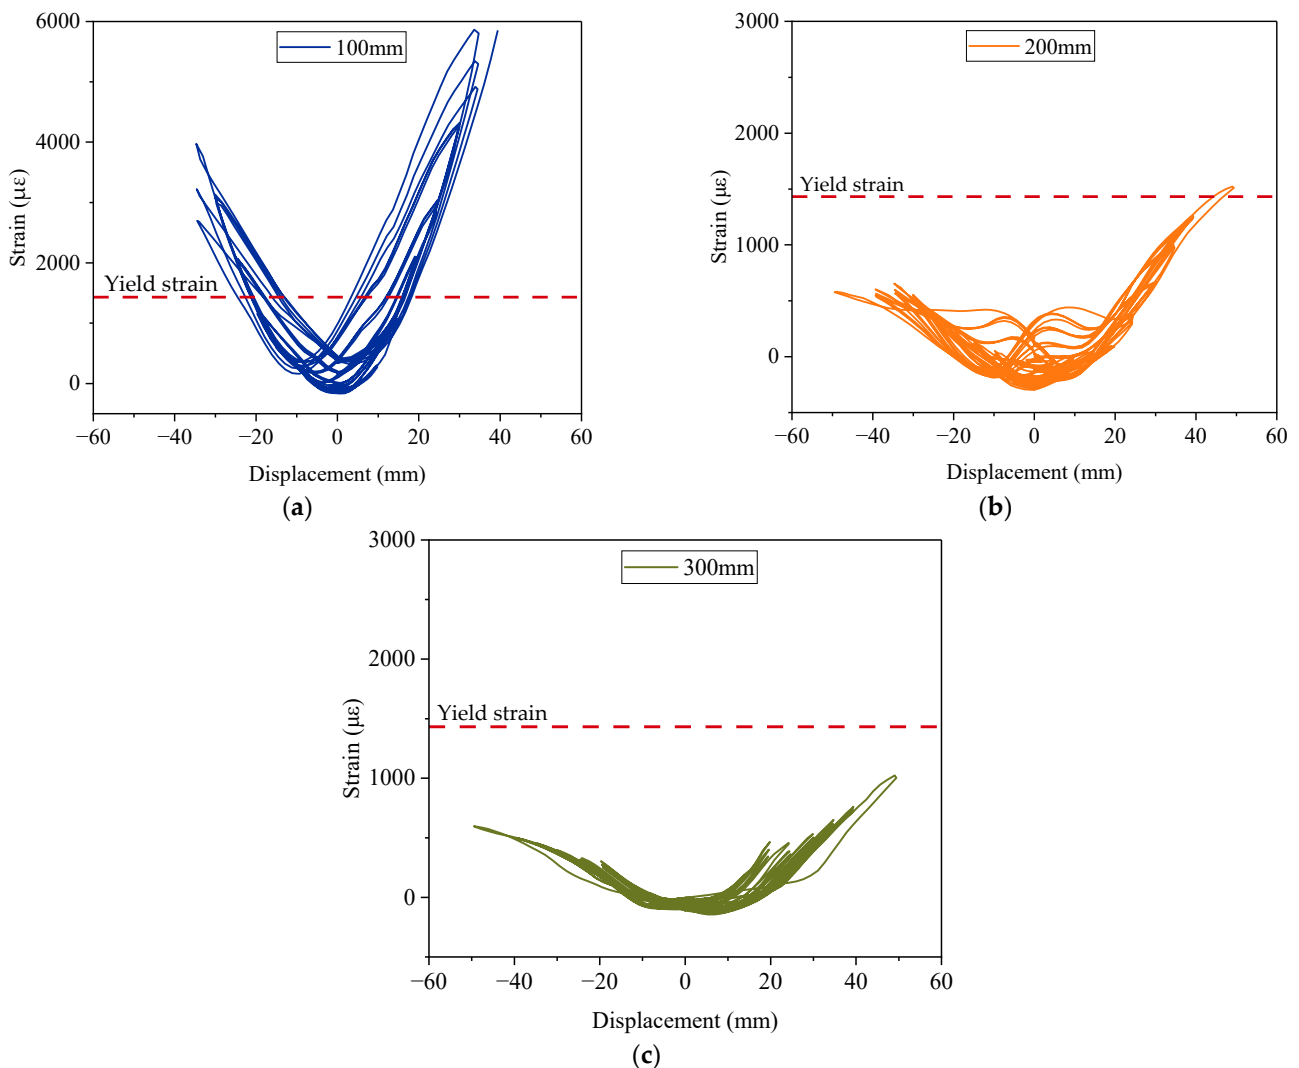
**Figure 17.** Measured strain of the column surface at different heights: (a) 100 mm height; (b) 200 mm height; (c) 300 mm height.

Strain gauges were instrumented on the surface of the CFRP fabrics to measure the strain of the column at different heights, as shown in Figure 6. The strain of the column surface at the heights of 100 mm, 200 mm, and 300 mm above the column–footing interface was recorded, as shown in Figure 17. The recorded data range was from displacement levels of 2 mm to 50 mm because they were complete cycles. The yield strain was calculated as  $1431.88 \mu\epsilon$ .

The surface concrete at the height of 100 mm and 200 mm reached the yield strain at the displacement level of 16.06 mm and 44.06 mm, respectively. The strain at the height of 300 mm did not reach the yield strain during the loading test. The curves of the strain were not strictly symmetrical. In particular, for the one at 100 mm above the column–footing interface, the minimal strain in the load cycles of 35 mm was at the displacement level of  $-10$  mm, as shown in Figure 17a. The column surface experienced obvious residual deformation at this position, which correlated with the debonding and stress concentration of the fabrics as discussed before. The maximum strain at the height of 100 mm reached  $5841 \mu\epsilon$  at the displacement level of 39.36 mm in advance. The strain data exceeded the feasible range of the strain gauge later. The maximum strains at the heights of 200 mm and 300 mm were  $1522 \mu\epsilon$  and  $1024 \mu\epsilon$ , respectively. The particularly high strain at the height
