*Published in:* Fatigue Design 2013, International Conference Proceedings

# 5th Fatigue Design Conference, Fatigue Design 2013

# Effect of Microstructure on the Fatigue Behavior of a Friction Stirred Channel Aluminium Alloy

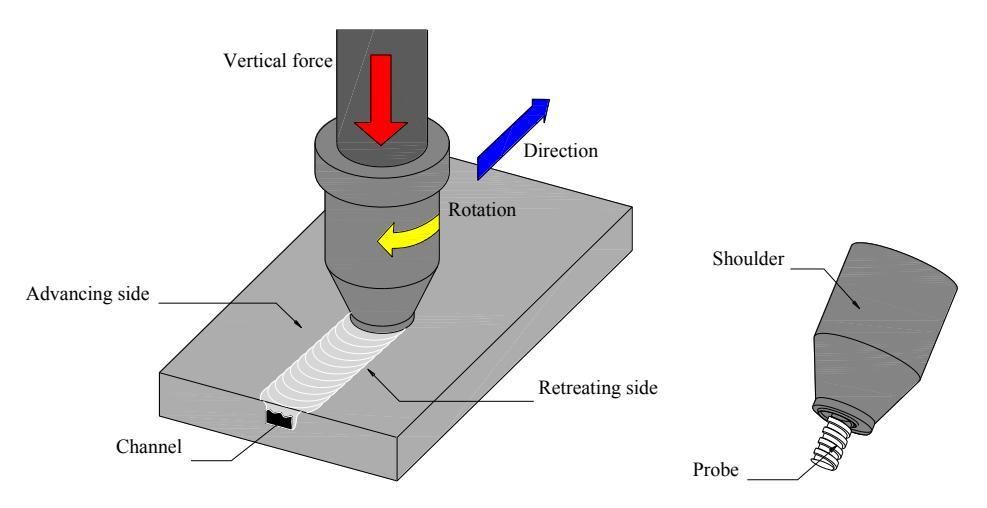
Fig. 1. Schematic representation of the Friction Stir Channeling parameters and tool.

In Fig. 1 is presented a schematic representation of the FSC process and tool. To perform the FSC process, a non-consumable rotating tool with a specially designed probe and shoulder is inserted into the metal component to be stirred channel and subsequently traversed along its length [5]. During the tool plunge, the rotating FSC tool is forced into the metal workpiece. After the dwell period has passed, the tool begins the forward traverse along a predetermined path, creating a fine grained recrystallized microstructure behind the tool above the channel. The simultaneous rotational and translational motion of the tool during the channeling process creates a characteristic asymmetry between the channel sides. Significant microstructural changes in the stir and thermo mechanically affected zones (TMAZ) have been observed previously [6].

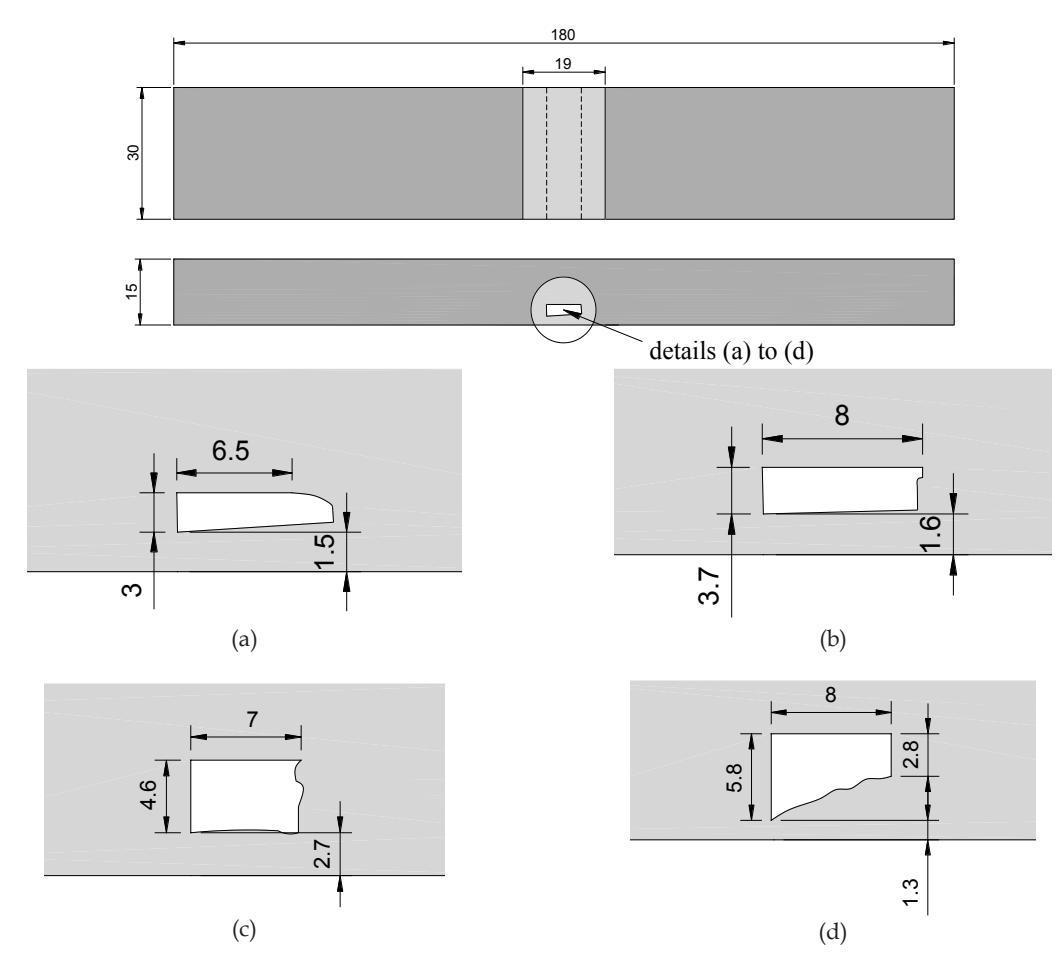
Fig. 2. Geometry and dimensions of the fatigue specimens. Details showing the schematic representation of the channels produced with FSC set (a) U1, (b) U2, (c) L1 and (d) L2.

Specimens for fatigue tests were manufactured according to the standard E 290-97a [7] requirements as shown in Fig. 2.

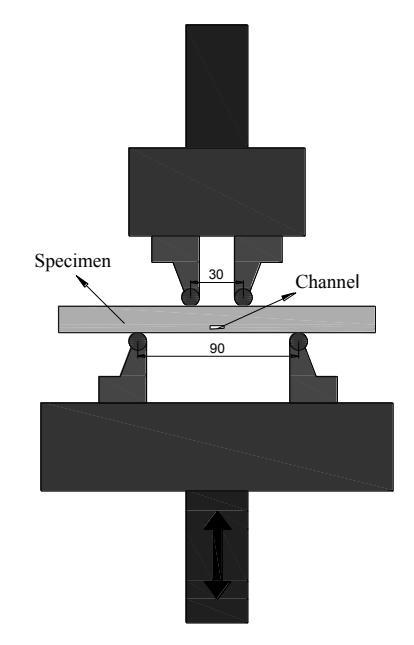
Fig. 3. Schematic representation of the experimental setup.

The fatigue tests were carried out on an Instron 8502 servo-hydraulic testing machine with a load cell of 100kN at a range of frequency between 5-10 Hz and a stress ratio R=0.1. The experimental setup is presented in Fig. 3. Fatigue tests were performed in load-controlled mode at constant amplitude sinusoidal four-point bending loading in laboratory air at room temperature.

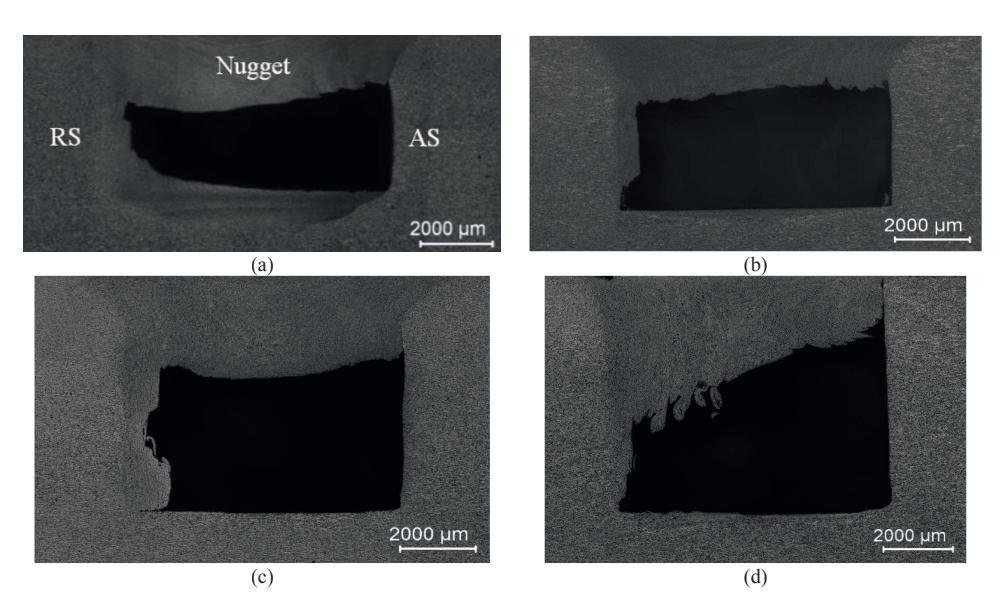
Fig. 4. Optical macrographs of cross-sections of the channels produced with FSC set (a) U1, (b) U2, (c) L1 and (d) L2.

Cross-sectional macrographs of the channels produced according to the parameters described in Table 3 are presented in Fig. 4. The geometry of the channels varies with the process parameters and tool's features. The channel geometry can be attributed to the volume of processed material that is displaced from the base of the probe for every rotation of the tool and also the compacting force that is applied on the channel nugget during the linear forward movement by the shoulder.

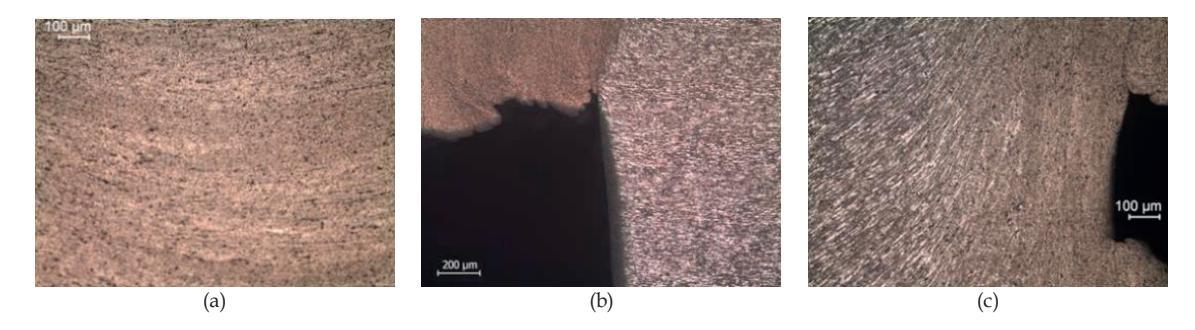
Fig. 5. Optical micrographs from an U1 sample (etched with Keller's reagent).

In all the channels analyzed, the flow of material inside the nugget is evidence of substantial plastic stirring during FSC process. In nugget zone, the microstructure of the material appears as very fine and equiaxed grains in all the channeling conditions (Fig. 5(a), Fig. 6(b), Fig. 7(b) and Fig. 8(b)). During the FSC process, although the thermo mechanically affected zone (TMAZ) undergoes plastic deformation, the heat and deformation are proved to be insufficient for totally recrystallization, and a distinct interface between the nugget and the TMAZ could be obtained as it is depicted in detail (a) of Fig. 6. Base material (BM) microstructure reveals the elongated grains belonging to the rolling process.

On the advancing side (AS), the plastic deformation rate is greater than on the retreating side (RS), microstructure changes quickly from the channel side as can be seen in details (b) and (c) of Figures 5 and 7, respectively. On the other side, on the RS, microstructures from the nugget to TMAZ change more smoothly (Fig. 5(c) and Fig. 7(a)). In the region adjacent to the TMAZ – the heat affected zone (HAZ) – the microstructure is affected by the heat but not by deformation and it is similar to that of BM.

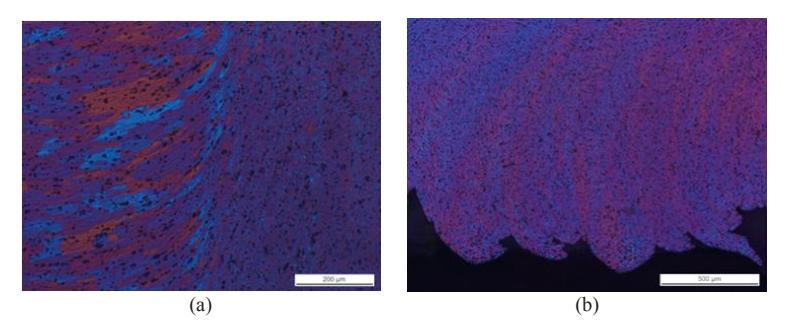
Fig. 6. Optical micrographs under polarized light from an electrolytic etched U2 sample.

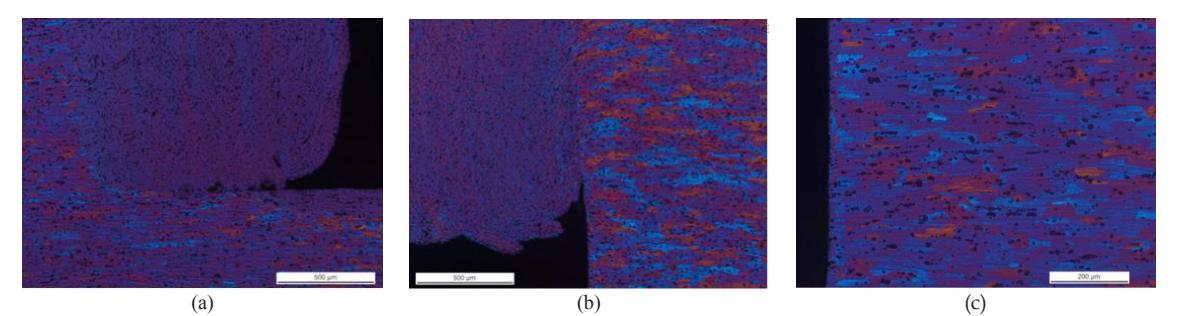
Fig. 7. Optical micrographs under polarized light from an electrolytic etched L1 sample.

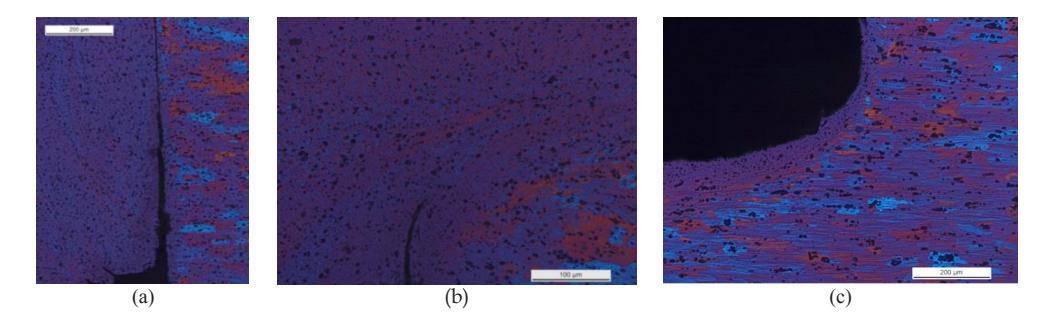
Fig. 8. Optical micrographs under polarized light from an electrolytic etched L2 sample.

Based on observations can be inferred that higher vertical forces during the process lead to a more extensive nugget under the channel's base. Micrographs obtained from sample L2 and presented in Fig. 8 revealed a defect on the channel's AS in the interface between the nugget and the TMAZ. This defect is related with the greater removal material rate combined with an insufficient heat input and plastic metal flow caused by a lower tool rotation speed

and a higher tool travel speed. This defect will have significant implications in the fatigue lifetime of the channel produced with FSC set L2.

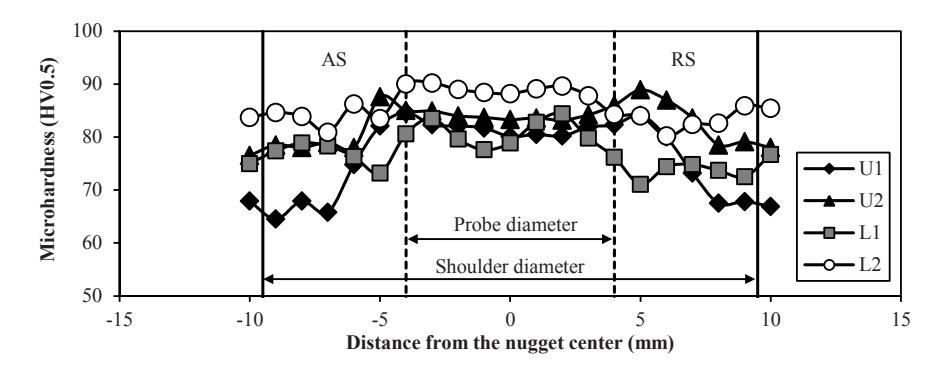
Fig. 9. Microhardness profiles of the friction stirred channel samples.

The microhardness profiles evolution across mid thickness between the channel top and the upper surface are shown in Fig. 9. A softening region having lower hardness than the BM was produced in all friction stirred channel plates above the channel performed. The hardness of the nugget is lower than that of the BM, even though the grain size has decreased.

The hardness values in the nugget are lower than in the BM, but higher than in the TMAZ and HAZ. An increase in hardness in the nugget compared to TMAZ and HAZ points that some work hardening due to intensive stirring has taken place during the channeling process. The samples exhibit a hardness drop in around HAZ and TMAZ indicating that these regions have undergone an annealing process.

The channels produced at the tool travel speed of 50mm/min. (U1 and L1) exhibit the lowest hardness values in around the HAZ and TMAZ on both AS and RS indicating that the thermal exposure was higher. In addition, the average hardness value in the nugget increases with the decreasing of calorific energy input  $(\propto \Omega/v)$  during the channeling process.

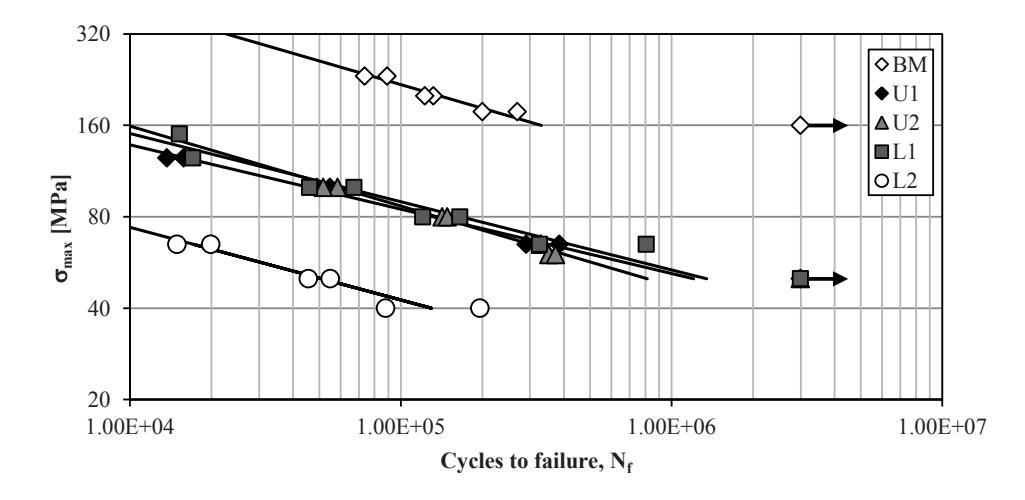
Fig. 10. S-N fatigue curves at R=0.1 for FSC specimens at room temperature. Four-point bending.

Fig. 10 shows the fatigue life of AA5083-H111 stirred channel specimens in the form of *S*-*N* curves. *S*-*N* curves were obtained by measuring the number of cycles to failure that the specimen supported under a sinusoidal waveform as described in *Section 2*. *S*-*N* curves are presented in log-log scale. Each point represents an experimental test and the curves were obtained by fitting a linear regression equation (2), assuming  $\sigma_{max}$  as the dependent variable:

The fatigue strength of unprocessed AA5083-H111 is 160MPa. The FSC process is found to be detrimental on fatigue strength of AA5083-H111 as shown in Fig. 10. All specimens with channels without defects (U1, U2 and L1) exhibit very low fatigue strength value. The fatigue strength of FSC specimens without defects in the vicinity of the channel is 50MPa which is 68.75% lower compared to that of the BM. Considering the FSC specimens, for the same maximum nominal stress level, higher fatigue crack initiation periods were obtained for condition U2, as reflected by  $K_0$  value presented in Table 5. From the analysis of Fig. 11 is also possible to verify that  $K_0$  value increases with the increasing of the nugget width, which points that a greater recrystallized zone slows down the fatigue crack initiation. The fracture of all specimens took place in the nugget/TMAZ interface on the AS. This interface is a region of stress intensity between very fine and coarse grains that is amplified by channel corner geometry.

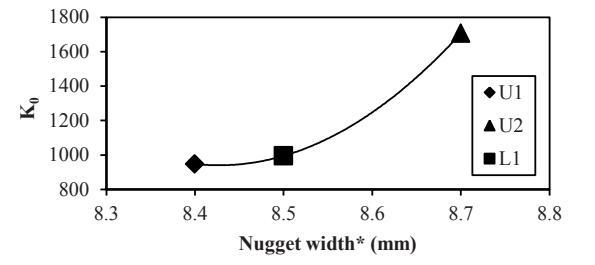
Fig. 11.  $K_0$  versus nugget width at mid thickness between the channel top and the upper surface.

The empirical constants m and  $K_0$  were evaluated and these are presented in Table 5. In order to examine the effect of microstructure on the fatigue behavior, the evolution of the empirical constant  $K_0$  with the nugget width, measured at mid thickness between the channel top and the upper surface, was computed as shown in Fig. 11. For this analysis it was excluded the condition L2, for having revealed a defective condition.

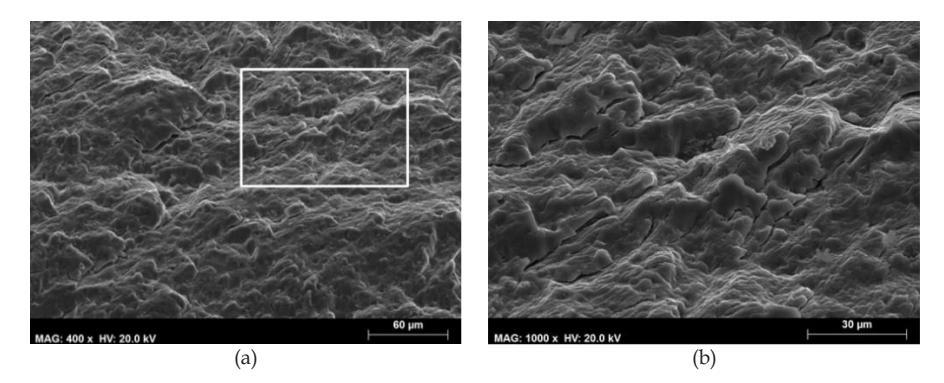
Fig. 12. Sequence of SEM fractographs of a region tangent to the advancing side, at increasing magnifications, which show a fracture in a FSC specimen L1 under a maximum stress of 65MPa. The rectangle in fractograph (a) indicates the area that is shown at higher magnification in fractograph (b).

An examination of the fatigue fracture surfaces does provide useful information concerning the contribution of the microstructural features to the channel's strength. It was selected for presenting the fatigue fracture surface of a FSC specimen L1 tested under a maximum stress of 65MPa as it is depicted in Figures 12 and 13.

Fatigue crack propagation on the TMAZ was mainly characterized by fatigue striations along with secondary cracks as it can be observed in Fig. 12. Fatigue ripples can be seen along the surface. There is a clear coexistence of the intergranular fracture mode and the transgranular fracture mode. The fractographs of the nugget presented in Fig. 13 show a smoother fracture surface without evidence of fatigue striations. Some authors [8] attribute this fact to the presence of compressive residual stresses that caused crack closure.

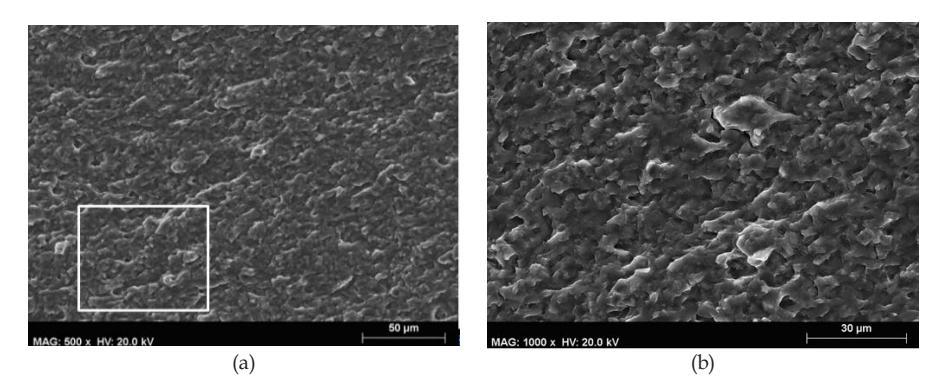
Fig. 13. Sequence of SEM fractographs, at increasing magnifications, which show the other side of the fracture surface of the FSC specimen L1 under a maximum stress of 65MPa. The rectangle in fractograph (a) indicates the area that is shown at higher magnification in fractograph (b).
