Effect of Surface Wear on Corrosion Protection of Steel by CrN Coatings Sealed with Atomic Layer Deposition

Published in: ACS Omega

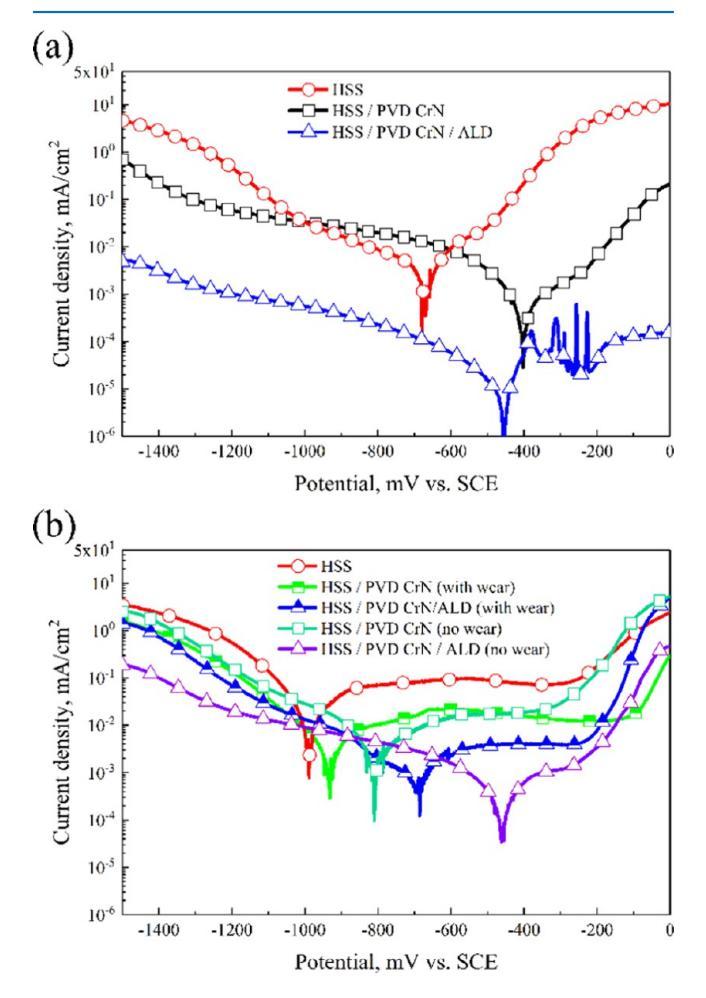
Figure 1. Polarization curves for the electrochemical measurements (a) before wear (LSV1-Wear0) and (b) after five LSV measurements and approximately 13 h in salt solution. Results for both samples, with wear (LSV5-Wear4) and without wear, are shown.

2.1. Electrochemical Measurements. Figure 1 shows the results of LSV measurements. Figure 1a shows polarization

curves before any wear (LSV1-Wear0), whereas Figure 1b shows the polarization curves at the end of the investigation for both, with wear (LSV5-Wear4) and without wear. From Figure 1a, it is seen that the CrN coating initially reduces the corrosion current density approximately with an order of magnitude compared to noncoated high-speed steel (HSS) and shifts the corrosion potential to less negative. With addition of ALD coating, corrosion current density is reduced further by almost 2 orders of magnitude due to the sealing of pinholes. Similar results have been reported previously by growing ALD

nanolaminates on PVD CrN coatings.^{4,10} Wearing the top surface of the hybrid PVD/ALD coating reduces the corrosion protection to some extent. As seen in Figure 1b, the corrosion current density is almost an order of magnitude higher with the extensive surface wear of the sample LSV5-Wear4. The corrosion potential has also moved to -700 mV, close to the value of the PVD CrN coating itself.¹⁰ This is as expected, as the ALD nanolaminate has been completely removed from the top surface of the PVD CrN coating. Even after the complete removal, the corrosion current density of worn hybrid PVD/ ALD coatings is still less than half compared to the CrN coating only, without any wear.

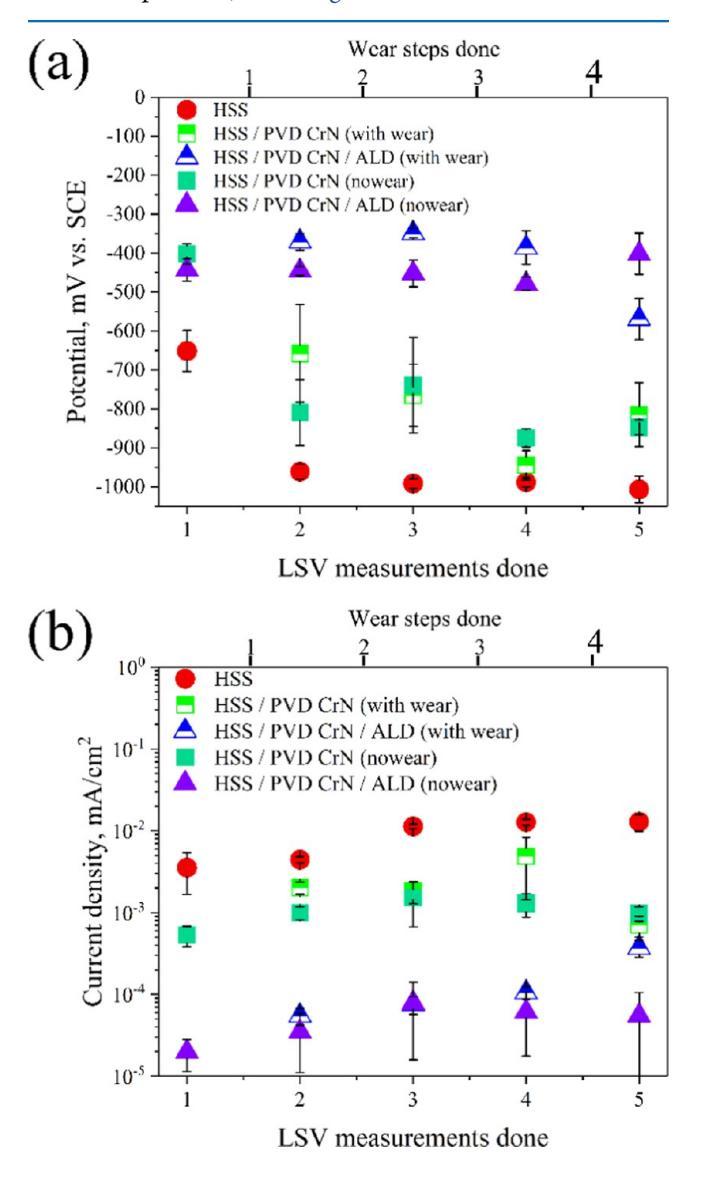
Figure 2. (a) Corrosion potentials and (b) corrosion current densities versus the number of LSV measurements done. The bottom axis shows the total number of the LSV measurements done. The total contact time to the salt solution was approximately 2.5 h for each LSV measurement. The top axis shows the amount of wear steps in samples with wear—the first three wear steps were with ball-on-disk, and the last one was by sandpaper grinding. Each data point was averaged from three measurements, and the mean of standard deviation was used as error bars.

Figure 2 shows all LSV measurement results (Figure 2a for corrosion potential, and Figure 2b for corrosion current

density), with each measurement point averaged from the three LSV measurements done. For HSS, the surface is completely rusted and corrosion potential has stabilized to approximately

-1000 mV already after the second LSV measurement. With the CrN coating, corrosion potential and corrosion current density approach those of noncoated HSS with increasing

amount of time in salt solution and LSV measurements done. Wearing the CrN surface has a minor effect on the electrochemical behavior, as the differences between samples with and without wear are generally smaller than the measurement variation.

After the first three wear steps, the corrosion current density for the hybrid PVD/ALD-coated HSS slightly increases, whereas the corrosion potential remains approximately the same. Only after the complete removal of the ALD nanolaminate from the PVD CrN surface, a notable difference is observed between the samples without wear as the corrosion potential has moved to a more negative value (-560 mV) and the corrosion current density has increased by an order of magnitude.

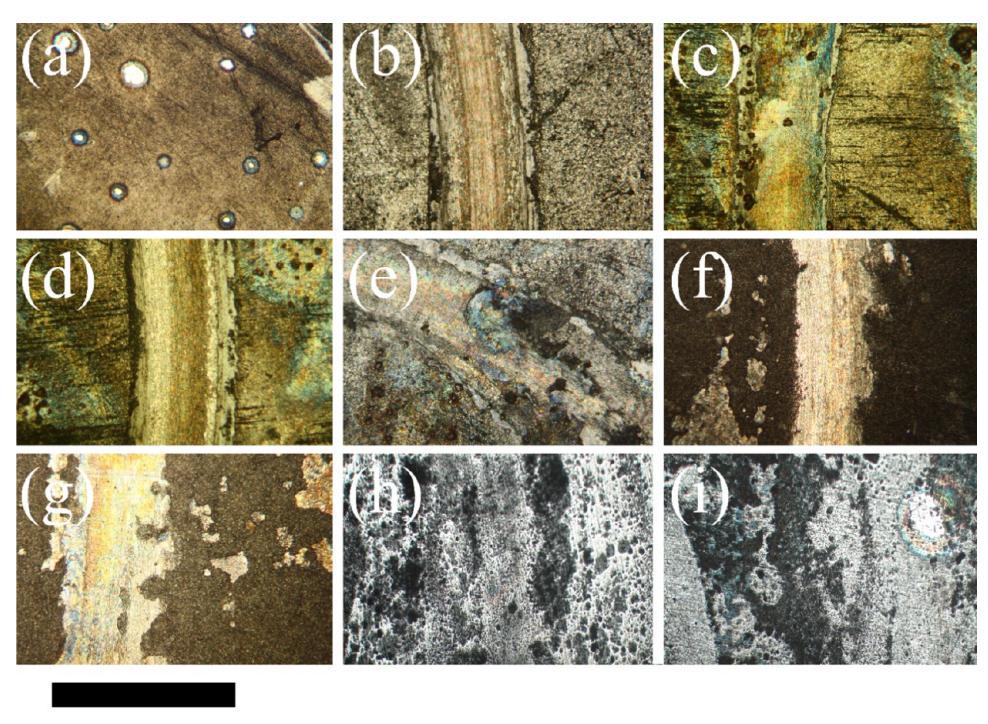
Figure 3. Optical microscopy images after each measurement step for noncoated HSS: (a) LSV1-Wear0, (b) LSV1-Wear1, (c) LSV2-Wear1, (d) LSV2-Wear2, (e) LSV3-Wear2, (f) LSV3-Wear3, (g) LSV4-Wear3, (h) LSV4-Wear4 (sandpaper grinding), and (i) LSV5-Wear4.

2.2. Surface Analysis on Wear and Corrosion. Figures 3–5 show the optical microscopy images of each sample type after each test step. Figure 3 shows that the surface of the noncoated HSS is rusted already after one LSV measurement (Figure 3a), and this rusting progresses by further LSV measurements and time in salt solution (Figure 3c,e,g,i). The wear steps carried out for the noncoated disks (Figure 3b,d,e,h)

remove rust from the surface, as observed from the lighter color of the wear tracks.

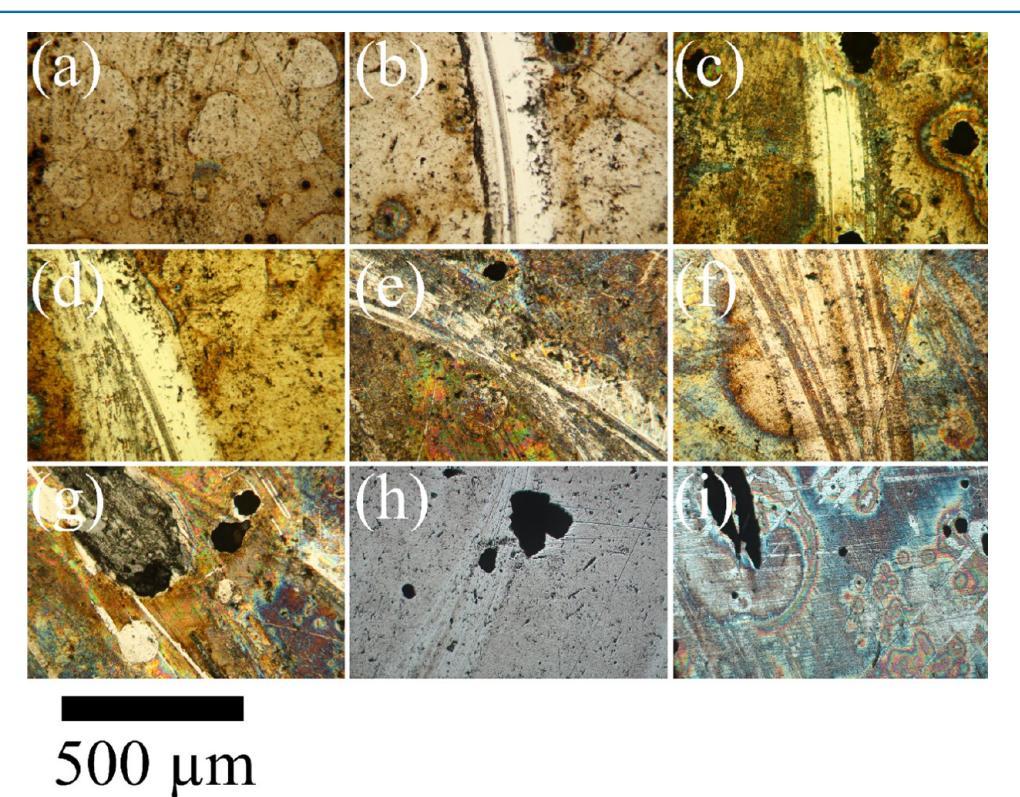
Figure 4. Optical microscopy images after each measurement step for the CrN-coated HSS: (a) LSV1-Wear0, (b) LSV1-Wear1, (c) LSV2-Wear1, (d) LSV2-Wear2, (e) LSV3-Wear2, (f) LSV3-Wear3, (g) LSV4-Wear3, (h) LSV4-Wear4 (sandpaper grinding), and (i) LSV5-Wear4.

The surface of the PVD CrN coating is oxidized in the LSV measurements, as can be seen in Figure 4. The final wear step by sandpaper grinding (Figure 4h) has removed all of the oxidized CrN surface. The grinding step has also removed the wear tracks from first two wear steps with shorter run distance. Some rusted steel surface is observed as dark areas on wear tracks after the second LSV measurement (Figure 4c), and the amount of these areas increases as the test progresses.

The approximate depths of the rust spots observed at coated sample surfaces after LSV5-Wear4 was 22 \pm 14 μ m for the PVD CrN-coated samples (Figure 4i) and 12 \pm 5 μ m for the

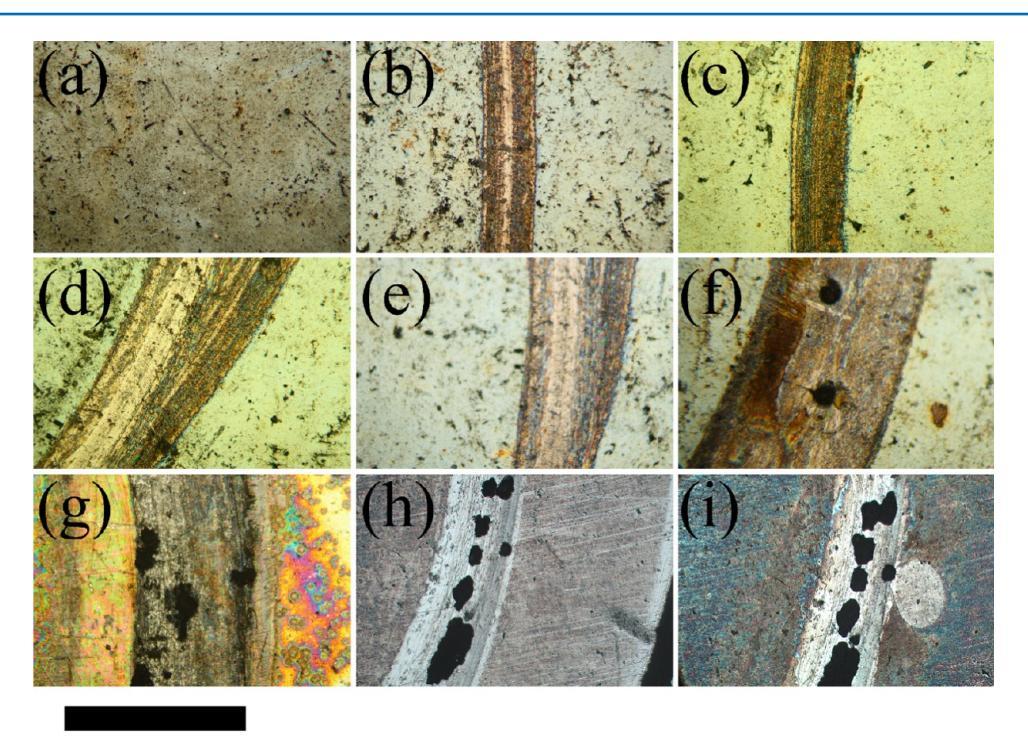
Figure 5. Optical microscopy images after each measurement step for the hybrid PVD/ALD-coated HSS: (a) LSV1-Wear0, (b) LSV1-Wear1, (c) LSV2-Wear1, (d) LSV2-Wear2, (e) LSV3-Wear2, (f) LSV3-Wear3, (g) LSV4-Wear3, (h) LSV4-Wear4 (sandpaper grinding), and (i) LSV5-Wear4.

As seen in Figure 5, the hybrid PVD/ALD-coated surface appears initially unaffected by corrosion. Surface oxidation of the PVD CrN coating can be seen at wear tracks on the second LSV measurement (Figure 5c). After the third LSV measurement, a small amount of rusted steel is observed as darker area in Figure 5e. The number of these dark spots increases as the testing progresses. These rust spots are located preferentially at spots where the wear tracks converge, such as in positions shown in Figure 5g. After sandpaper grinding, only wear tracks from the longer total distance ball-on-disk test remain (Figure 5h). At this point, the rust spots are almost solely located on these deepest wear tracks (Figure 5h,i).

hybrid PVD CrN-coated samples (Figure 5i). Both of these values are greater than coating thickness, showing that a significant amount of base steel material has corroded and

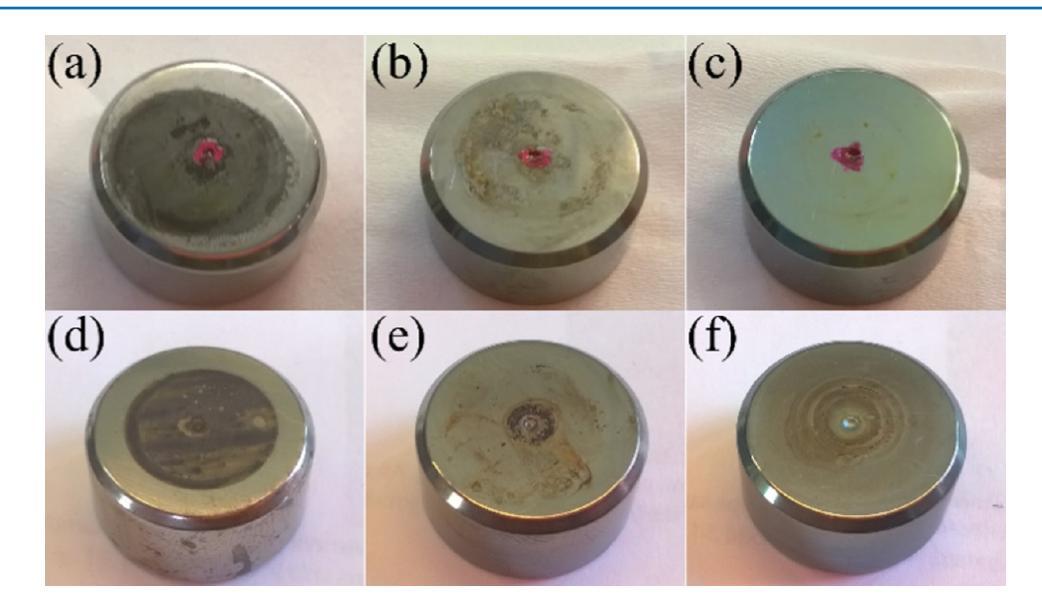
Figure 6. Photographs of the samples at the end of measurements, after five LSV measurements, and approximately 13 h in the salt solution. Samples without wear are shown in the upper row: (a) noncoated, (b) CrN-coated, and (c) hybrid PVD/ALD-coated. The lower row shows samples after the LSV5-Wear4: (d) noncoated, (e) CrN-coated, and (f) hybrid PVD/ALD-coated. For the samples in the lower row, ultrasonication was used to remove the lacquer before taking the images.

Figure 6 shows photographs of noncoated (Figure 6a,d), CrN-coated (Figure 6b,e), and hybrid PVD/ALD-coated (Figure 6c,f) steel disks after all of the measurements, for both without wear and with wear (LSV5-Wear4). The noncoated HSS is completely rusted in both cases (Figure 6a,d). The PVD CrN-coated samples appear quite identical (Figure 6b,e), which is as expected by the electrochemical measurement results. On the basis of the surface images, the profilometer results, and the electrochemical analysis, most of the PVD CrN coating still remains after the wear procedure, and the protection by the PVD CrN coating alone is mostly unaffected by the surface wear. For the hybrid PVD/ALDcoated HSS without wear (Figure 6c), there are only few small rust spots. In the case of the hybrid-coated samples with wear, some surface oxidation of the CrN coating is observed after the LSV5-Wear4 (Figure 6f). Additional rust spots are observed on the wear tracks of the hybrid PVD/ALD-coated samples.

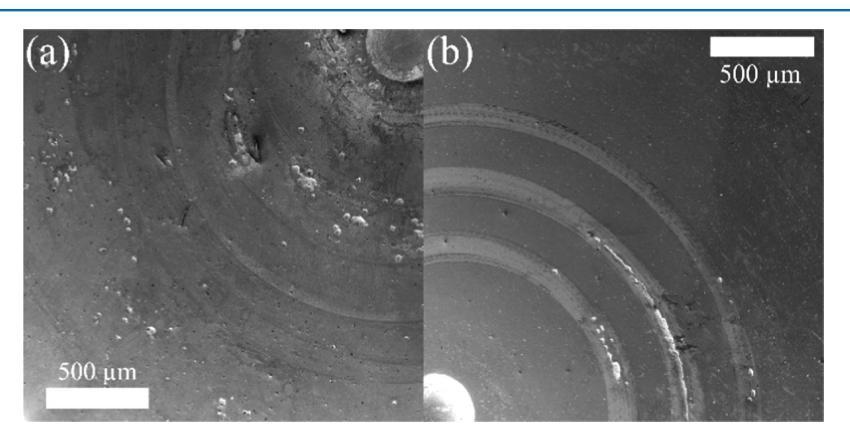
Figure 7. SEM images of sample surfaces after LSV4-Wear3 for (a) the PVD CrN-coated steel, where a notable amount of spot corrosion is observed, preferentially on wear tracks, and (b) the hybrid PVD/ALD-coated steel, where the corrosion is only observed at positions where wear tracks converge.

The rust spots were observed to be located preferentially at the wear tracks of the PVD CrN-coated and hybrid PVD/ALDcoated steel. Figures 7 and 8 show SEM images of coated sample surfaces after LSV4-Wear3 and LSV5-Wear4, respectively. With the CrN coating only (Figures 7a and 8a), some rust spots are seen outside the wear tracks, whereas for the hybrid PVD/ALD-coated HSS (Figures 7b and 8b), the rust spots are almost exclusively located at the wear tracks. After grinding the surface by sandpaper (LSV4-Wear4), only the deepest wear tracks remain, and higher-magnification SEM images of rust spots in these wear track positions are presented in Figure 8. These rust spots were up to 2 orders of magnitude larger than the biggest pinholes (few micrometers) observed in the CrN coating.

The energy-dispersive spectrometry (EDS) analysis gave strong Fe signals from the rust spots. A strong Cr signal without any Fe or Ti signal was observed from the wear tracks. For the hybrid PVD/ALD-coated HSS after LSV4-Wear3, an EDS Ti K α peak at 4.5 keV for the ALD nanolaminate¹⁰ was observed outside the wear tracks. At the edge of the wear track, increased aluminum signal was obtained, indicating residues from the counterface alumina balls.

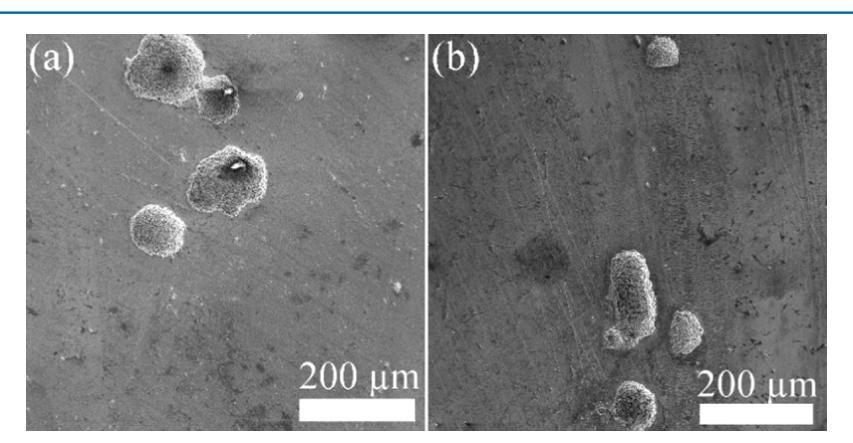
Figure 8. SEM images of rust spots at the wear tracks positions (vertical direction in the image) after sandpaper grinding (LSV5-Wear4) for (a) the PVD CrN-coated steel and (b) the hybrid PVD/ALD-coated steel.

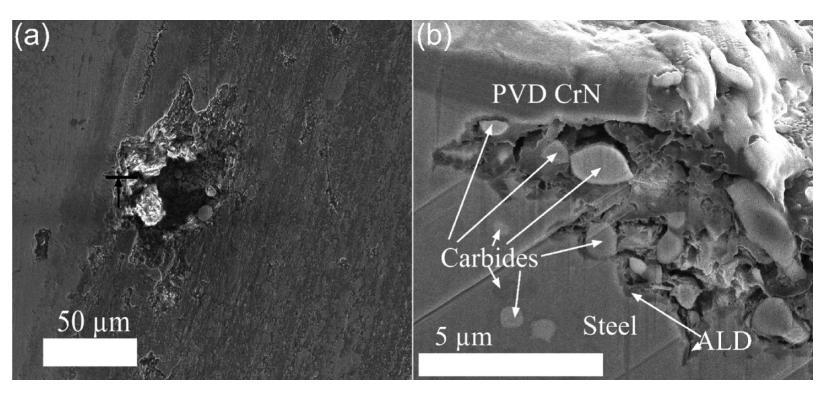
Figure 9. FIB/SEM analysis done on the hybrid PVD/ALD-coated steel after the LSV5-Wear4. Top view (a) of a major defect on a wear track. The black arrow denotes the location of the cross-sectional image (b) prepared by FIB milling.

2.3. SEM Imaging of Defect Site Cross Sections Prepared by Focused Ion Beam Milling. FIB/SEM images of the hybrid PVD/ALD-coated sample after the whole test procedure (LSV5-Wear4) are shown in Figures 9 and 10. Figure 9a shows a top-view SEM image of a major defect on a wear track with a heavy local corrosion. A black line and an arrow have been added to Figure 9a to illustrate the crosssectioned line spot and the view in Figure 9b, respectively. The cross section shows clearly characteristic, grainlike carbides in the steel and an edge of the PVD CrN coating on top of the steel. The corrosion has progressed below the PVD CrN coating. These observations are also in line with earlier research.¹⁰ Some of the PVD CrN coating appears collapsed. The ALD nanolaminate can be seen at the bottom, following the varying surface shapes conformally. It is notable that the ALD coating can be found deeper than the bottom surface level of the PVD CrN coating; it is plausible that the original defect in PVD CrN coating was caused by a major defect on the steel surface, which prevented successful PVD coating on this spot. The ALD coating would then have been deposited to cover the bottom of this defect.

The thickness of the ALD coating at the far ends of the defect cavity is larger than 100 nm. This can be attributed to possible chemical vapor deposition (CVD) reactions between the surfaces, precursors, and byproducts. This is a known issue for ALD on complex shadowed and other high-aspect-ratio (HAR) structures when precursors or byproducts do not have enough time to diffuse out from the structure before the following precursor pulse enters the space.¹⁹ Even with long purge time set in this investigation (10 s), complete prevention of the parasitic CVD seems to be challenging due to the high structural complexity of these HAR defect cavities.

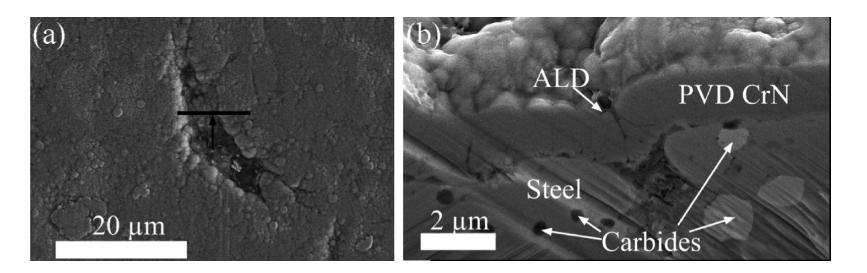
Figure 10. FIB/SEM analysis done on the hybrid PVD/ALD-coated steel after the LSV5-Wear4. Top view (a) of defect (shallow pit, probably left by a particle). The black arrow indicates the location of the cross-sectional image (b) prepared by FIB milling. Some milling artifacts are shown along the diagonal direction in the steel area (final polishing *z*-depth too short).

Figure 10a shows a top-view SEM image of a defect site outside of wear track. Only the last wear step, sandpaper grinding, has affected this area. A black line and arrow have been added to show the field of view for the image of the prepared cross section shown in Figure 10b. The observed defect is a shallow pit with mostly intact PVD CrN coating. Some corrosion has progressed through the right-hand side of the recess. An approximately 100 nm thick layer can be observed at the right edge of the recess. No such layer could be observed at the middle of the recess or at the top surface outside the defect.

Probably, there has been some kind of particle present at this recess, which has mostly blocked the ALD deposition on the recess. The sandpaper grinding has then removed the particle and ALD at the top surface outside the recess, but ALD at the edge of the recess and inside the PVD CrN coating remains. Removal of particle by sandpaper grinding has also probably expanded the cracks observed at recess in the PVD coating, and the one corrosion step carried out after the sandpaper grinding

has caused some steel dissolution at the right-hand side of the recess.

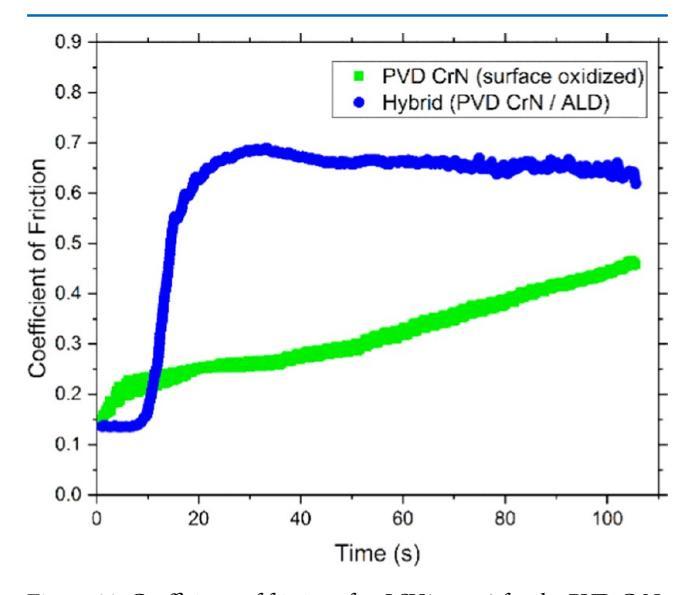
Figure 11. Coefficients of friction after LSV1-wear1 for the PVD CrNcoated and hybrid PVD/ALD-coated HSS. The CoF for the oxidized PVD CrN is lower than that for the nonoxidized PVD CrN.

2.4. Coefficient of Friction (CoF) for the Hybrid PVD/ ALD Coating. Figure 11 shows coefficient of friction (CoF)

value for ball-on-disk measurement on the PVD CrN-coated and the hybrid PVD/ALD-coated steel (LSV1-Wear1). The CoF of oxidized PVD CrN surface (see Figure 4b) is lower than that of PVD CrN protected from surface oxidation by the ALD nanolaminate (0.44 ± 0.03 vs 0.67 ± 0.04). This oxidized layer did wear away as the tribometer test progressed, and the CoF approaches the value for nonoxidized PVD CrN (0.67).

For the hybrid PVD/ALD-coated steel, low CoF (0.16 \pm 0.01) of the ALD nanolaminate is observed at the start of the measurement. Mayer et al. reported a larger value of CoF(0.3)for ALD $Al_2O_{3,}^{19}$ although they used silicon substrate and Si_3N_3 counterface ball, so the results are not directly comparable. Mohseni et al. obtained more similar CoF (0.15-0.22) for ALD nanolaminate,²⁰ although their investigations focused on different nanolaminates (ZnO/Al₂O₃/ZrO₂) and their tests used pin-on-disk configuration. In the research reported here, the ALD nanolaminate was worn off after 200 \pm 100 wear cycles (using 10 N force; 0.2 m/s linear speed; 6 mm diameter alumina ball). After this, the CoF increased rapidly, until it stabilized to CoF value of nonoxidized PVD CrN coating. Huang et al. reported similar rapid increase in CoF, followed by stabilization to a value above 0.6 with identical loads and similar sliding speed for PVD CrN.²¹

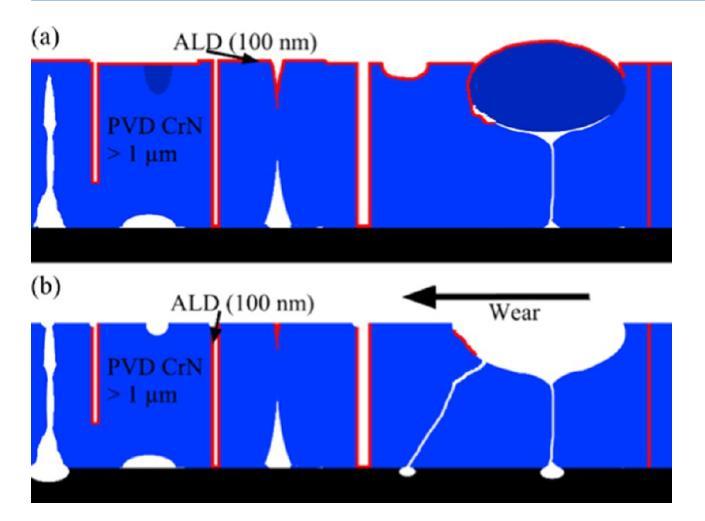
Figure 12. (a) Schematic of corrosion protection by hybrid PVD/ALD coatings. Defects shown are based on various defects observed in FIB investigations by Panjan et al.: open voids, closed pinholes, large (>1 μ m) flakelike defects, cone-shaped submicron defects.²² (b) Surface wear of the coating opens closed pinholes and can open cracks through coating and creating paths for the corrosion to attack the substrate.

2.5. Wear Mechanism Schematic on Corrosion-Protecting Hybrid PVD/ALD Coatings. It was shown that removal of the ALD nanolaminate from the top surface of the CrN coating reduced the corrosion protection of the hybrid PVD/ALD coatings. Despite this, the corrosion protection was superior to that of the corresponding PVD CrN coating alone. Figure 12 shows the schematic of the effect of wear on the

structure and the corrosion protection obtained by hybrid PVD/ALD coatings. This schematic has been constructed on the basis of the LSV results and the SEM images in this work as well as some relevant previously reported research: a simplified pinhole sealing schematic proposed by Härkönen et al.,⁴ previous FIB/SEM images showing ALD nanolaminate covering the bottom of PVD CrN pinholes,^{4,10} and defect-type investigations on PVD nitride coatings by Panjan et al.^{22,23}

Figure 12a shows the structure of the hybrid PVD/ALD coatings. This structure offers corrosion protection that is mostly unaffected by surface wear. Even with surface wear removing all ALD coating and some PVD CrN from top of the structure (Figure 12b), the pinholes remain sealed by ALD, and corrosion protection largely remains. Some of the corrosion protection is, however, lost due to four factors: (i) some of the defects in PVD coatings are closed during the PVD deposition process.²² These pinholes, which are not sealed by ALD, can be opened when the surface of the PVD coating is worn. (ii) Particles on steel-PVD CrN interface can be removed by wear, thus revealing areas that are uncovered by ALD. (iii) Wear can cause crack propagation through the whole PVD coating,¹² opening up new paths to the steel substrate. (iv) Some of the ALD coverage at pinholes can be potentially lost, if ALD film adhesion is poor due to unfavorable precursor-surface reactions. Regarding the fourth factor, plasma pretreatment has been reported critical to obtain sufficient adhesion and enhanced corrosion protection on PVD CrN and steel surfaces.^{5,10}
