Published in: Scientific Reports

# In-situ ToF-SIMS analyses of deuterium re-distribution in austenitic steel AISI 304L under mechanical load

One goal of the present study is to investigate structural and microstructural changes induced by hydrogen. For this purpose, samples made from austenitic stainless steel AISI 304L were electrochemically charged with deuterium and analysed by electron back-scatter diffraction (EBSD) and scanning electron microscopy (SEM). The work further aims to generate more knowledge about both the capability of different phase constituents to bind or trap hydrogen and the mobility of hydrogen in the microstructure under external mechanical load. To this end, the distribution of hydrogen and its behaviour within the specimen before and during the application of mechanical load were examined by time-of-flight-secondary ion mass spectrometry (ToF-SIMS). Due to the difficulties to distinguish between artificially introduced hydrogen and abundant hydrogen in the rest gas of the ToF-SIMS, deuterium (<sup>2</sup>H, D) was used as a tracer for hydrogen (H) .

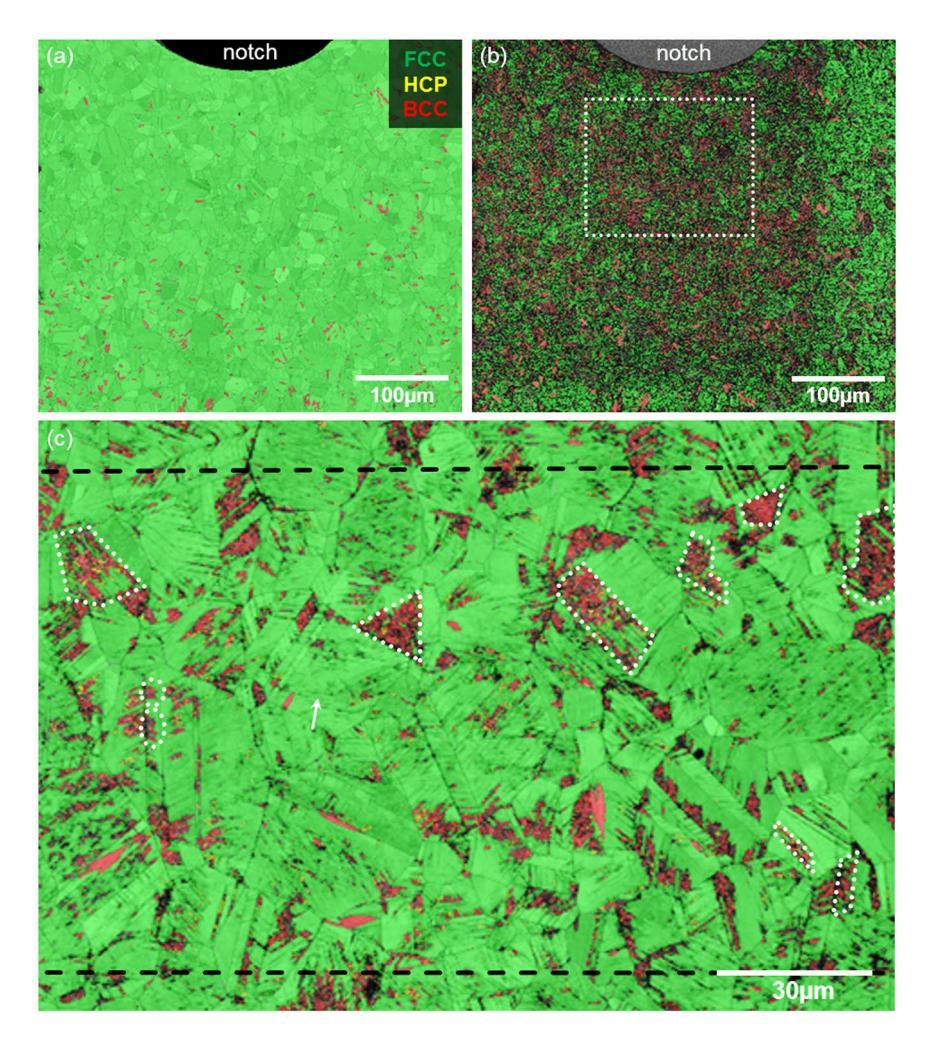
**Figure 1.** The overlay of pattern quality (PQ) and phase distribution map of the sample *before* charging is shown in (**a**). The same region *after* electrochemical charging for five days and ToF-SIMS experiments is depicted in (**b**). The dashed frame in (**b**) indicates the magnified area within the field of analysis in (**c**). Dotted white lines indicate newly-formed martensite, a white arrow marks slip bands. The dashed black lines represent the same ROI shown in Fig. 3.

**Deuterium-induced structural changes.** The results of the EBSD analyses before and after electrochemical charging for five days are shown in Figs. 1 and 2. Figure 1(a) shows the materials condition after sample preparation (cf. section *Materials and preparation*). The surface consisted mainly of austenite, indicated by green colour, with approximately 4% of residual martensite coloured in red. This martensite stems from cold rolling of the sheet material.

After five days of electrochemical charging (cf. Chapter *Electrochemical charging*) and ToF-SIMS analyses, the surface underwent changes. EBSD is able to illustrate the transformation of the original FCC phase into BCC martensite (cf. Fig. 1(b)) by analysing the same region of interest (ROI) as before charging. Due to the impact of the Cs<sup>+</sup> beam, used for removing contaminants from the surface, the sputtered region is visible. It was damaged more severely and contained a larger fraction of martensite. Areas where no diffraction bands could be indexed, i.e. measurement points with zero solution for the Kikuchi patterns, are indicated in black colour in the phase maps. The high number of these locally unsolved patterns is due to the higher thickness and density of the damaged surface.

Figure 1(c) shows the pattern quality and phase maps that are marked by the white dashed square in Fig. 1(b). It has a higher magnification and was taken with a smaller step size of the rastering electron beam. This significantly improved the image quality and its information content. A reduced step size thus leads to slower but more precise measurements. This is why the non-indexed measurement points in (b) are reduced dramatically. Figure 1(c), thus, shows that the influence of the sputter beam is overestimated in the phase distribution map in (b). Furthermore, Fig. 1(c) not only displays the BCC  $\alpha$ '-martensite coloured in red but also the yellow-hued  $\epsilon$ -martensite. As described in the literature, this hexagonal phase reflects the intermediate step in the transformation sequence of the FCC austenite into BCC martensite<sup>25-28</sup>.

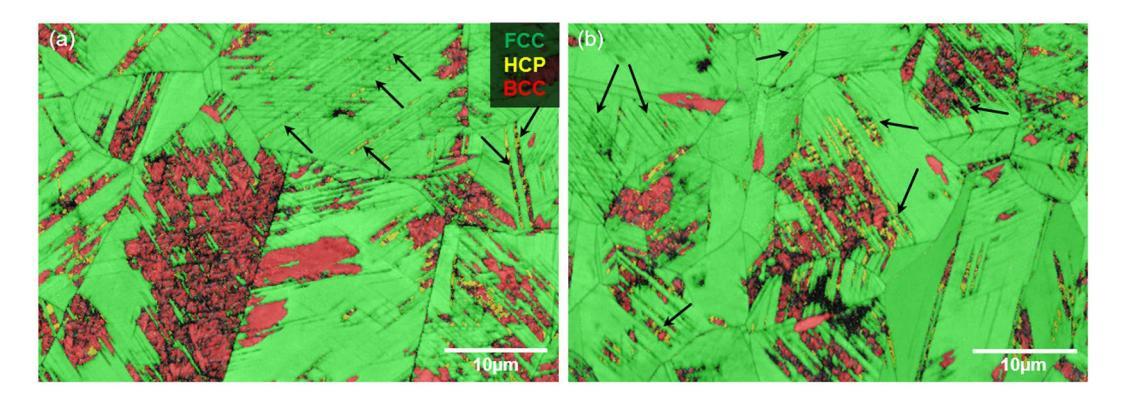
**Figure 2.** The overlay of pattern quality (PQ) and phase distribution map of the surface *after* electrochemical charging for five days. Both images (**a**,**b**) were taken outside the region sputtered and analysed by ToF-SIMS. Black arrows indicate slip bands as nucleation sites for  $\epsilon$ - and  $\alpha$ '-martensite.

To fully proof that the phase transformation was not induced by sputtering in the ToF-SIMS, but by deuterium-charging, EBSD images were taken outside of the sputter crater. Figure 2(a,b) exemplary show such locations. The ingress and accumulation of deuterium generated  $\gamma \rightarrow \epsilon \rightarrow \alpha'$ - transformation on slip bands. The formation of martensite on such deformation bands during quenching and straining was already described by Olson and Cohen<sup>29</sup>. Analogous to their description, stacking faults (SF) formed due to high localised mechanical strain that was induced by deuterium accumulation. These SFs were the basis of both  $\epsilon$ -martensite and mechanical twins. Stacking faults arranged on every second {111}-plane of the FCC lattice, lead to an ABABAB stacking sequence and thereafter  $\epsilon$ -martensite<sup>30</sup>. Within the newly formed  $\epsilon$ -regions, acting as nucleation sites,  $\alpha'$ -martensite evolved by a further shear of atomic planes due to the ingress of more deuterium into the lattice. Black arrows in Fig. 2 indicate slip bands as nucleation sites for phase transformation.

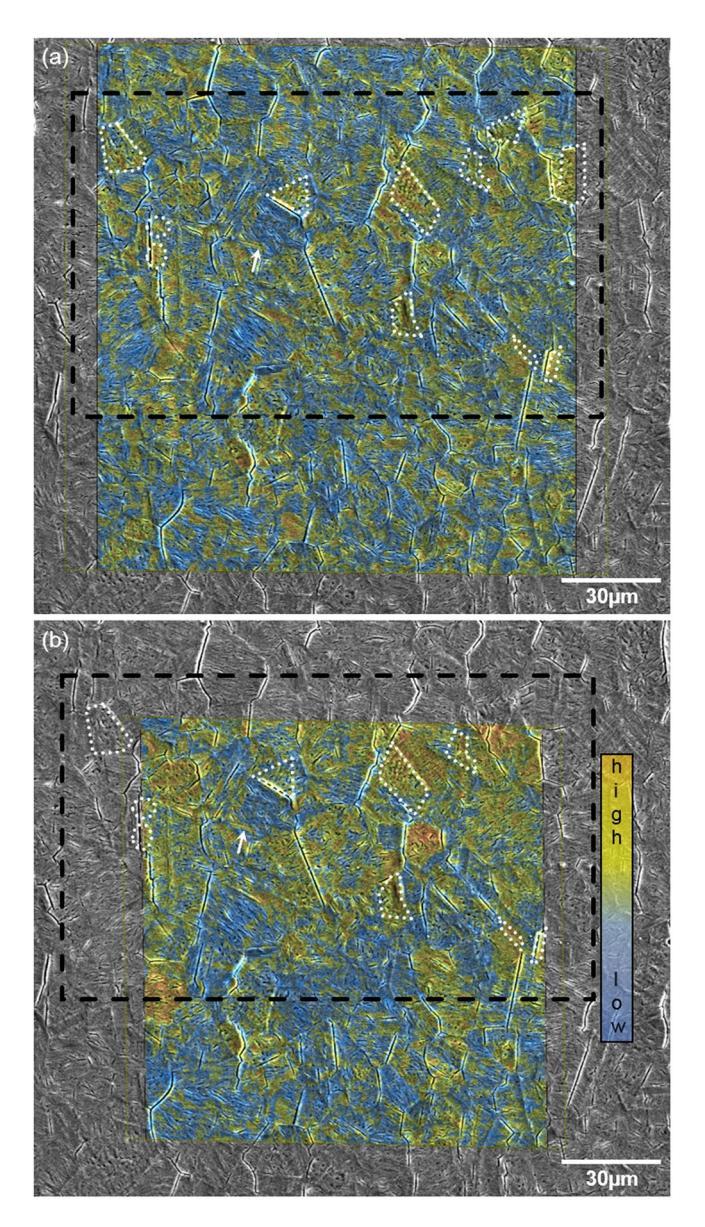
**Figure 3.** The overlay of an SEM micrograph and the SIMS data after principal component analysis (PCA) *before* (**a**) and *during* applying mechanical load (**b**). The distribution of deuterium and its covariant fragments is reflected as principal component two (PC2) in (**a**) and PC1 in (**b**). Brighter colours refer to a higher intensity of the signal. For a better orientation, the same ROI as shown in Fig. 1(**c**) is marked by dashed black lines, whereas the same features are marked by dotted white lines. Due to the sample drift during bending and temperature variations, the image in (**b**) had to be cropped. The notch of the sample is located appr. 85  $\mu$ m above the SIMS images.

For instance Tavares *et al.* claimed that typical features of the decohesion are (quasi-)cleavage and intergranular fracture<sup>40</sup>. This becomes obvious in the micrograph in Fig. 3 where cracking occurs along grain and twin boundaries. Differences in the orientation of neighbouring grains cause a mismatch between them. As a result of that, highest stress and, thus, cracking occurs along grain boundaries with highest misorientation angle. Due to the loss in cohesive energy in the presence of deuterium, the localised stress concentrations are not accommodated plastically. However, the SEM micrograph in Fig. 3 reveals several short transgranular cracks too. These formed mainly parallel to slip bands and at their intersections.

The distribution of deuterium in the matrix is heterogeneous. Areas with a higher intensity of deuterum-related signals (orange) can be found as well as locations with a relatively lower intensity (yellow) and regions where the signal was too weak to be detected (blue). Considering Fig. 1(c) together with Fig. 3(a), it becomes obvious that deuterium is dissolved in both the austenite and trapped by the newly formed martensite. Solute deuterium in the FCC phase after charging can be explained by its high solubility. The presence of deuterium in the BCC phase, however, stands against the common assumption of its low solubility for hydrogen and deuterium, respectively. Martensite contains a high number of defects. Especially dislocations that form during transformation are regarded as effective trapping sites for hydrogen, and in consequence, for deuterium<sup>41</sup>. Kim *et al.* showed furthermore that interfaces, grain boundaries and point defects within the newly formed martensite bind hydrogen<sup>42</sup>. The white arrow in Figs. 1(c) and 3 shows the accumulation of deuterium already at slip lines, i.e. the precursor of martensite. In addition to that, it is anticipated that deuterium may not only be trapped at these defects but also dissolved within the lattice. Due to the rapid  $\gamma$ - $\alpha$ -transformation, diffusion of deuterium was restricted so that the newly formed BCC matrix was supersaturated with deuterium. It was already discussed in a previous work that deuterium can be incorporated into the newly formed BCC/HCP lattice<sup>20</sup>.

In order to fully exploit the information content of the ToF-SIMS results, principal component analysis (PCA) was applied<sup>47</sup>. This allowed to incorporate not only the deuterium signal but other deuterium-related fragments such as OD<sup>-</sup>. The obtained principal components (PC) contain several peaks of different masses that were detected during SIMS analysis. The influence of each peak within the principal component is weighed which shows the contribution of an element to the PC. Deuterium together with several deuterium-related fragments is reflected by PC2 in the measurement *without* external mechanical load, shown in Fig. 3(a). In contrast to that, PCA on the data gathered *during* applying mechanical loading resulted in the deuterium signals condensed in PC1. The first two to three PCs are typically containing the main amount of variance and are therefore used for data interpretation<sup>48</sup>. The variance of higher PCs is usually very small or even zero. Consequently PC1 explains a higher amount of the total variance than PC2. The deuterium-related peaks had a higher variance after applying the mechanical load. This gives an indication of the stronger signal intensity as a result of the strain.

During mechanical loading of the specimen, the part of the sample farther away from the notch encountered compressive stress, while in the vicinity of the notch tensile stress prevailed. The highest stress and strain occurred directly below the notch. The material was plastically strained in the notch root. The size of this plastic zone was approximately  $65 \,\mu\text{m}$ . The field of analyses was located about  $85 \,\mu\text{m}$  from the notch, where the material was deformed elastically. However, this was sufficient to induce a movement of deuterium towards the notch, viz. the area under tensile stress. This was energetically favourable since tensile stress expanded the lattice, offering more space for deuterium<sup>49</sup>. The comparison of Fig. 3(a,b) reveals that not only the overall intensity of the deuterium-related signals is higher in Fig. 3(b) as compared to (a). Additionally, the concentration of deuterium increases towards the upper part of the ROI, thus, towards the notch where the highest stress and strain are assumed to occur.

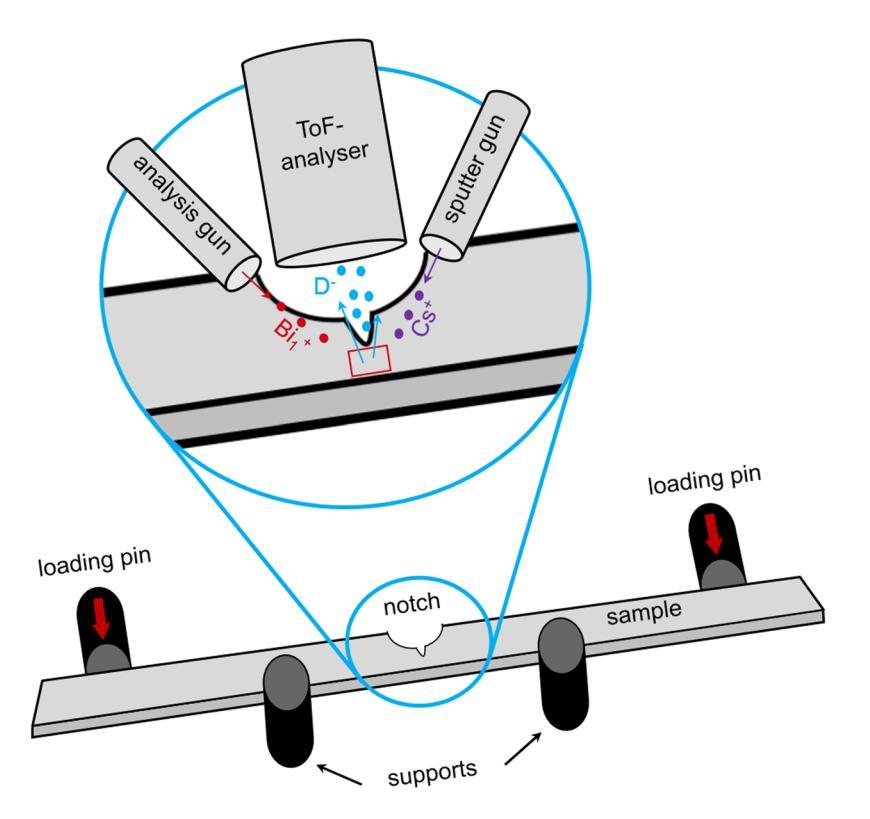
**Figure 4.** Sketch of the setup of the ToF-SIMS experiments. Secondary ion images were taken both *before* and *during* mechanical loading. Bismuth ions were used for analysis, caesium ions for a preceding sputter step. The analyser gathered only negatively charged secondary ions.

*Time-of-flight secondary ion mass spectrometry.* Analyses of the deuterium distribution were done with a TOFSIMS IV (*IONTOF GmbH, Münster, Germany*). Micro four-point-bending specimens were mechanically ground and polished and electrochemically polished. Subsequently, they were charged. To prevent outgassing of deuterium from the sample, it was cooled to  $-70^{\circ}C \pm 5^{\circ}C$ . An area of  $400 \times 400 \ \mu\text{m}^2$  was sputtered for five minutes with a 1 keV Cs<sup>+</sup> beam directly before ToF-SIMS analyses. This was done to remove contaminations and to enhance the secondary ion yield of deuterium<sup>54</sup>. The data was acquired using the collimated burst alignment mode (CBA) using a 25 keV Bi<sub>1</sub><sup>+</sup> ion beam<sup>55</sup>. A ROI of  $150 \times 150 \ \mu\text{m}^2$  was scanned in a sawtooth mode with 512 by 512 pixels and one shot per pixel. Figure 4 gives a sketch of the experimental setup of the ToF-SIMS.

External mechanical load was applied on the specimen by an innovative, custom-made four-point-bending sample holder. The load transmission was realised by two piezo actuators type PA 50/T14 ("loading pin" in Fig. 4) purchased from *piezosystem jena GmbH (Jena, Germany)*. By that, a displacement of  $\leq$ 50 µm was accomplished. The first SIMS analysis was performed *without* applying mechanical load, whereas the second (on the same ROI) was performed *while* applying the mechanical load. In the latter case, the sample was constantly strained during the acquisition. The highest mechanical stress developed in the notch root was approximately 365 MPa. A detailed description of the four-point-bending device can be found in<sup>56</sup>.
