# Experimental Study on Steel-Concrete Composite Twin I-Girder Bridges

Published in: Journal of Bridge Engineering

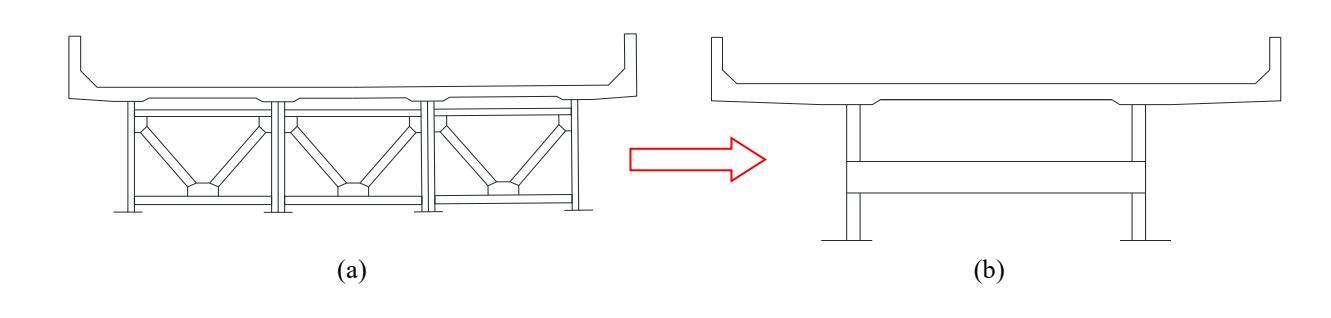
- 2 Fig.1 Traditional multi-girder composite section and new structural form of twin girder composite section: (a) Multi-
- 3 girder composite section; (b) Twin girder composite section.

Multi-girder bridges, as shown in Fig.1 (a), are one of the most common types of medium span composite bridge, which can be used for a single span or for continuous multiple spans, and it is particularly effective where

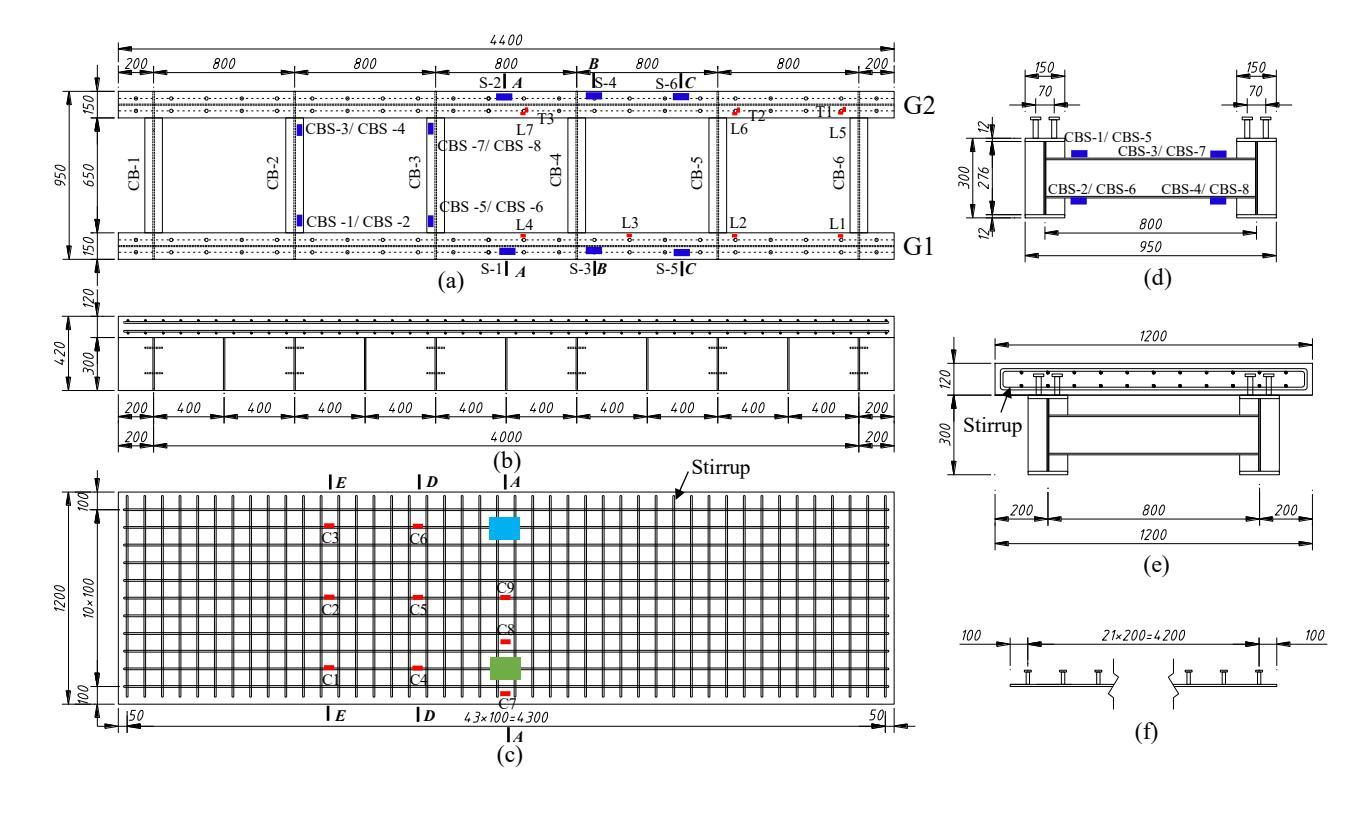
- 4 Fig.2 Size dimensions of the connection joint after strengthening (unit: mm): (a) Plane view of steel girder and shear
- 5 strain gauge on studs; (b) Side elevation; (c) Plane view of concrete deck and reinforcement; (d) Cross-section of steel

- 6 girder; (e) Composite section; (f) Stud distribution.
- 7 Fig.3 Instrumentation in the loading test ((a) LVDT for displacement, (b) Strain gauges on main girder, (c) Strain

A simply supported steel-concrete composite twin I-girder bridge specimen was designed according to Japanese 92 bridge design specifications (JRA, 2012; JSCE, 2007). The specimen was designed as 4.4m in length and was 93 simply supported at a span length of 4m, by considering the available space in the structural laboratory. The width-94 to-span ratio and depth-to-width ratio are taken similar to that of typical composite twin I-girder bridges used in 95 Japan. Two I-girders with a height of 300mm were used as main girders, and the width of the concrete slab was 96 determined as 1200mm. According to bridge design specification in Japan (JRA, 2012), the minimum thickness of 97 concrete slab is 110mm. To also study the real behavior of studs and avoid the possible damage of the slab during 98 transportation, the slab thickness was determined as 120mm. The influence of the deck thickness on general 99 behavior of such structures was investigated based on the numerical analysis (Lam et al., 2017a and 2017b), and 100 101 the results clearly indicate that thickness of the concrete slab as well as the concrete strength have no effect on the 102 global behavior of such structures. Vertical stiffeners were welded at support points and other key sections at an interval of 400mm to prevent buckling failure and crippling of the web before flexural failure. Six cross beams (CB-103 104  $1 \sim 6$ ) were also used between the twin main girders for load redistribution. Vertical stiffeners on the web were also appropriately designed and arrange between cross beams. Four rows of shear stud connectors with the diameter of 105 16mm were placed with a uniformly spacing of 200mm in the longitudinal direction to ensure the full (or complete) 106 connection between the steel girder and the concrete slab. The theoretical values of yield and ultimate bending 107 moment capacity of the specimen considering the actual yield stress from the material tests are determined as 108 676kN m and 886kN m, respectively. Size dimensions and design details of test specimen are shown in Fig.2. 109

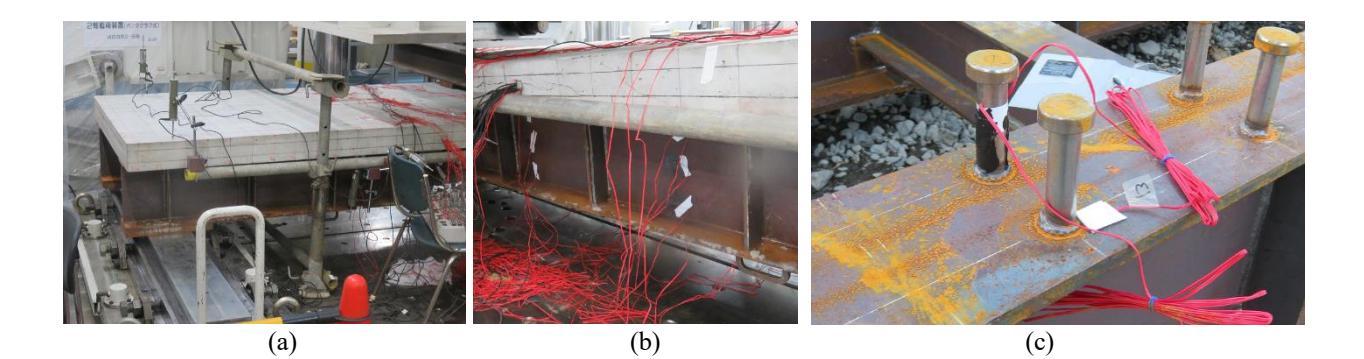
- 8 gauges on stud)
- 9 Fig.4 Loading conditions ((a) Symmetric load, (b) Asymmetric load)
- 10 Fig.5 Loading test set-up ((a) Symmetric load (P<150kN), (b) Asymmetric load)

The instrumentation of the loading test is shown in Fig.3. Linear variable differential transducers (LVDTs) were used to measure the vertical deformation at the span center section and support location at both ends. With the purpose of determining the neutral axis, strain gauges were used to measure the strain in the web, steel flanges, the reinforcement as well as the concrete slab surface in key sections. In addition, shear strain on stud connectors in both longitudinal and lateral directions were also measured.

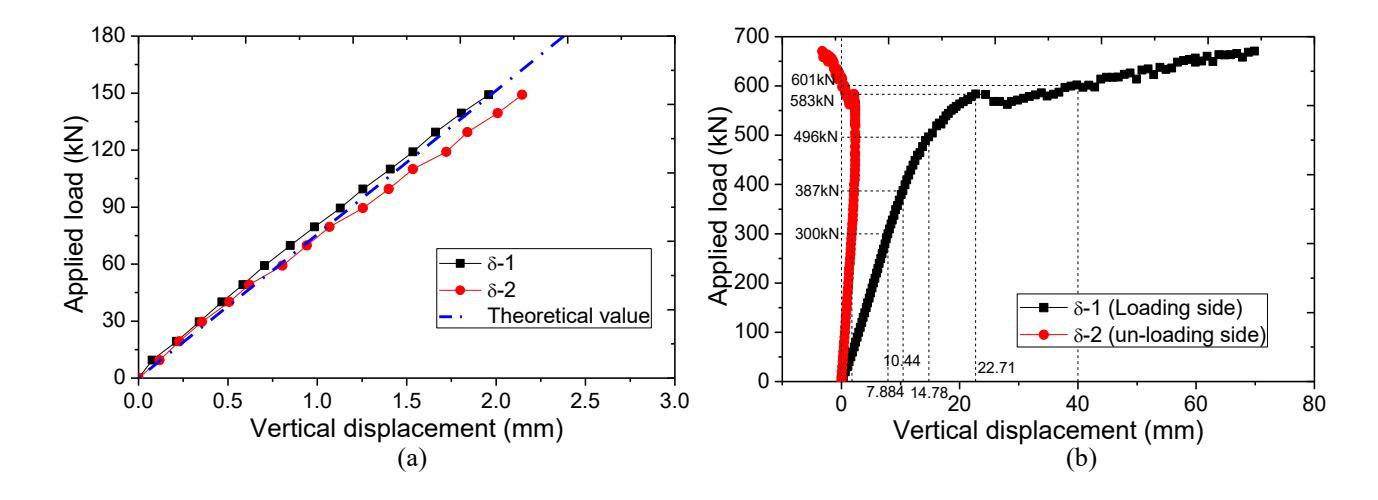
- 11 Fig.6 Load-displacement relationships ((a) Symmetric load (P<150kN), (b) Asymmetric load)
- 12 Fig.7 Effective width of flange
- 13 Fig.8 Failure mode of the test specimen ((a) Top view of the concrete slab, (b) Bottom view of the concrete slab)

The load-vertical displacement curves of the test specimen under both symmetrical and asymmetrical loading were illustrated in Fig.6. The displacement was taken at mid-span section of the test specimen. Due to space limitations under the deck, the LVDTs were used on the bottom of the concrete slab but not the bottom of the main girders. The displacements on girder-1 (G1) and girder-2 (G2) are referred to as  $\delta$ -1 and  $\delta$ -2, respectively. For asymmetrical loading, the load was only applied on G1, as shown in Fig.4.

When subjected to a symmetrical load, the load-vertical displacement curves were shown in Fig.6 (a). It can be 153 found that both  $\delta$ -1 and  $\delta$ -2 increase linearly with the increase of the applied load. Though there is small difference, 154 the displacement of  $\delta$ -1 was similar to that of  $\delta$ -2, indicating that identical loads were applied on two main girders. 155 In addition, theoretical value of the load-displacement curve of the specimen was also provided. In computing the 156 theoretical value, all the materials were assumed as elastic and the effective width of the concrete slab was 157 considered to account for the shear lag effects. The effective width of concrete slab in twin I-girder bridges was 158 determined according to Eq.(1) according to the Specifications for Highway Bridges (JRA, 2012) in Japan. "Full 159 connection" was assumed for the steel-concrete interface, and the transformed section method was used to determine 160 the moment of inertia of the composite section. The theoretical values were then determined according to the classic 161 theory for simply support girders. The comparison indicates that the theoretical results determined according to 162 current elastic design theory agree well with the test results, demonstrating the twin I- girder bridges can be designed 163 appropriately on the basis of the current bridge design method. 164

168 When subjected to an asymmetric load, the load-vertical displacement relationships were shown in Fig.6 (b). In 169 the initial loading stage, both  $\delta$ -1 and  $\delta$ -2 also increase linearly with the load increases. However, the  $\delta$ -1 was much 170 larger than that of  $\delta$ -2, caused by the asymmetrical load applied on the side of the G1. Taking the applied load of 171 300kN as an example, the corresponding displacement at G1 (7.884mm) was nearly 4.5 times of the displacement 172 at G2 (1.764mm), thus the G2 carries around 18.3% (=1.764/(1.764+7.884)) of the load carried by the main girders. 173 The results indicate that before crush or cracking, the concrete slab is capable of transferring a certain level of 174 applied load from G1 to G2, but not zero as can be predicted according to the "lever principle".

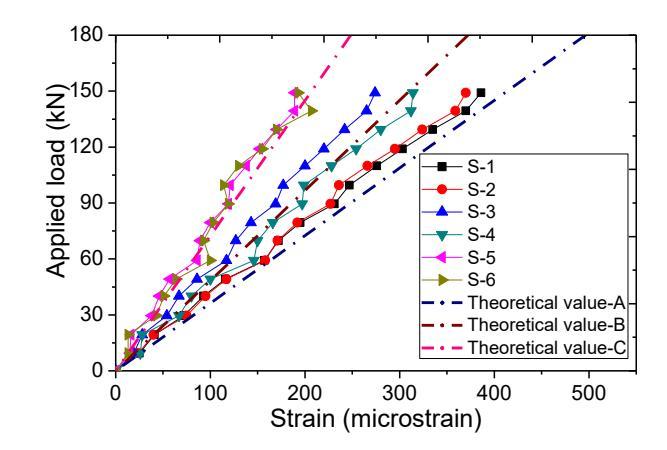
- 14 **Fig.9** Strain on bottom flange (Symmetric load)
- 15 Fig.10 Strain on bottom flange (asymmetric load) ((a) Whole loading stage, (b) Initial loading stage)

When the specimen subjected to symmetric loading, the strain on the steel girder was shown in Fig.9. The corresponding theoretical relationships between the applied load and the strain on the basis of the elastic theory at section-A, section-B, and section-C (denoted as "Theoretical value-A", "Theoretical value-B" and "Theoretical value-C", respectively) were also provided. Both strains on G1 and G2 increase linearly with the increase of the load, and the strains on G1 were similar to that on G2. Also, the comparison shows that the theoretical results agree well the measured results in all three sections, indicating that the applicability of elastic design theory in designingsuch bridges.

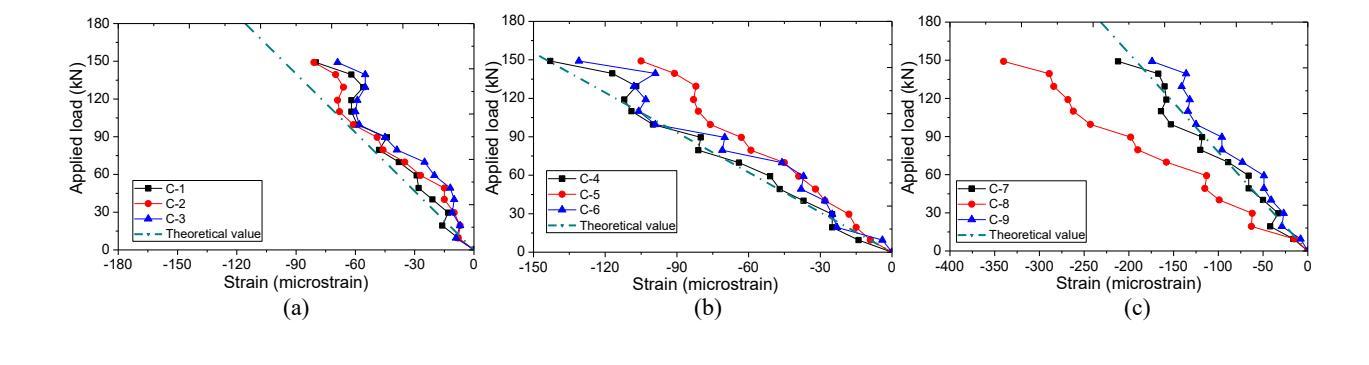
- 16 Fig.11 Normal strain on top surface of the concrete slab (symmetric load) ((a) Section-A, (b) Section-D, (c) Section-E)
- 17 Fig.12 Normal strain on top surface of the concrete slab (asymmetric load) ((a) Section-A, (b) Section-D, (c) Section-E)

When two symmetric loads were applied, the normal strain on top surface of the concrete slab was shown in Fig.11. The corresponding theoretical values of the normal strain according to elastic theory were also determined and provided. The results indicate that the normal strain on the concrete increased linearly with the increase of the applied load. For sections-A and –B, the normal strains on the right top of the main girders (C-1, -3, -4, and -6) are close to the strain on the middle top of the cross section (C-2, and -5), indicating the negligible shear lag effect of the concrete slab under symmetric loads. This is also confirmed in the effective width calculation for the concrete slab. According to Eq. (1), the effective width of the concrete slab is determined to be 1.12m, which is very close to the actual width of the slab (1.2m). Also, the comparison shows that the theoretical results agree well the measured results in all three sections, indicating that the applicability of elastic design theory in designing such bridges.

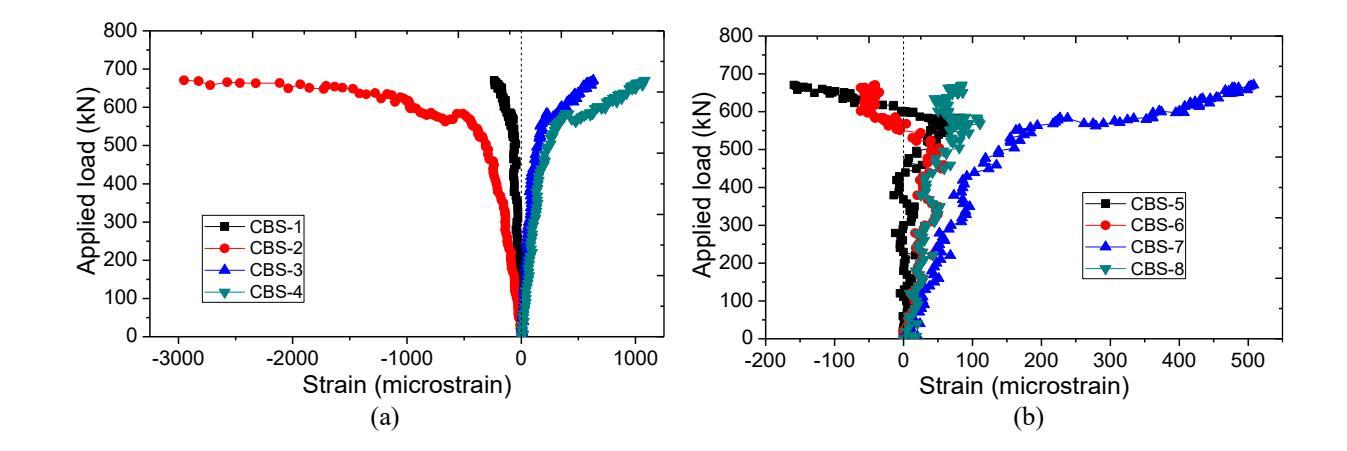
- 18 **Fig.13** Normal strain on cross beams ((a) CB-2, (b) CB-3)
- 19 Fig.14 Shear strain gauge on shear stud ((a) Shear strain gauge location, (b) Stud in the test specimen)

The load-flexural strain results of two cross beams are shown in Fig.13. As the flexural strain keeps increasing 258 259 with the increase of the load, the cross beams in twin girder bridges are functional. Also, it was found that the further the cross beam located from the loading point, the larger strain can be confirmed. The deformation of cross beams 260 may consist of vertical deformation, longitudinal deformation, and twist deformation. As the vertical deformation 261 decreases with the distance from the cross beams to loading point, the strain was mainly caused by the lateral 262 deformation of the beam. Another interesting phenomenon is that the flexural strain on both top and bottom flanges 263 in cross beams are in same sign conversion, indicating that they are in either tension or compression simultaneously. 264 If the cross beams are main subjected to vertical forces (shear or bending), the flexural strain on top and bottom 265

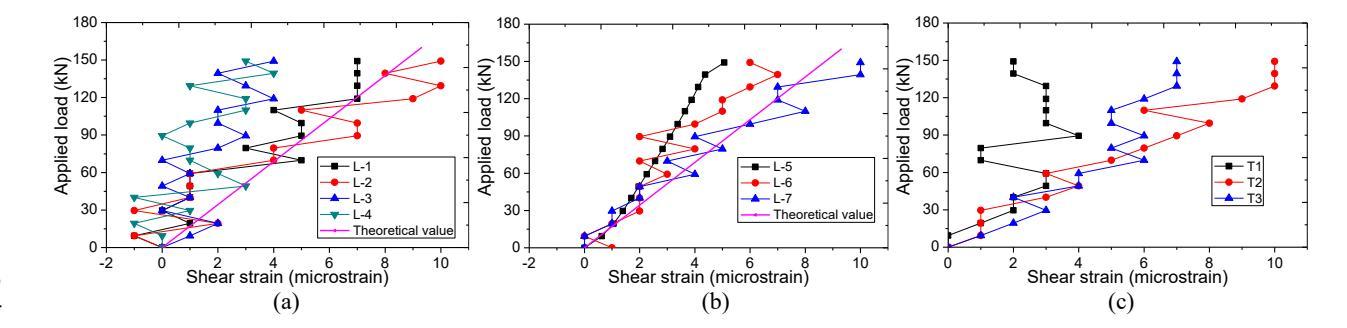
- 20 Fig.15 Longitudinal and transverse shear strain on shear studs (symmetric load) ((a) Longitudinal shear strain, G1; (b)
- 21 Longitudinal shear strain, G2; (c) Transverse shear strain, G2)

Shear strain results of studs in the loading tests subjected to symmetric load are shown in Fig.15. Also, the theoretical prediction of the longitudinal shear strain at the measured location based on elastic theory was also provided. "Complete connection" was assumed on the steel-concrete interface, which means the slip on the interface was not considered. The theoretical value of longitudinal shear strain was determined by using the following equation:

294 The longitudinal shear strain of studs on G1 and G2 were shown in Fig.15. Zigzag increase of shear strain on

studs was observed, which might be caused by shear force transmission at the initial loading stage. Theoretically 295 speaking, the shear strain at different sections should be the same due to the same shear forces under symmetric 296 loading applied at the mid-span. However, the strain results in Fig.15 (a) and Fig.15 (b) indicate that the shear strain 297 on studs near the 1/4 span was larger than those on studs near the girder end section or mid-span section, which was 298 similarly to the results observed in previous tests (Lin et al., 2014), and the fraction forces on the interface caused 299 by reaction forces at the supports and the applied loads are considered as the main reasons. In addition, the 300 comparison indicates that the theoretical results agree well with the results with the measured shear strain at L1 and 301 L2, but slightly larger than the results at L3 and L4. Therefore, it can be confirmed that the slip on the steel-concrete 302 can be ignored at the elastic stage, and "full shear connection" can be used for designing the twin I-girder bridges 303 with "full connection". On the other hand, the results in Fig.15 (c) indicates that the shear strain of studs in the 304 lateral direction have similar increasing trend with those in longitudinal direction as shown in Fig.15 (a) and Fig.15 305 (b). 306

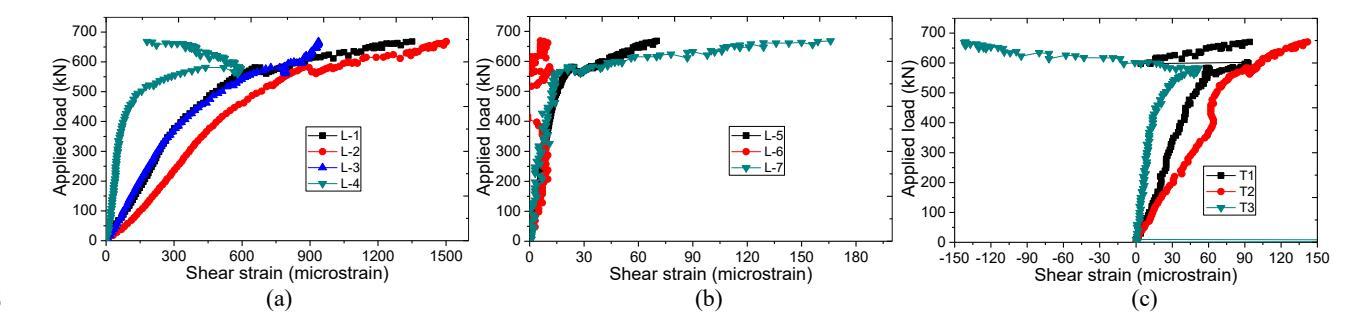
- 22 Fig.16 Longitudinal and transverse shear strain on shear studs (asymmetric load) ((a) Longitudinal shear strain, G1; (b)
- 23 Longitudinal shear strain, G2; (c) Transverse shear strain, G2)

307 When subjected to an asymmetric load, the shear strain increase on study versus applied load relationship was shown in Fig.16. The results in Fig.16 (a) show that shear strains on all measured studs increase linearly with 308 increase of the applied load at the linear stage. After that, shear strains increase significantly as the applied load 309 increase, which might be caused by two reasons: upward movement of the neutral axis and breaking of the bonding 310 on the interface. After the yielding of the bottom flange, the neutral axis on G1 moves from the elastic neutral axis 311 (in the web of the steel girder) to the steel-concrete interface which caused the higher shear force transmission on 312 the interface. On the other hand, the failure of the chemical bond or friction on the steel-concrete interface cause 313 the shear force transmission from the chemical bond to the stud shear connectors. In addition, the comparison of the 314 shear strain on different studs on G1 indicates the similar conclusion observed in Fig.15, the maximum shear strain 315 is more likely to occur on studs near the 1/4 span. Approximately equal shear strain according to the constant shear 316 force distribution was not confirmed at the measured studs on G1. The shear strains on studs near the girder end 317 and near the mid-span are likely to be smaller, which might be caused by the friction forces on the interface due to 318 the reaction force and the applied load at girder end and mid-span, respectively. The shear strain shown in Fig.16 319 (a) indicates that the shear studs on G2 undertake very small shear force under the concrete crush, indicating that 320 little shear force was transmitted from G1 to G2. When the applied load increased to 583kN (local crush of concrete), 321 significant shear strain increase was observed on L5 and L7, but little increase was observed in L6. However, all 322 the shear strain are relatively smaller than those observed in studs on G1.It can be concluded that for asymmetric 323 load applied right top of the one main girder, the shear force transmission on the other main girder (un-loaded girder) 324

can be ignored. Fig.16 (c) shows the transverse shear strain at the foot of studs on G2. It can be seen that the transverse shear strain of shear studs on G2 was much larger than their longitudinal shear strains in both elastic and plastic stage. Therefore, the results clearly indicate that the combination of shear strains at both longitudinal and transverse directions should be considered in the design of studs in twin I-girder steel-concrete composite bridges.
