Sulphide-induced stress corrosion cracking and hydrogen absorption of copper in deoxygenated water at 90°C

Published in: Materials and Corrosion

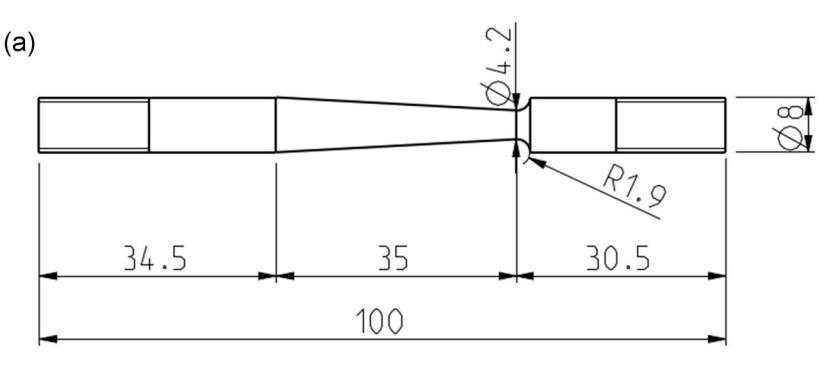
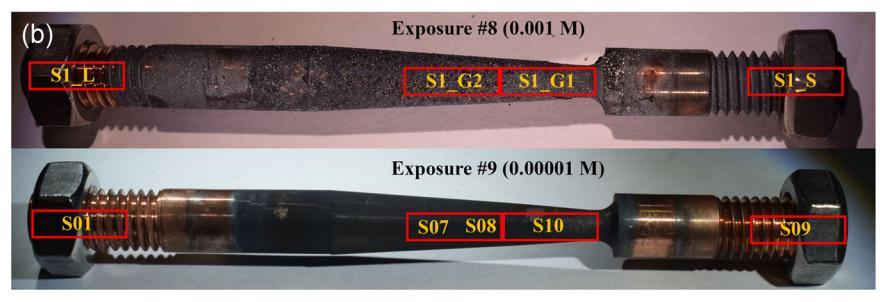
FIGURE 1 (a) Schematic illustration of the SSRT specimen geometry. (b) SSRT specimens #8 and #9 after exposure. Locations and naming of the hydrogen TDS samples are marked with red rectangles and yellow text^[9] (reprinted with permission from SSM). SSRT, slow strain rate tensile testing; TDS, thermal desorption spectroscopy [Color figure can be viewed at wileyonlinelibrary.com]

The two SSRT specimens were manufactured from Cu-OFP, cut from top part of a canister lid.^[3] The chemical composition is shown in Table 1. The geometry of the SSRT specimens, previously determined by finiteelement method (FEM) calculations to obtain a desired strain in the narrowest part of the gauge section by the end of the SSRT,^[3] is shown in Figure 1a. The lower half (Figure 1b) shows the two SSRT specimens after exposure together with the locations and naming of samples cut for the hydrogen content measurements.

Samples for TDS were cut with EDM from the SSRT specimens from locations shown in Figure 1 to measure hydrogen absorption in different parts of the tensile specimens. The TDS samples of the coupon specimens were cut mechanically before and after exposure to the sulphide-containing environments. To remove the cutting-affected surface layer, the samples were mechanically ground to size

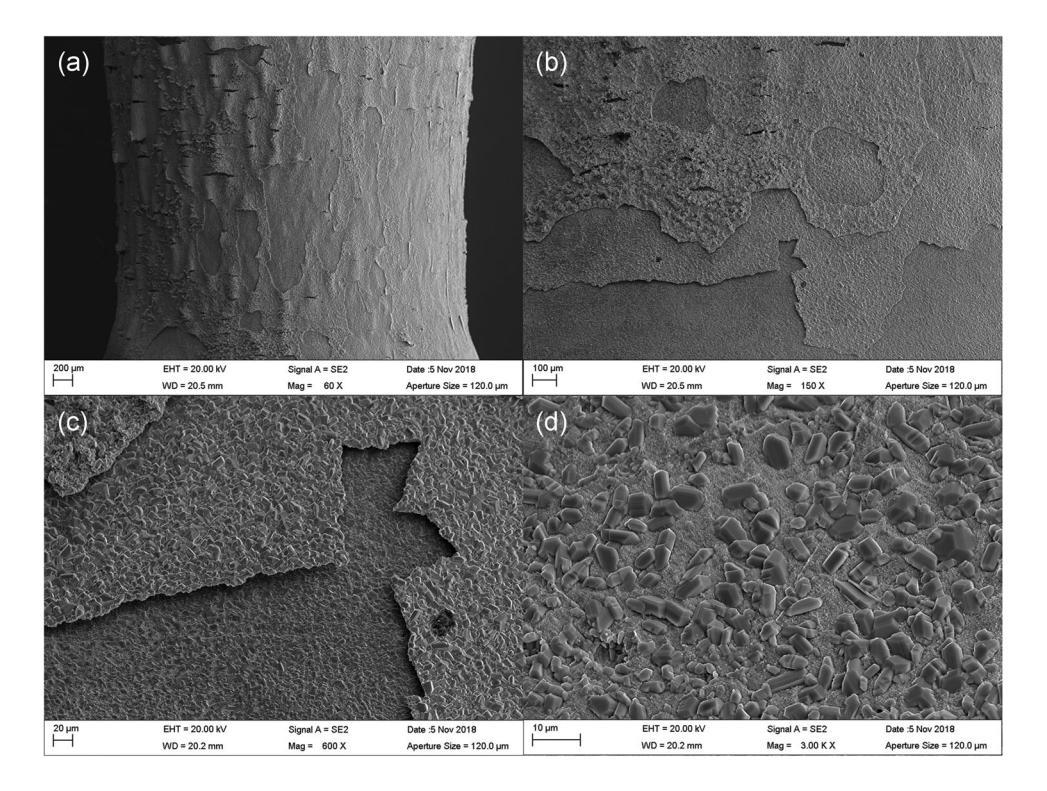
FIGURE 2 (a) General view of SSRT specimen #8. (b) Several copper sulphide films formed in 0.001 M sulphide. (c) The films detached from the copper surface due to plastic deformation of the copper substrate. (d) The crystals grow directly from the copper surface. SSRT, slow strain rate tensile testing

The SSRT specimens from both exposures were observed with SEM before and after removal of the sulphide film. SSRT specimen #8, which was tested in the high sulphide concentration of 0.001 M, is shown in Figure 2. A thick, multi-layer sulphide film was formed, where the multiple layers consist of single layers of sulphide crystals. This is

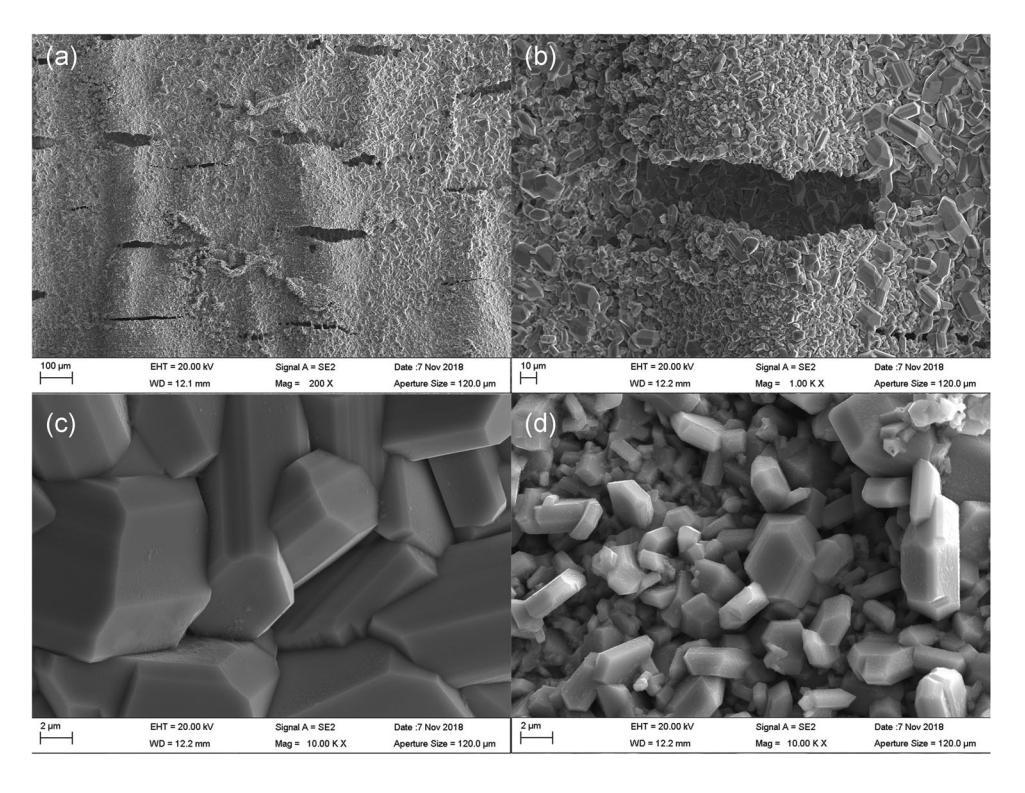
FIGURE 3 (a,b) The copper sulphide films crack perpendicular to the loading direction. (c) The inner (but still detached) film consists of larger crystals and their size does not vary much. (d) The outer film consists of smaller crystals and their size varies more

There were at least three film layers formed on SSRT specimen #8, and the different layers had different crystal morphologies (shown in Figure 3). The crystals were confirmed by EDS to contain only Cu and S implying that they were Cu₂S crystals, later confirmed by XRD measurements. The surface underneath the crystals was confirmed by EDS to be Cu. Side view of the inner, but still detached copper sulphide film is shown in Figure 4. Cracking of the film occurred intergranularly. The crystals are most likely held, at least partially, in place by mechanical locking as evidenced by the brittleness of the films.

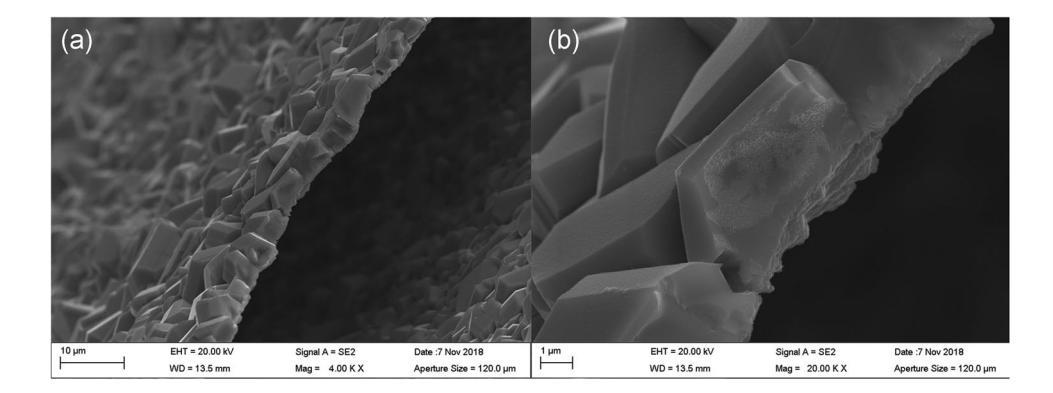
FIGURE 4 Side view of the inner detached copper sulphide film

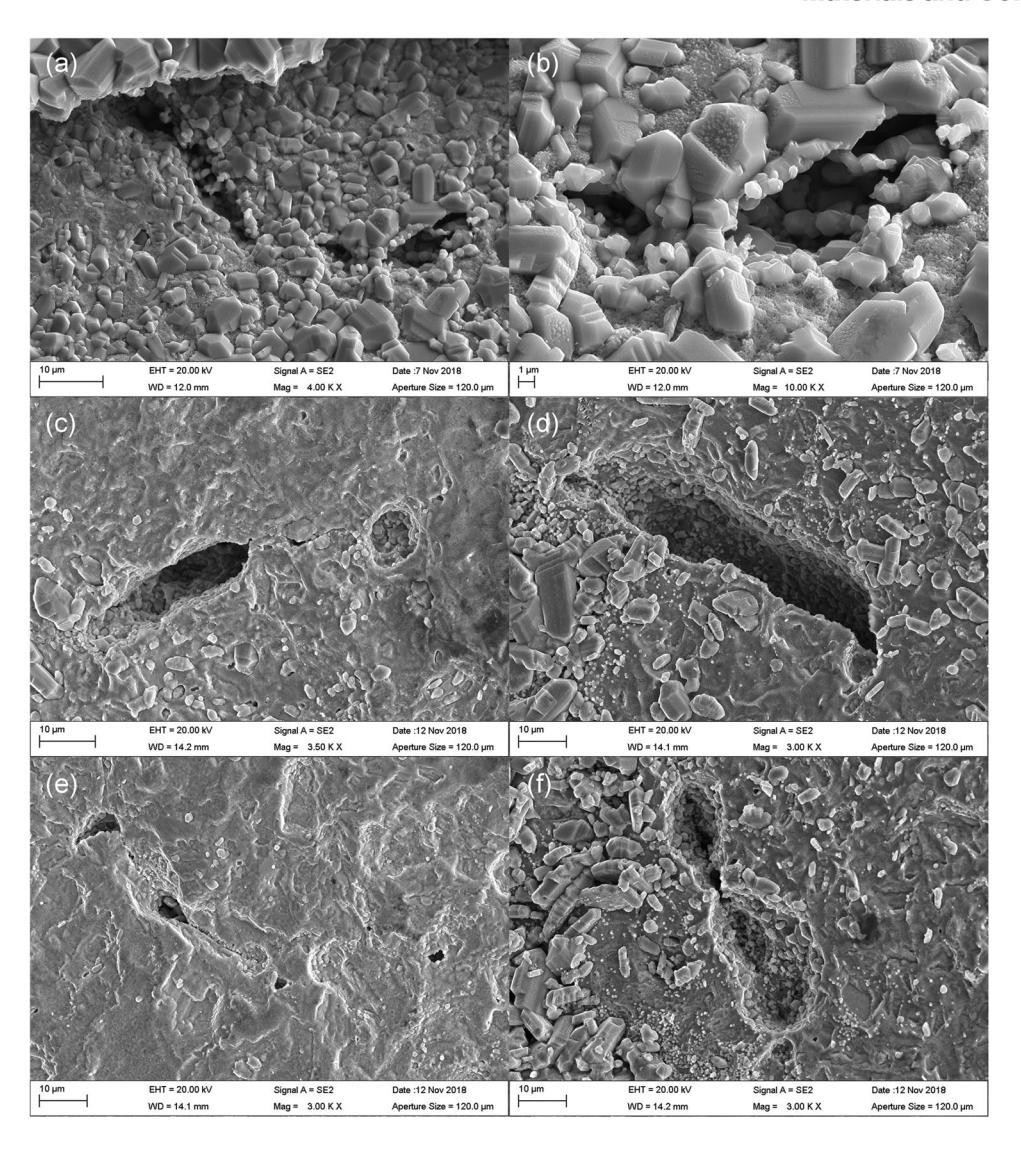
FIGURE 5 (a,b) Surface defects form underneath the copper sulphide film. (c) More defects were found after film removal, (d) the largest defects being about 80 μ m in length along the surface. (e) Small pitting-like corrosion forms on the grain boundaries, (f) which may later join and form larger defects^[9] (reprinted with permission from SSM)

Observations of the copper surface underneath the copper sulphide films revealed several surface defects, resembling the defects found in References [3,4]. These surface defects, some of them shown in Figure 5, form underneath the copper sulphide film, and thus they are difficult to find without removal of the film. In many locations, small pitting-like corrosion was also found on

the grain boundaries (Figure 5e). These later possibly form larger defects by joining together (Figure 5f). Similar defects were not found in the coupon specimens.

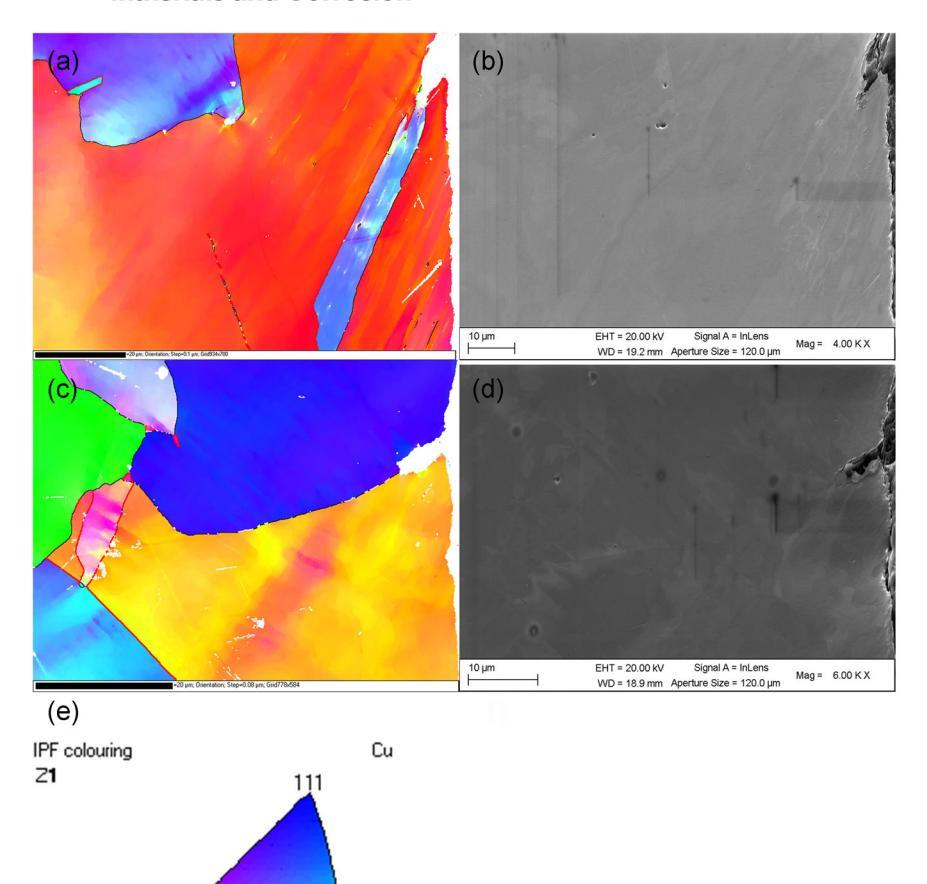
FIGURE 6 (a-d) EBSD maps (on the left) and secondary electron images (on the right) of surface defects found in specimen #8. In the EBSD maps, white is nonindexed data points, black lines represent random high-angle grain boundaries, and red lines represent Σ 3 twin boundaries. The length of the black scale bar in EBSD maps is $20 \,\mu\text{m}$. (e) The orientation of the copper grains may be interpreted by using the IPF colour key shown in the zdirection^[9] (reprinted with permission from SSM). EBSD, electron backscatter diffraction; IPF, inverse pole figure [Color figure can be viewed at wileyonlinelibrary.com

The depth of the surface defects was examined by cutting specimen #8 in half by EDM from the location of the largest defects and examined in SEM with EBSD. Several surface defects were found in the same crosssection. Two of them are shown in Figure 6. The EBSD analysis confirms that the defects grow preferably on random high-angle grain boundaries. However, in one instance, shown in Figure 6a,b, the defect formed on a thin-twinned grain, growing between the two parallel twin grain boundaries, which are generally considered more resistant to corrosion and deformation than random grain boundaries.

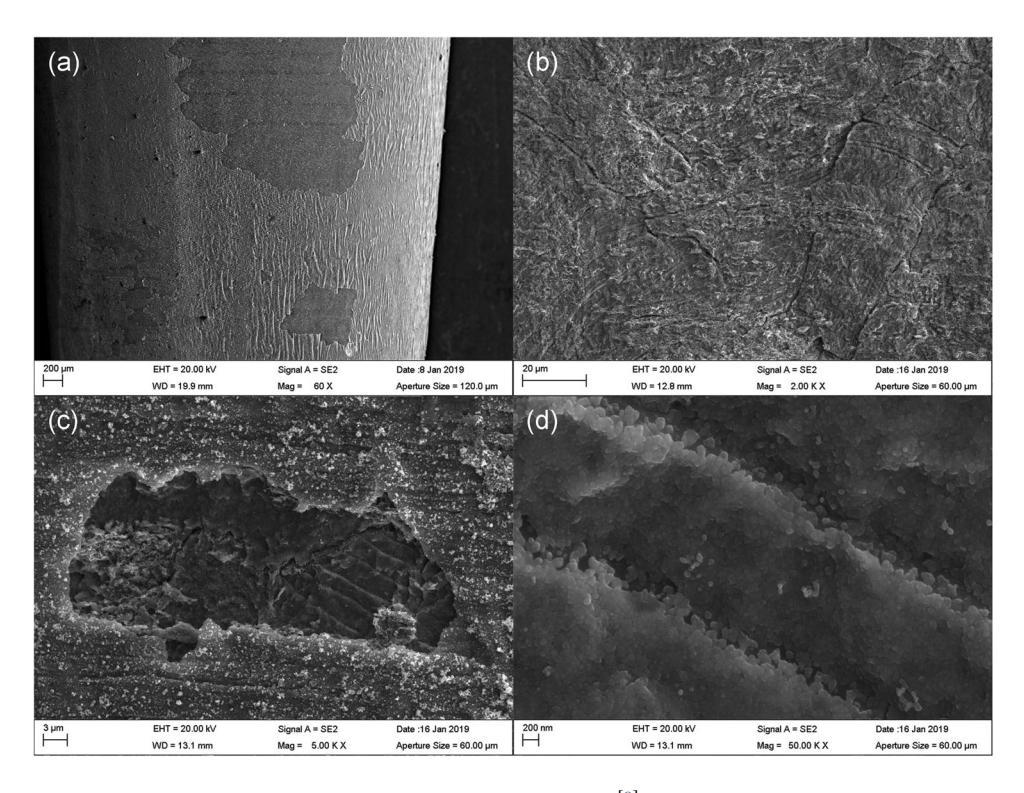
FIGURE 7 (a) General view of specimen #9 before ultrasonic cleaning^[9] (reprinted with permission from SSM). (b–d) The copper surface underneath the sulphide film shows slight corrosion on grain boundaries and slip lines

SSRT specimen #9 was tested in the low sulphide concentration of 0.00001 M, which is an order of magnitude lower than that measured in Forsmark groundwater.^[5] Figure 7 shows the general appearance

of the specimen and the thin film after exposure to the sulphide solution. Similar to specimen #8, the film was wavy, caused by the plastic deformation of the copper substrate, but otherwise the appearance is markedly different. Only a single layer of thin film formed, again very brittle and easily removed by mechanical contact or ultrasonic cleaning utilised after the initial observations. No cracking of grain boundaries or any other form of clear surface defects were found in this specimen, but many grain boundaries and slip lines were slightly corroded (Figure 7b-d).

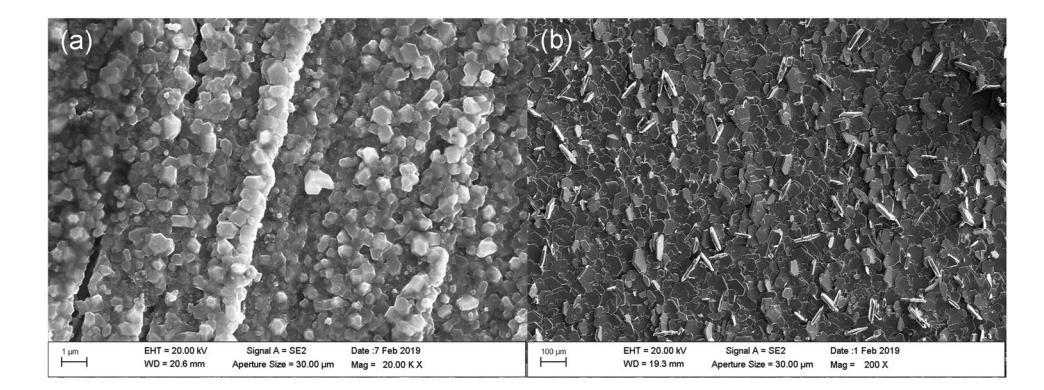
FIGURE 8 (a) Thin cellular Cu₂S crystal film formed in 0.00001 M sulphide solution at 90°C (coupon specimen 1W4-LS). (b) Thick plate-like Cu₂S crystal film formed in 0.001 M sulphide solution at 90°C (coupon specimen B3-HS)

The coupon specimens of the two exposures were examined by SEM for sulphide film structure and appearance. The general appearance of the sulphide films is shown in Figures 8 and 9. A thick, multi-layer film is formed in high sulphide conditions, while a thin singlelayer film is formed in low sulphide conditions. The sulphide crystals formed in different environments are markedly different. Large plate-like crystals are formed on the top-layer in high sulphide conditions, whereas

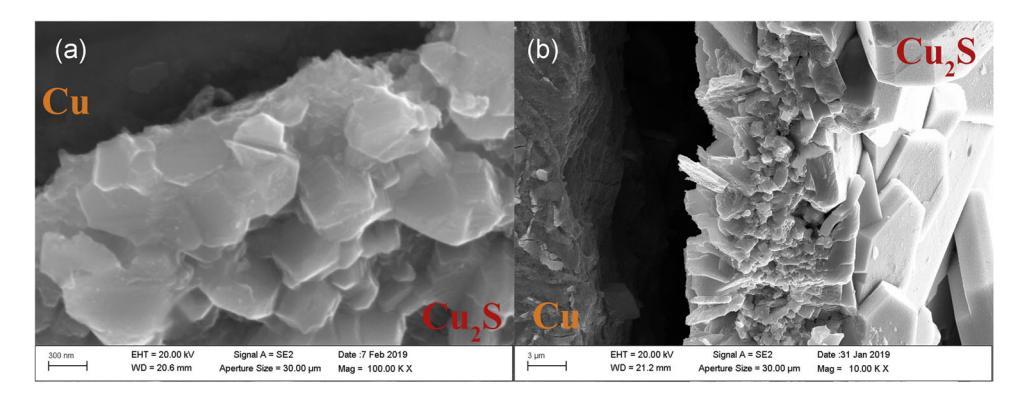
FIGURE 9 (a) Cross-section of thin copper sulphide film formed in 0.0001 M sulphide solution at 90°C (coupon specimen 1W3-LS). (b) Cross-section of thick copper sulphide film formed in 0.001 M sulphide solution at 90°C (coupon specimen 1W3-HS) [Color figure can be viewed at wileyonlinelibrary.com]

The thickness of single-layer film formed in low sulphide conditions was about 200–400 nm and the films were often porous. A much thicker multi-layer film of $10-30 \,\mu\text{m}$ in thickness was formed in high sulphide conditions and the films were more compact, but still often contained free volume in them. Cross-sections of the two different films are shown in Figure 9.

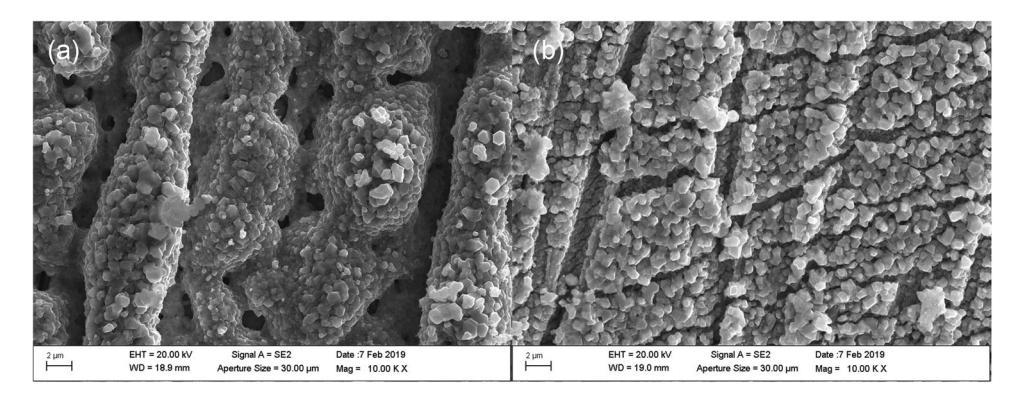
FIGURE 10 Thin crystalline copper sulphide film formed in 0.00001 M sulphide solution at 90°C. (a) Coupon specimen 2W1-LS. (b) Coupon specimen B5-LS

Some of the films formed in low sulphide conditions are shown in Figure 10. The films were porous and large openings in the films were often present. The copper surface showed very little roughness when compared with high sulphide conditions when the films were removed, or in locations of openings in the films. Before exposure to the sulphide solutions, some coupon specimens where pre-oxidised to study the conversion of the Cu_2O film into a Cu_2S film in the aqueous sulphide solutions. Appearance of the oxide film before exposure to the sulphide solution is shown in Figure 11a. After exposure to the solutions, the sulphide films formed on the pre-oxidised specimens were similar to the other specimens tested in the same environment. In some locations, debris of the oxide film was preserved locally under the film (Figure 11b), but for the most part the Cu_2O films were converted almost entirely into Cu_2S films. Thus, the pre-existing oxide film did not affect markedly the Cu_2S film formation.

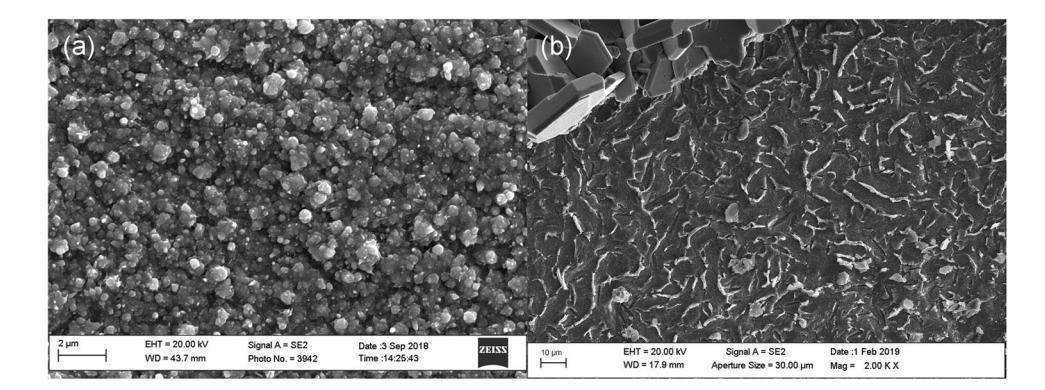
FIGURE 11 (a) Pre-oxidised copper surface before exposure to sulphide solution. (b) Debris of the oxide film may be found underneath the copper sulphide film (coupon specimen B2-ox-HS)^[9] (reprinted with permission from SSM)

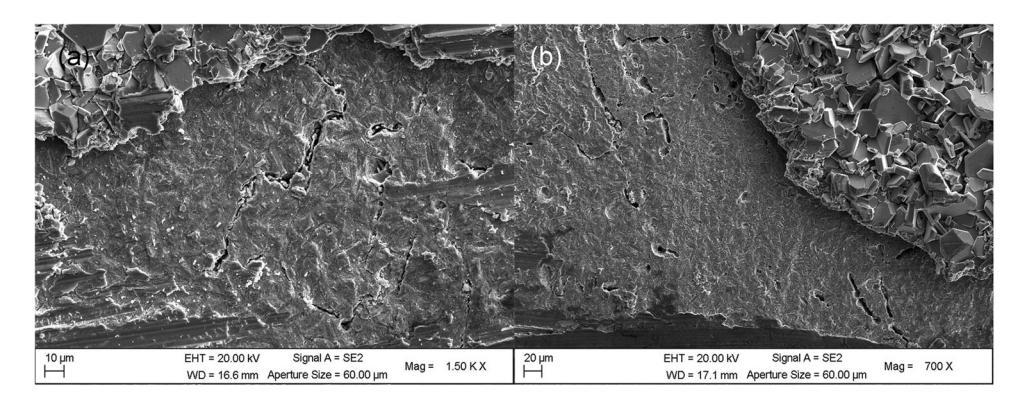
FIGURE 12 Corrosion attack underneath the sulphide film on the air-welded coupon specimen tested in 0.001 M sulphide solution at 90°C (coupon specimen 1W1-ox-HS)

Figure 12 shows the corroded 1W-weld metal surface formed underneath the Cu₂S film. The penetrations on the surface are caused by local corrosion of oxide particle stringers embedded in the weld metal welded in air. The oxide particles are very small ($\leq 1 \mu m$) in diameter and they are consumed by the sulphide corrosion process. Cross-sections of the defects (Figures 13 and 14) show that they are located on grain boundaries of copper, where most of the oxide particles are located,^[10] and locally attacked by the sulphide solution. Thus, the Cu₂O particles embedded in the weld metal are also destabilised by the sulphide solution similar to the pre-existing oxide films. Similar defects were not found in the weld metal welded in shielding gas.

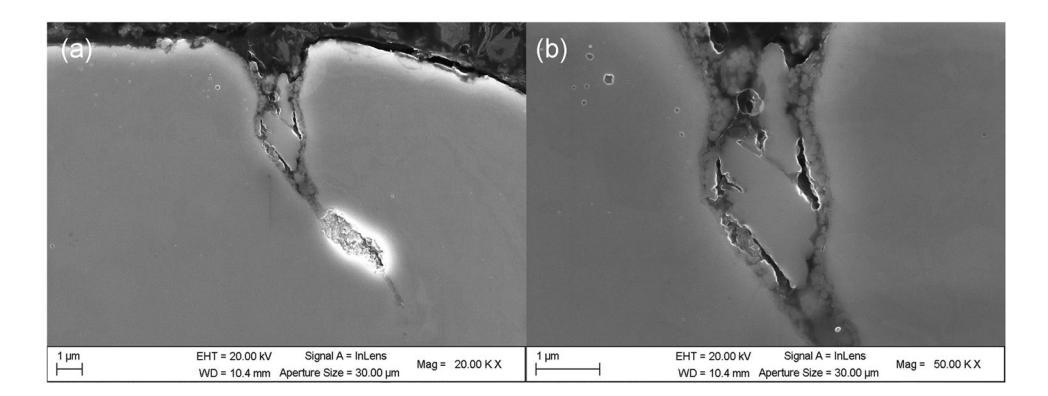
FIGURE 13 Cross-section of a defect formed on an oxide particle stringer (coupon specimen 1W1-ox-HS)

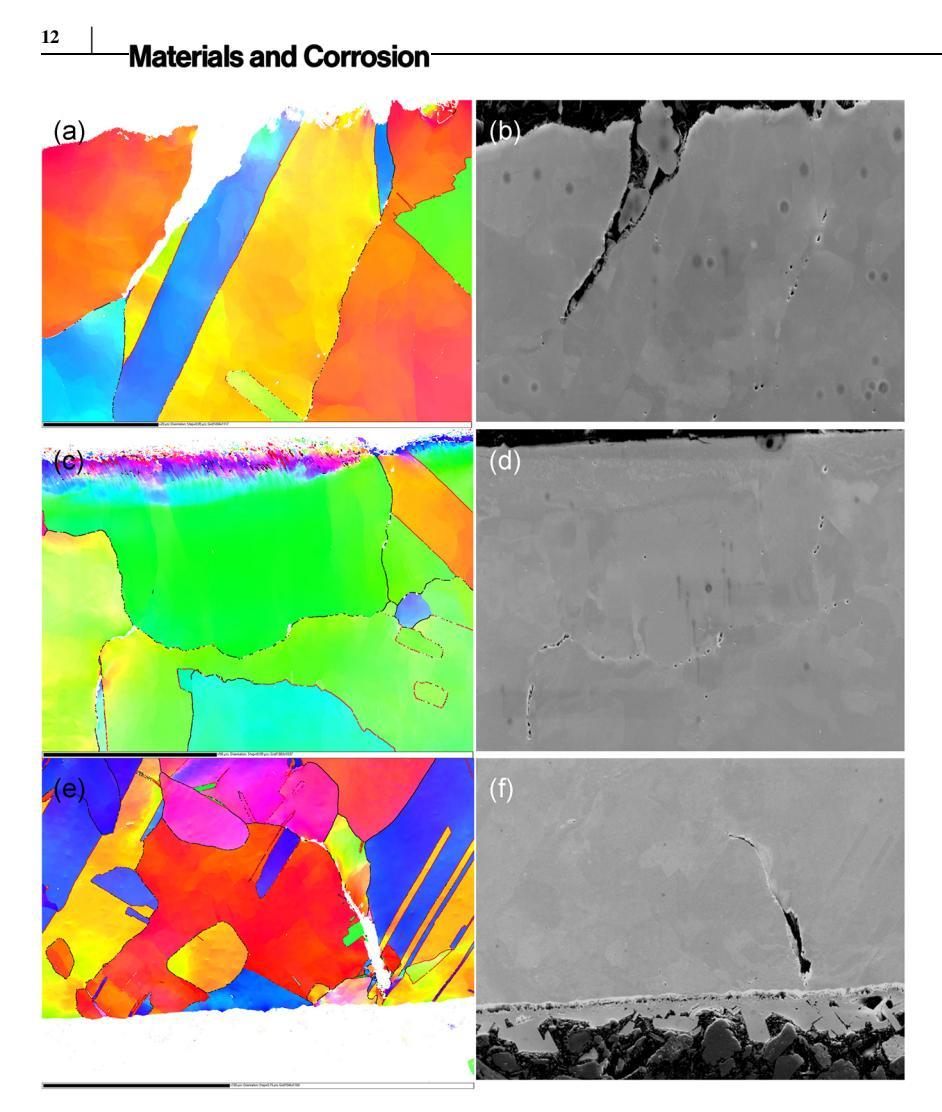
FIGURE 14 (a–f) EBSD maps (on the left) and secondary electron images (on the right) of some of the attacked oxide particle stringers in coupon specimen 1W1-ox-HS. In the EBSD maps, white is non-indexed data points, black lines represent random high-angle grain boundaries, and red lines represent twin boundaries. The length of the black scale bar is (a) $20 \,\mu$ m, (c) $50 \,\mu$ m, and (e) $100 \,\mu$ m. EBSD, electron backscatter diffraction [Color figure can be viewed at wileyonlinelibrary.com]

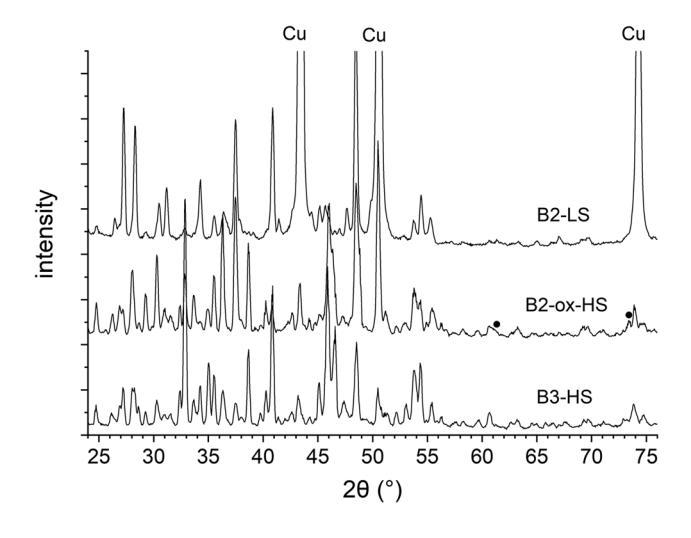
FIGURE 15 XRD measurement of Cu_2S films formed on two high sulphide coupon specimens (B3-HS and B2-ox-HS) and one low sulphide coupon specimen (B2-ox-LS)^[9] (reprinted with permission from SSM). XRD, X-ray diffraction

on the specimen exposed to the low sulphide environment), there are large variations in intensities. This is most likely due to the very large crystallites and non-random orientation of the crystallites, which causes preferred orientation effects and poor particle statistics. CuS does not seem to be present at all, according to these measurements. When compared with the other two specimens, there are noticeable reflections from residual Cu_2O phase in the pre-oxidised B2-ox-HS specimen. These are marked with solid dots (ICDD PDF card 5-667) in Figure 15.

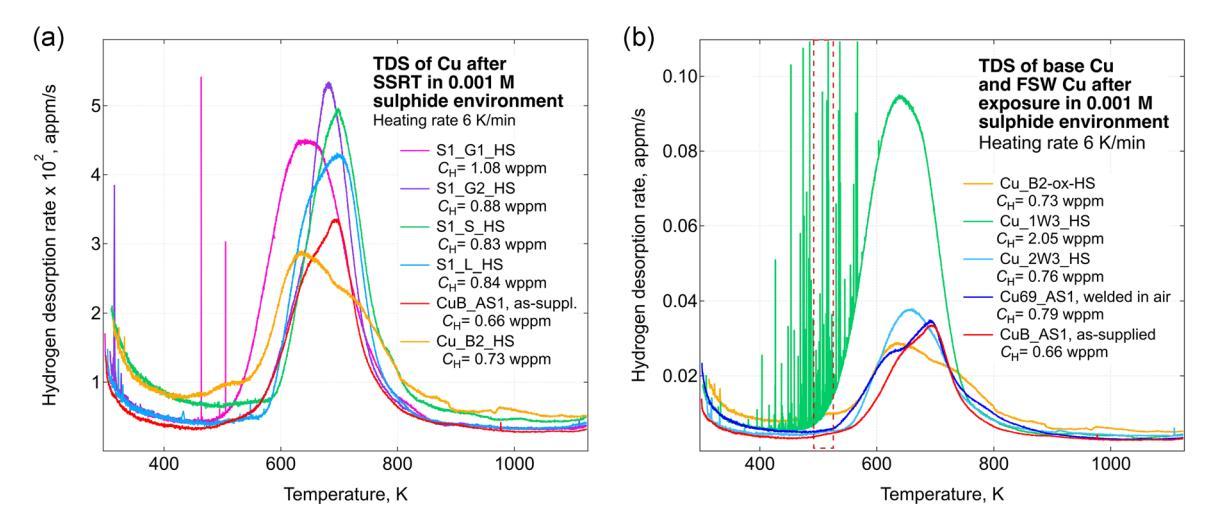
FIGURE 16 (a) Hydrogen desorption rates for samples cut from specimen #8 after SSRT in 0.001 M sulphide environment. (b) Hydrogen desorption rates for coupons of base copper (B2-ox-HS), FSW weld metal welded in air (1W3-HS), and FSW welded in protective atmosphere (2W3-HS) after exposure to 0.001 M sulphide environment, as well as for the non-exposed as-supplied state^[9] (reprinted with permission from SSM). SSRT, slow strain rate tensile testing [Color figure can be viewed at wileyonlinelibrary.com]

except for the FSW weld metal welded in air (Figure 16b). The specimen welded in air (1W3-HS, green curve) manifests almost three times higher hydrogen content (2.05 wt ppm) than the material welded in protective atmosphere (2W3-HS, blue curve) (0.76 wt ppm). This indicates that the Cu₂O particles embedded in the weld metal act as strong trapping sites for hydrogen. Moreover, a great number of hydrogen partial pressure spikes is observed at the low-temperature side of the TDS peak, evidencing that hydrogen forms gas-filled voids at the Cu₂O particles, some of which are located close to the specimen surface and open suddenly due to increasing gas pressure with increasing temperature.

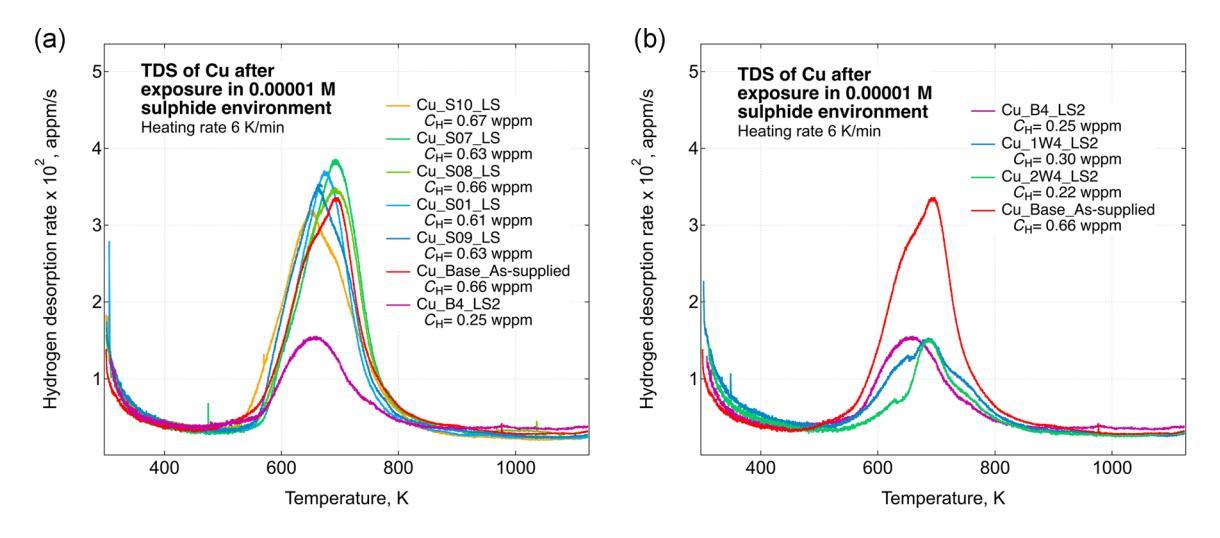
FIGURE 17 (a) Hydrogen desorption rates for samples cut from specimen #9 after SSRT in 0.00001 M sulphide environment. (b) Hydrogen desorption rates for coupons of base copper (B4-LS2), FSW weld metal welded in air (1W4-LS2), and FSW welded under shielding gas (2W4-LS2) after exposure in 0.00001 M sulphide environment, as well as for the non-exposed as-supplied state^[9] (reprinted with permission from SSM). SSRT, slow strain rate tensile testing [Color figure can be viewed at wileyonlinelibrary.com]

The TDS measurements for the specimens exposed to low sulphide environment (abbreviated here as LS) are shown in Figure 17. The hydrogen desorption curves of SSRT specimen #9 show, similarly to specimen #8, an increase in hydrogen content when compared with the coupons exposed to the same environment. However, it should be noted that the hydrogen content of the coupons

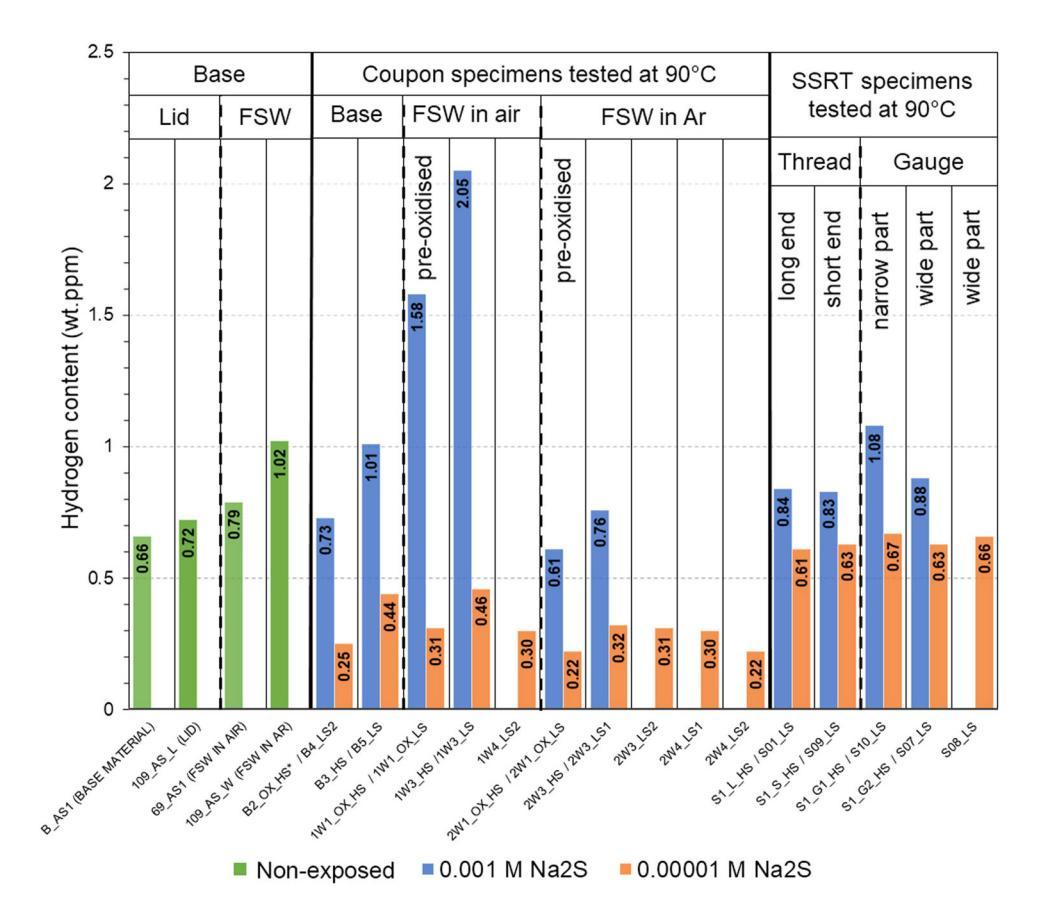
FIGURE 18 Hydrogen contents of base materials, and coupon specimens and SSRT specimens tested in the two different sulphidecontaining environments at 90°C. SSRT, slow strain rate tensile testing [Color figure can be viewed at wileyonlinelibrary.com]

A summary of the hydrogen contents is shown in Figure 18. Coupons of base material are marked with B(n),

coupons of FSW made in air are marked with 1W(n), coupons of FSW produced in protective atmosphere are marked with 2W(n) and SSRT specimens are marked with S(n), where (n) represents the numbering of the specimen. Several TDS samples were cut from some of the coupons. In addition, the as-supplied base materials were measured for hydrogen content. The highest value for these unexposed samples was measured in the as-supplied weld metal of the argon shielded weld (1.02 wt ppm). The hydrogen content in the lid material of the same mock-up canister weld was lower (0.72 wt ppm), being closer to the hydrogen content of the base material of the SSRT specimens in the as-supplied
