Pavement distress detection using terrestrial laser scanning point clouds – Accuracy evaluation and algorithm comparison

Published in: ISPRS Open Journal of Photogrammetry and Remote Sensing

Keywords: Terrestrial laser scanning Pavement Road Crack Distress Point cloud

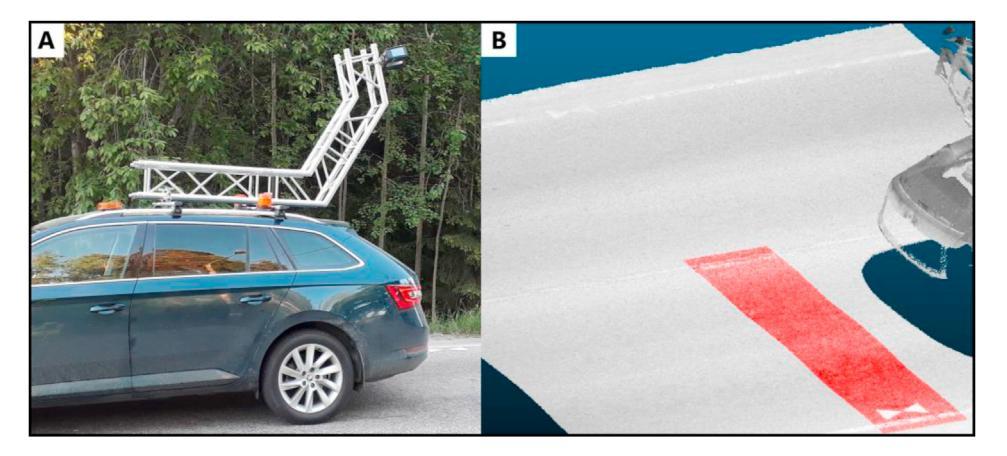
Fig. 1. Principle and measuring system for static TLS measurements in this study. Figure A shows the TLS scanner mounted on the roof of the car. Figure B shows the point cloud provided by TLS. The plot area is marked in red. (For interpretation of the references to colour in this figure legend, the reader is referred to the Web version of this article.)

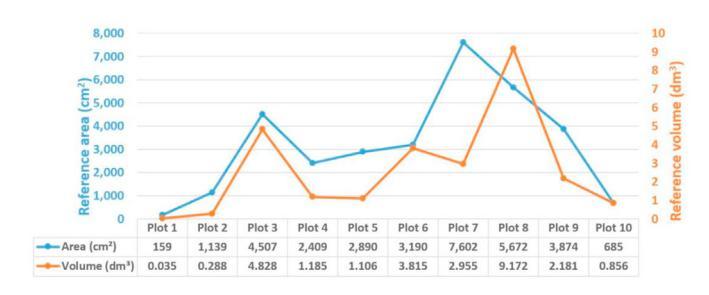
Fig. 2. Areal extent and volume of manually segmented cracks by plot.

In Finland, a pavement crack should be repaired when wider than 5 cm (Finnish Transport Infrastructure Agency, 2013). As early detection of road damage is needed for road maintenance planning, we decided to segment all surface distresses more than 1 cm wide. The segmentation was done manually using CloudCompare (version 2.10.2, http://www.cloudcompare.org/). To make classification easier and more accurate, a local elevation difference was used as follows: as pavements consist of planar features, test plots were first cut into smaller areas in the xy plane, after which the selected point cloud was levelled, making it parallel with the xy plane. Variations in height were used to extract the pavement distress points from the surrounding pavement points. The result was further improved using the CloudCompare Segment tool during the visual inspection. Fig. 2 shows the total area and volume of each manually

segmented plot, and it can be seen that the total crack volume and areal extent varied significantly across plots.

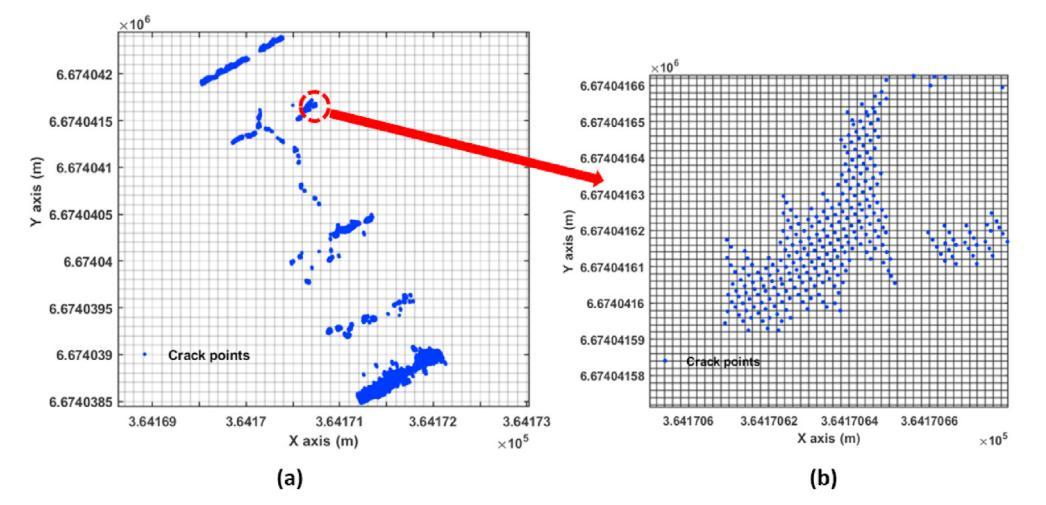
Fig. 3. (a) Crack points of one plot in the pixel map; (b) part of the crack pixel map.

Due to the irregular shapes of the cracks, the crack area was analysed pixel-wise at a plot level. Considering the adjacent points' average distance of the studied TLS data is 2.3 mm, the pixel size was set to be 5 mm to ensure the crack area calculation accuracy and avoid gaps between crack pixels. The plot was divided into 5-mm-by-5-mm pixels, and crack points were allocated to corresponding pixels according to their coordinates. A pixel containing at least one classified crack point was treated as a crack pixel. Finally, the crack area was estimated corresponding to the number of crack pixels. Fig. 3a presents an example plot, and Fig. 3b is the detail of the partial plot.

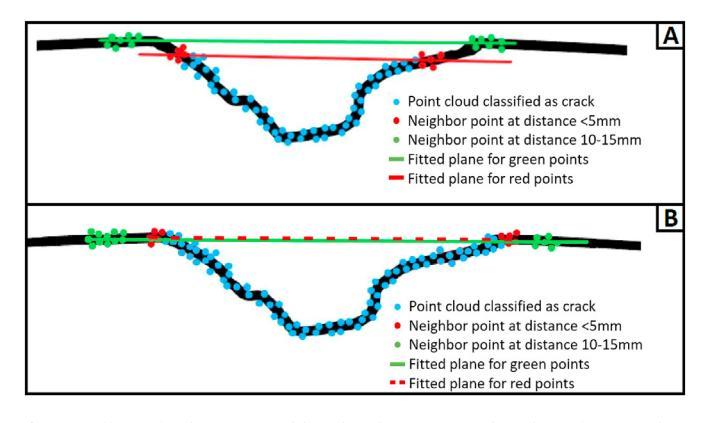
Fig. 4. Effect of selecting neighbourhood points on the plane fitting, when distress is underestimated (A) or perfectly/overestimated (B).

the nearest pavement points to enable plane fitting. Fig. 4 illustrates the effect of selecting neighbouring points from different distances. To improve the tool's accuracy, neighbouring points were selected from a distance of 1-1.5 cm. Underestimation of volume can thus be avoided.

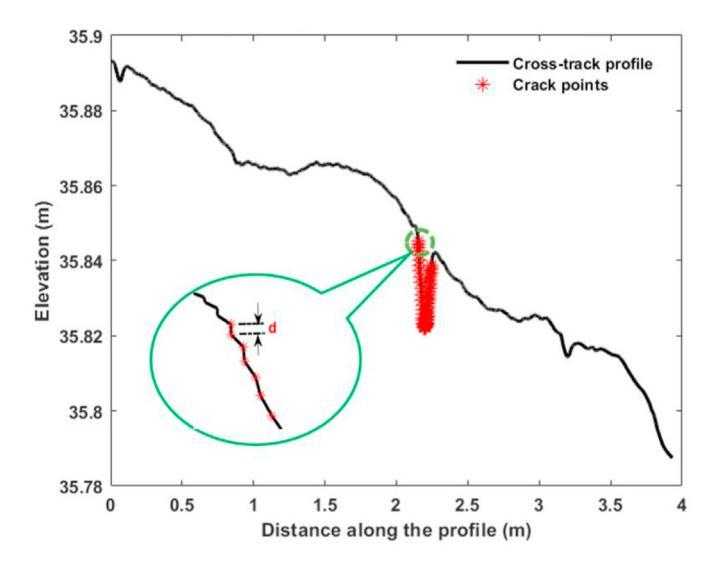
Fig. 5. Crack detection results with neighbouring points elevation inspection (d is an example of the elevation change of the neighbouring point).

A crack causes a sharp elevation dip. An intuitive and common method to detect cracks is therefore to examine the elevation dips in point cloud neighbourhoods. Once the elevation dip exceeds a pre-set threshold value, the corresponding point will be treated as a crack point. This method was applied to the cross-track profiles. Fig. 5 demonstrates how the baseline method finds the crack points in one profile.

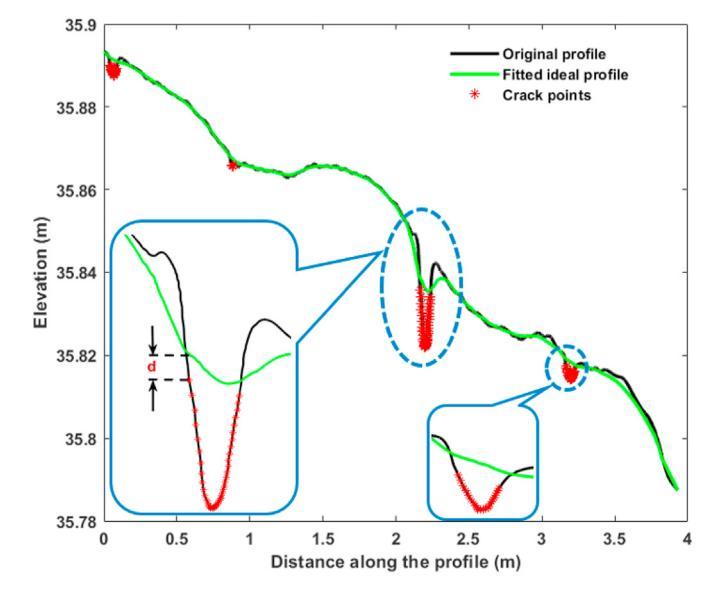
Fig. 7. Crack detection using profile-based filtering.

Through the crack points demonstration in Fig. 7, there were always some crack points near the start and end part of the crack missing because of the imperfect fitting profile. This could be improved by adjusting the fitting filter parameter values, but could not be eliminated. In addition, the pre-set threshold value was an experience value based on the overall road conditions in all the plots, which did not work perfectly in certain plots with special crack types. Fig. 8 presents the general process of the algorithm.

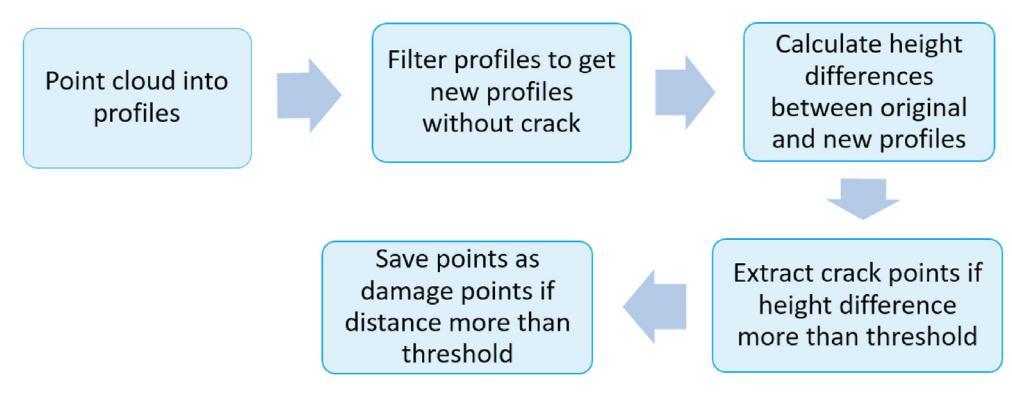
Fig. 8. Workflow of profile-based filtering algorithm.

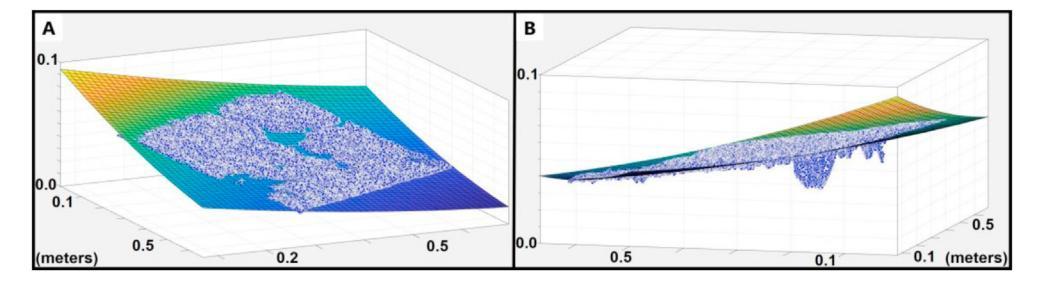
Fig. 9. Surface fitted to a 50 cm by 50 cm point cloud of a road surface.

In this study, a surface fitting-based crack detection algorithm (SF) was developed. SF fits a polynomial surface to the road surface and separates pavement points from those points that remain below the surface, classifying them as road damage points, following polynomial curve fitting research such as (Arlinghaus, 1994; Johnson and Williams, 1976; Su et al., 2015). Our method is based on the assumption that a small piece ($0.5 \text{ m} \times 0.5 \text{ m}$ in this study) of asphalt would form a plane in the ideal situation. However, in reality, the road surface is not a perfect plane, as the rut depths and other changes in the road surface caused by the use of the road already cause significant differences in the flatness of the road. We therefore used a quadratic polynomial surface to approximate the shape of the road surface in the small pieces. Fig. 9A presents a surface fitted to a small test patch ($50 \text{ cm} \times 50 \text{ cm}$). Fig. 9B shows a side view of the same surface, where the road pavement damage points can be clearly seen below the surface.

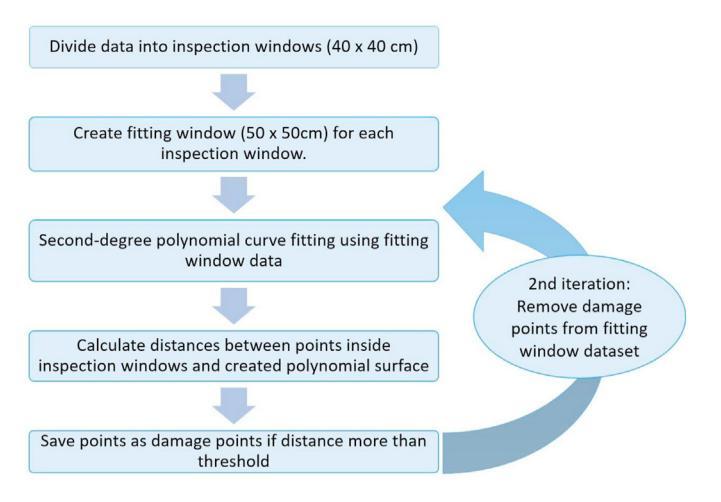
Fig. 10. Workflow of surface fitting algorithm.

inspection window. In addition, a 50-cm-by-50-cm area is formed on top of the inspection window, which acts as a fitting window. The centres of both windows are the same. The fitting window, as its name implies, is the part of the data to which the polynomial surface is fitted. This method ensures that the fitting windows have a side coverage of 20% to their neighbouring windows, allowing a better continuous extraction of road damages at the edges of inspection windows. The fitted surface is compared to the data inside the inspection window, and distances between the dataset and fitted surface are calculated, after which all distances exceeding the threshold value are classified as damage points. The algorithm then starts a new iteration by removing the crack points from the fitting window dataset, allowing a better surface fitting. The algorithm implements only two iterations, as during the study it was found that most of the damage points could already be extracted in the first iteration phase, in which case the second iteration has only been used to slightly improve the result. Fig. 10 shows the workflow of the algorithm.

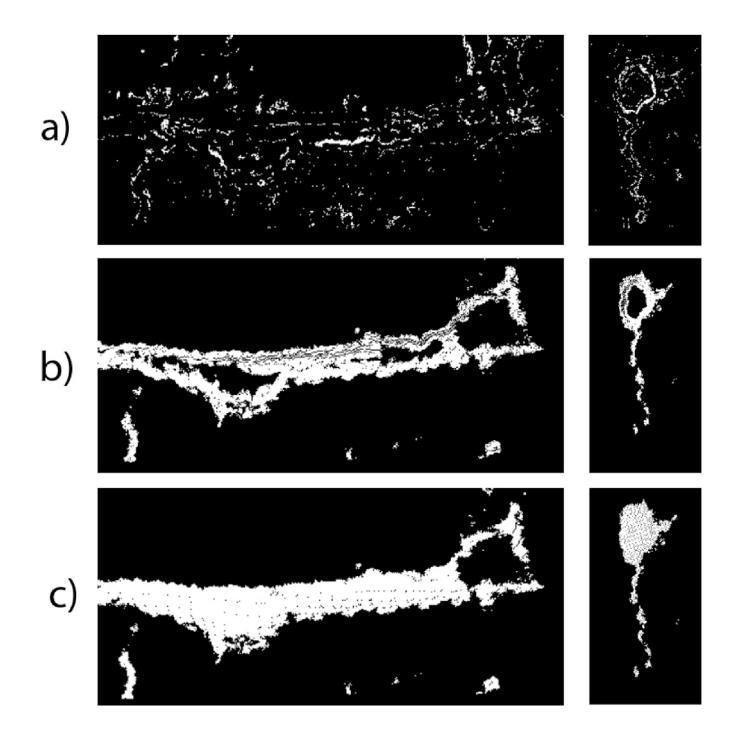
Fig. 12. Random forest classification of two crack areas: a) raw classification results; b) after the noise reduction process; c) after application of flood-fill operation.

Fig. 12a) shows that the results contain salt-and-pepper noise. To remove this noise and to improve the distinction between the classes, crack points that contained fewer than five other crack points among their 15 nearest neighbours were ignored. Fig. 12b) shows that the cracks are more clearly defined after the process, and the noise is significantly reduced.

The small neighbourhood size retains small and narrow cracks even in the presence of noise. However, false negatives are found in the results, particularly in larger potholes, as the surface variation is low in flat areas, regardless of whether they are located within a crack, and the verticality seeks out the edges of the cracks. Smaller discontinuity areas are also present, with correctly classified crack areas containing small areas classified as roads. As these take the form of holes with respect to the crack area, a morphological hole filling operation – similar to that applied in the surface roughness method – was noted as a viable method for improving the results. The results show visible improvement from the noise-reduced crack classification (Fig. 12c): large holes have been filled, and most of the smaller discontinuity areas have been reclassified. Fig. 13 shows the workflow of the algorithm.

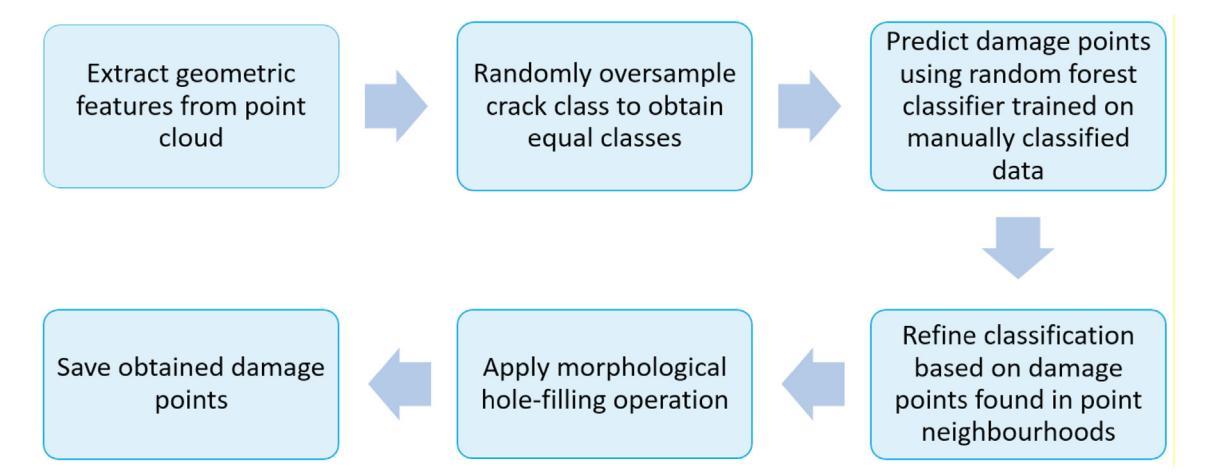
Fig. 13. Workflow of the random forest-based classification.

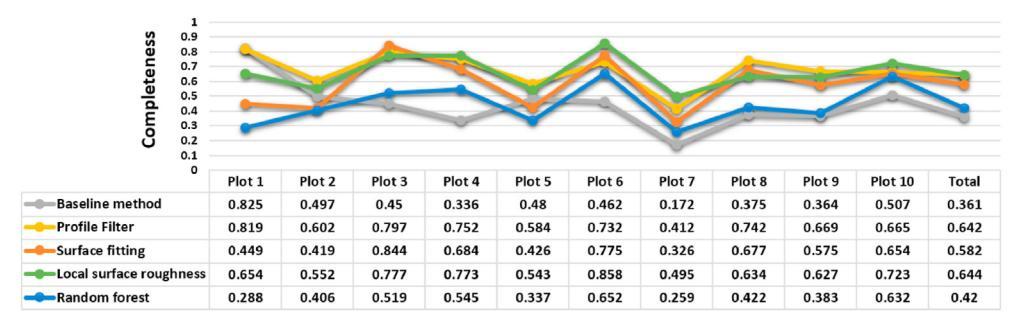
Fig. 14. Completeness for the five algorithms on the ten plots and the overall completeness.

evaluation indicators of each algorithm were calculated based on all the crack points of ten plots. The results are presented in Figs. 14–16.

For the overall algorithm evaluation based on all the plots, the baseline method had the worst performance of all three indicators, and the overall F_1 score was 0.409, while all the other algorithms had merits in distinct aspects. More specifically, based on Fig. 14, for the crack detection completeness, the profile-based filter method and the local surface roughness method had similar best performances of 0.642 and 0.644 respectively. However, Fig. 15 shows that the surface fitting method had the best detection correctness, which was 0.794, while the profile-based filter method and random forest-based method had slightly poorer results, which were 0.735 and 0.743. Regarding the overall performance of the algorithms, as shown in Fig. 16, the F_1 score of the profile-based filter method was 0.685 as the highest one, the surface fitting method obtained a slightly lower F_1 score of 0.672, and the local surface roughness method ranked third with an F_1 score of 0.645.

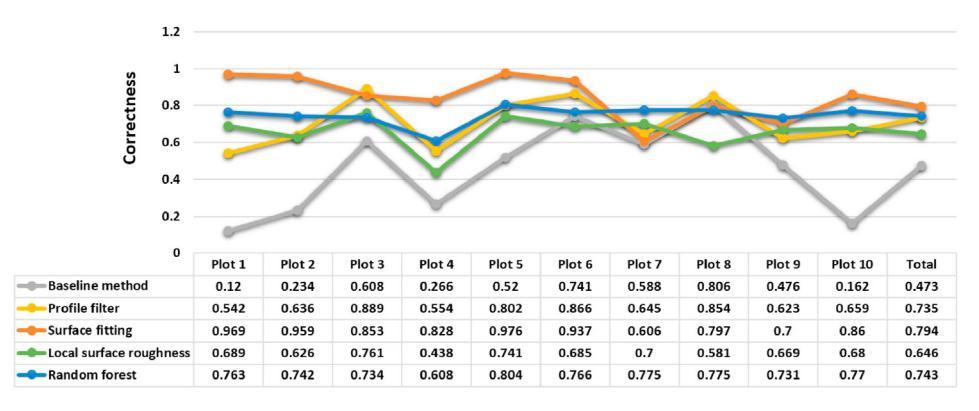
Fig. 15. Correctness for the five algorithms on the ten plots and the overall correctness.

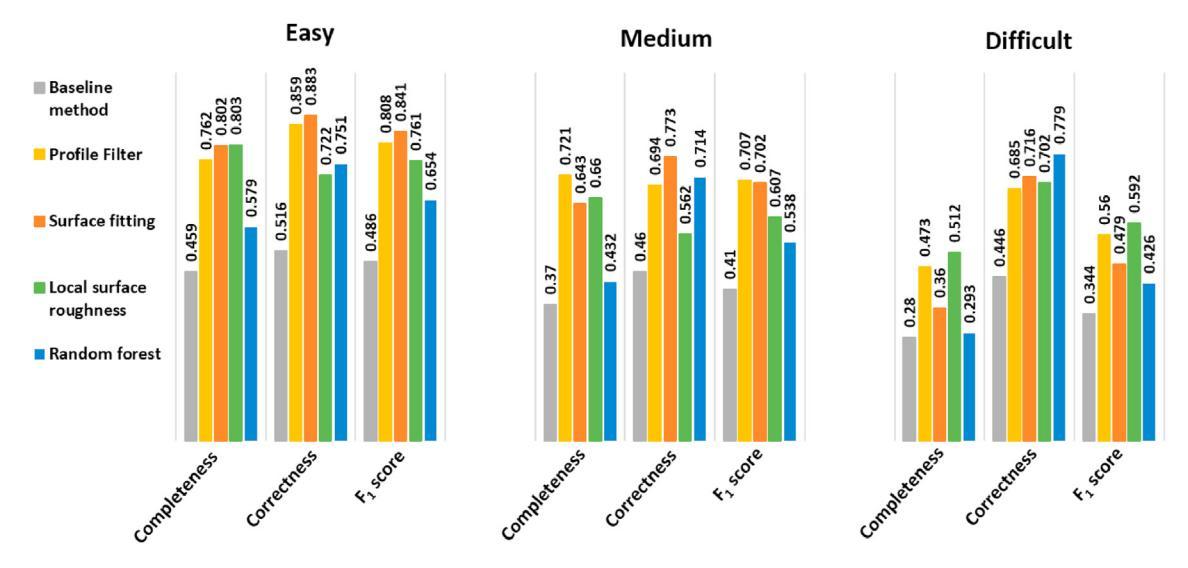
Fig. 17. The crack detection completeness, correctness, and F₁ score of all the algorithms for different plot categories, ranging from easy to difficult.

Through the previous results, the algorithms had different performances in different plots, which were not always consistent with the overall performance. This was because the plots contained distinct crack types, which led to various levels of complexity in crack detection. Considering both the real plot condition and manual crack detection complexity, the plots were divided into three groups: easy (plots 3, 6, 10); medium (plots 1, 4, 8, 9); and difficult (plots 2, 5, 7). The crack detection completeness, correctness and F_1 score of the five algorithms were calculated in each group, and the results are presented in Fig. 17.

Looking through the Fig. 17, as the detection complexity increased from the easy group to the difficult group, the crack detection completeness of the five algorithms gradually decreased respectively, proving that our plots' classification was reasonable.

For the crack detection correctness, the surface fitting and the local surface roughness methods had high correctness in both easy and difficult groups, and the surface fitting method reached the highest correctness of 0.883 in the easy group. The random forest-based method provided stable performances of correctness, which were 0.751, 0.714, and 0.779 in the easy, medium, and difficult groups respectively.

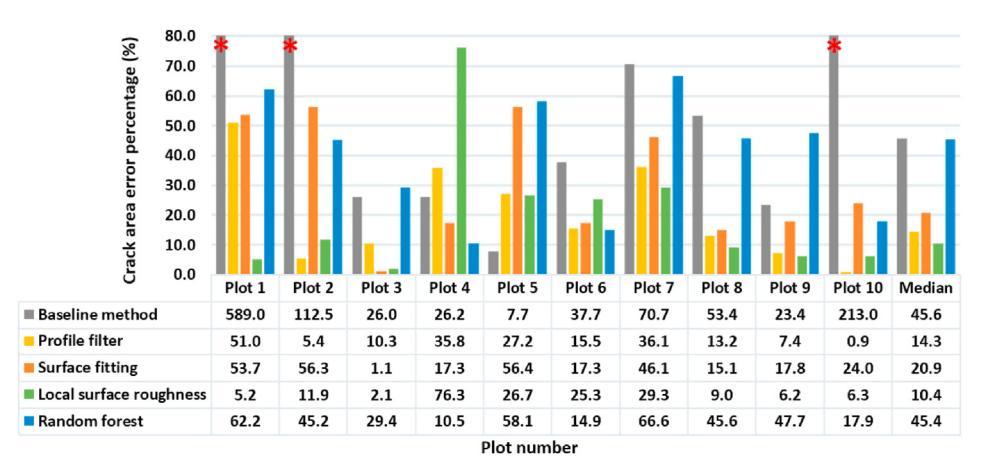
Fig. 18. The absolute crack area error percentages with five algorithms of ten plots (*: the bar value exceeds the max limit of the y-axis and is presented in the table below).

absolute crack area error percentages in each plot are presented in Fig. 18.

Obviously, the crack area percentages from the baseline algorithm were much larger than those from other algorithms in plots 1, 2, and 10, affecting the readability of the graphic. Therefore, the y-axis value in Fig. 18 was limited to present most of the percentages, and the specific values can be checked in the table.

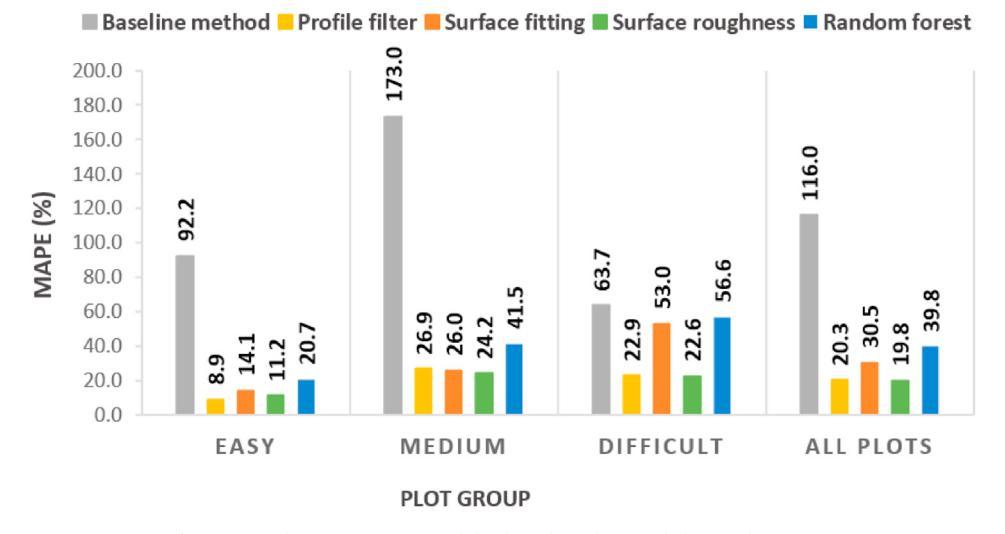
Fig. 19 shows that the surface roughness algorithm achieved the lowest MAPE of 19.8% over the 10 plots, while the profile filter algorithm produced a similar MAPE of 20.3%. In the easy, medium, and difficult plot groups, the best MAPEs were 8.9% from the profile filter algorithm, and 24.2% and 22.6% from the surface roughness algorithm respectively. The baseline method performed very badly in all groups, while the surface fitting and random forest algorithms had their best performance in the easy plot group, and the performance deteriorated as the crack detection difficulty increased.

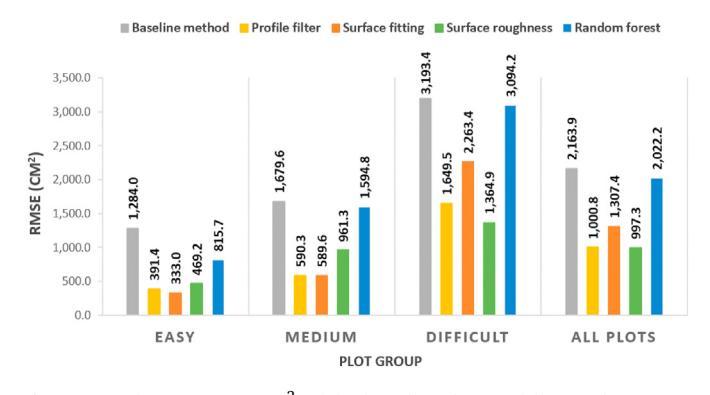
Fig. 20. Crack area RMSEs (cm²) of the five algorithms in different plot groups.

To further study the algorithm performance, the crack area estimation RMSEs of the five algorithms were calculated (Fig. 20). Fig. 20 shows that the RMSEs' distribution was quite similar to that of MAPE, while the performance of the surface fitting algorithm became a little different. Over all ten plots, the best RMSE still came from the surface roughness

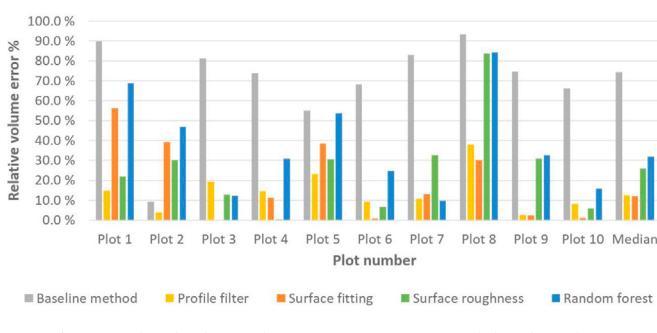
Fig. 21. The absolute volume error percentages of the algorithms.

and distresses classified by the five algorithms, using the tool presented in Section 2.3. Fig. 21 shows the absolute volume error percentage between algorithm and reference volumes for each plot, in addition to the median. The median error percentages equalled 69.5%, 12.6%, 12.1%, 26.0%, and 31.8% for the baseline method, profile-based filtering, surface fitting, local surface roughness, and random forest respectively.

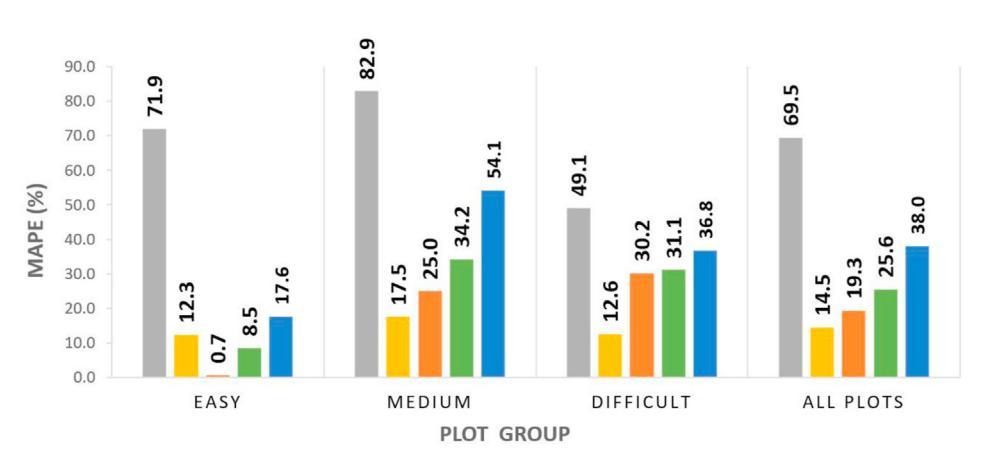
Fig. 22. Crack volume MAPE for each algorithm.

Fig. 22 shows the MAPE of the crack volume estimation in relation to the plot difficulty (Sec. 4.1). The surface fitting algorithm achieved the lowest MAPE of 0.7% for the easy plots. A small correlation was observed between the error of the volume estimates and plot difficulty in the surface fitting algorithm: the more difficult the test area, the worse the MAPE. Profile-based filtering worked equally well at each difficulty level (MAPE varied between 12.3% and 17.5% across the plot difficulty). Local surface roughness also performed well in the easy plots (an 8.5% MAPE), but in the medium and difficult plots, performance was worse (MAPE between 31.1% and 34.2%). The baseline method and random forest had poorer performance than the other methods: their MAPEs were between 38.0% and 69.5% when all the plots were included in the analysis.

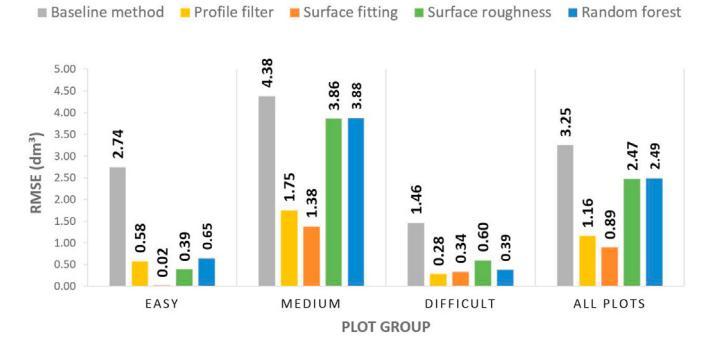
Fig. 23. Crack volume RMSE for each algorithm (dm³).

The RMSEs of the volume estimates were similar to the MAPEs (Fig. 23). The surface fitting algorithm performed excellently in easy plots (RMSE = 0.02 dm^3), but was only slightly better than profile-based filtering when all plots were taken into account. The local surface roughness algorithm worked well in the easy and difficult plots (RMSEs of 0.39 dm³ and 0.60 dm³), but in the medium plots, the RMSE was as high as 3.86 dm³, which significantly affected the total RMSE value of 2.47 dm³. The random forest algorithm performed better in the RMSE comparison than in the MAPE comparison, as its RMSE values were very consistent with the local surface roughness algorithm.

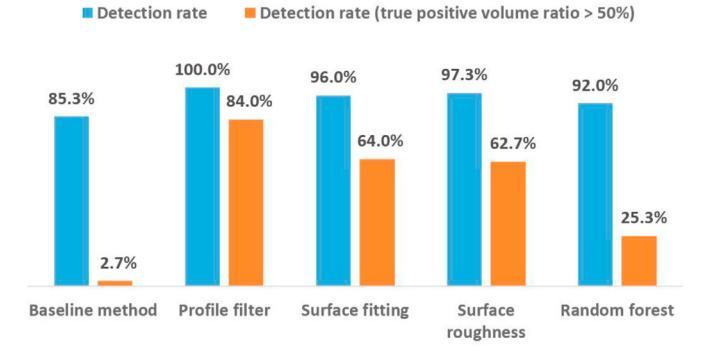
Fig. 24. Pavement distress object detection rate of each algorithm.

In the object level analysis, each distress was studied separately. Our ten plots contained 75 pavement distresses (hereafter referred to as objects). For each object, a true-positive volume ratio was defined as the true-positive volume of distress divided by the reference volume. Here, we evaluate the object detection rate, that is, how many distresses each algorithm found. The best-performing algorithm (the profile-based filter method) detected all 75 objects (detection rate 100%). The detection rate alone does not provide information on how comprehensively the distress was found, because some objects were only partly found. Therefore, the detection rate of the algorithms was also examined by considering only those objects found by the algorithm whose true positive volume exceeded half of the reference volume (true positive volume ratio over 50%). In this case, the best-performing algorithm detected 84% of all distresses. Fig. 24 shows the performance of each algorithm in more detail.

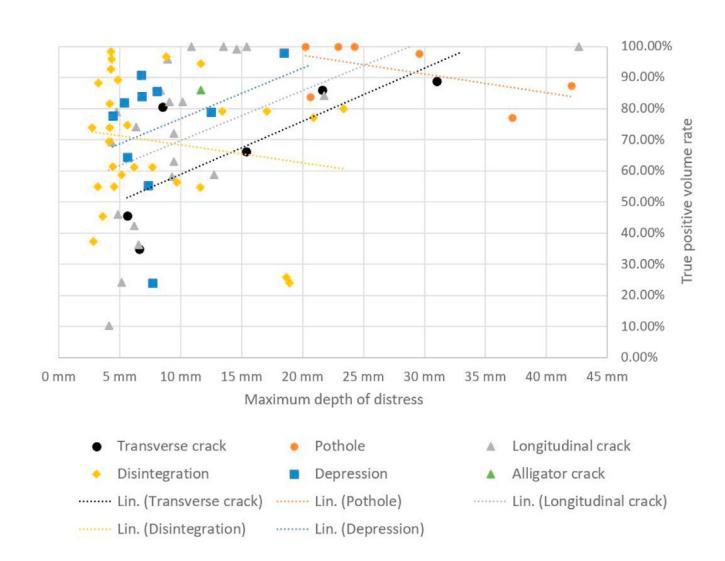
Fig. 25. Relation of maximum distress depth, true positive volume rate, and different distress types for the profile-based filter method. For each distress type, a linear trend line (Lin.) is drawn. The R^2 values for transverse crack, pothole, longitudinal crack, disintegration, and depression are 0.58, 0.30, 0.26, 0.03 and 0.10 respectively.

Object-level analysis was also used to evaluate the ability of algorithms to find different types of distress. Only the best performing algorithm, the profile-based filter, was evaluated. Objects were sorted according to maximum depths, and correlations between crack depths and different distress types were examined (Fig. 25). A trend line was fitted for each type of distress, as a result of which it was observed that certain distresses correlated better with the maximum depth of the distress than others. The results show that the algorithm found potholes well, because its true positive volume ratio was always higher than 70%. For other distresses, longitudinal and transverse cracks correlated well

with distress depth. The deeper the damage, the better the algorithm would find it. Depression and disintegration gave the worst R^2 values. In particular, observations of disintegration were most scattered, regardless of the depth of damage. No conclusions can be drawn from the alligator
