Material Forming: The 26th International ESAFORM Conference on Material Forming - ESAFORM 2023 - held in Kraków, Poland, April 19-21, 2023

# Effects of ultrasonic burnishing on the surface quality of corrosion-resistant tool steel using a hard-carbon-coated burnishing tool

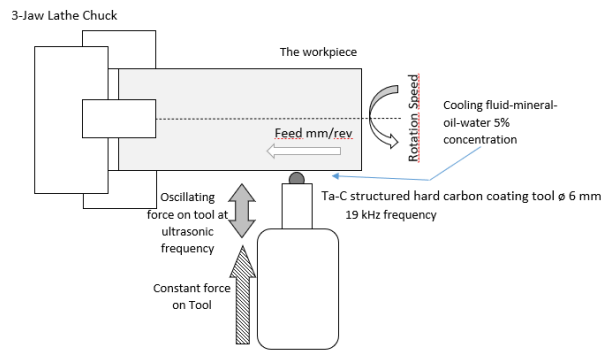
Fig.1. Schematic of the ultrasonic burnishing process.

Ultrasonic burnishing is less well known than the roller, ball, or diamond methods. This modern method is used for finishing metal surfaces by forging at very high frequency. Forging is performed with a ball-shaped finishing head at extremely high ultrasonic frequency while the workpiece rotates along a fixed axis, as depicted by the schematic in Fig.1. A constant spring load is applied to the burnishing tool to keep it in contact with workpiece surface. The process removes no material from the workpiece. Instead, it causes plastic deformations on the part surface, thereby creating residual stresses and improving surface quality [6].

However, in the present work, the burnishing parameters were changed to 500 RPM and a ø 6 mm carbon-coated tool was used. The tool feed and burnishing frequency of the tool head were kept constant, as in Fig.1 [2]. With this configuration, burnishing was only possible at 0° TMA, while a higher TMA resulted in deteriorated surfaces.

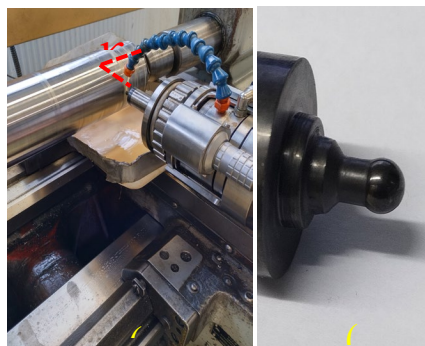
Fig. 2. Burnishing equipment: (a) tangential misalignment angle (TMA)  $\kappa$ , (b) carbon coated tool head.

HIQUSA ultrasonic burnishing equipment was used to burnish a workpiece manufactured from a corrosion resistant-tool steel with an initial hardness of 385 HV. As shown in Fig.2, ultrasonic burnishing was performed on the stainless steel, commercially available as Corrax. The workpiece was pre-machined from a diameter of 90 mm to 88 mm, with a length of 500 mm. The designations and typical compositions of the test material used are shown in Table 1. The test material is well-suited for mould-making parts and it exhibits excellent resistance to corrosion [13].

Fig. 2, below, depicts both the HIQUSA ultra burnishing equipment used to undertake the burnishing process and the Tangential Misalignment Angle (TMA), kappa ( $\kappa$ ). TMA is defined as

the angle formed between the burnishing tool axis and axis of the shaft. For the tool oriented 90° to the shaft, TMA is considered as 0 and it can increase on either side - hence positive and negative TMA are possible. It is important to study TMAs, since in burnishing process, one semi-spherical (burnishing tool) and a cylindrical surface get in contact with each other and double curved surfaces [2] could form. Beside the possible effect on cylindricity, surface roughness can be vary significantly [2].

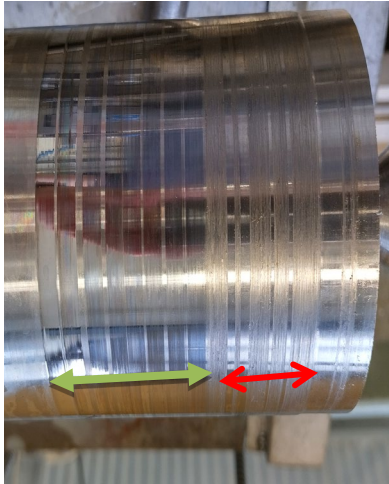
The test material surface after burnishing is shown in Fig. 3. The surface finish differences between the burnished surfaces produced by the Ta-C hard carbon coated tool (green) and the wolfram carbide tool (red) can be easily distinguished. This demonstrates that tool material and coating significantly affects the surface finish.

*Fig. 3. Surface with carbon coated tool head (green arrow) and a wolfram tungsten carbide (red arrow).*

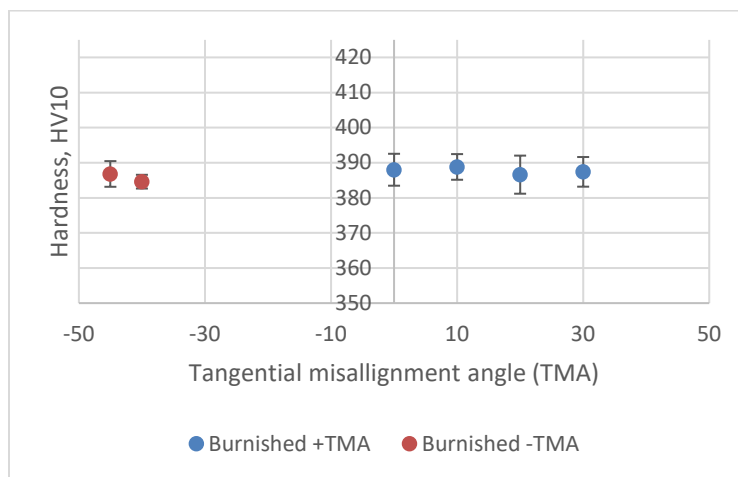
The use of coated tools during burnishing, resulted in a rather uniform surface hardness with both positive and negative tangential misalignment angles (TMAs), implying that TMAs has exert no effect on surface hardness (Fig 4). This finding contrasts with the results for Stavax (a stainless steel with a different composition from Corrax) where surface hardness increased (1.5-3.6%) compared to a machined but unburnished surface. This effect could be associated with material behaviour or the use of coated tools and therefore must be further investigated. However, ultrasonic burnishing has been found increase surface hardness by 6.8 % for 34CrNiMo4 steel [14].

*Fig. 4. Surface hardness measured on the Rockwell HRC scale for various test-material tangential misalignment angles.*

The hardness of the machined (after the turning operation) shaft prior to burnishing was measured as 385 on the HV10 scale  $\pm 15$ . The same value is 41 on the Rockwell C scale (HRC), which is comparable to the as-supplied hardness value provided by the manufacturer of Corrax [13].

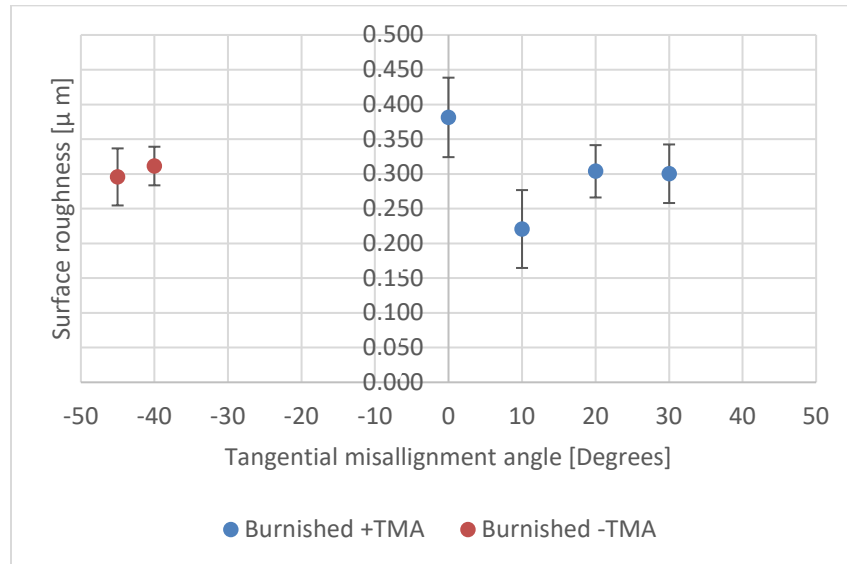
For purposes of comparison, the surface roughness of an unburnished and machined (turning only) surface was measured as 1.6  $\mu\text{m}$ . Surface roughness appeared to be affected by changing TMAs, where 0 degrees yielded a rough surface compared to higher TMAs. The increase in surface roughness compared to the machined surface was a minimum of 80% and maximum of 86%, which is an extremely positive influence. Overall, surface roughness, which reflects superior surface quality, improved significantly compared to the machined surface. This result is comparable to the burnishing of Stavax [2]. Fig 5 demonstrates the significant improvement in surface roughness achieved by using the coated tool. These findings are also in accordance those reported in the literature on the effect of burnishing on surface quality [2,7].

Fig. 5. Surface roughness of Corrax material (Ra).
