11th Nordic Symposium on Building Physics, NSB2017, 11-14 June 2017, Trondheim, Norway

The effect of positive pressure on indoor air quality in a deeply renovated school building – a case study

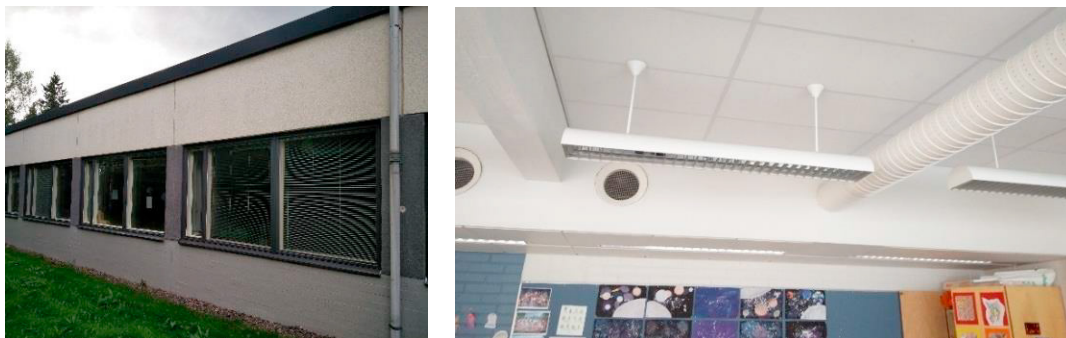
Fig. 1. (a) Studied building part; (b) A typical supply air duct diffuser and an extract air grille in a classroom.

The school was built in 1968 and fully renovated 2003-2005. It has a mechanical supply and exhaust ventilation system with heat recovery. The mechanical ventilation system in all classrooms and corridors was installed in 2002. Each classroom has 2-3 supply air duct diffusers and 1-2 extract air grilles. Air flow rates are adjusted by dampers in the main air handling unit and with regulation and measuring devices connected to each terminal device. The studied section of the building as seen from the outside, and the typical supply and extract terminal units of a classroom in the section are shown in Fig. 1a and 1b.

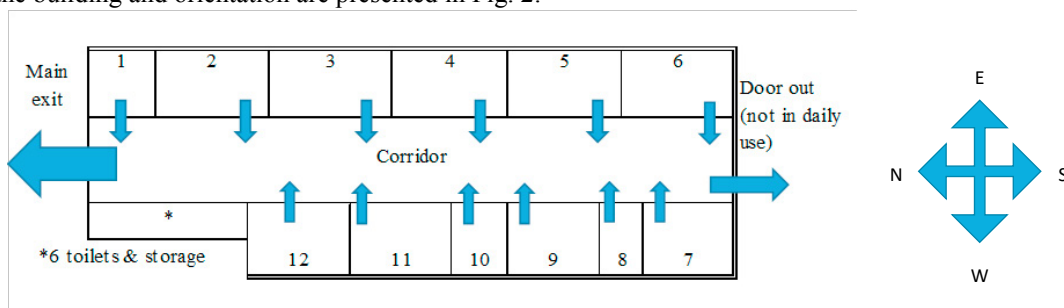
Fig. 2. Layout of the studied building part, exits and orientation. Outer walls are marked with double line.

In the set up a small 5-7 Pa positive pressure was generated to prevent both a potential infiltration of harmful agents and a strong exfiltration of indoor air. The studied part of the building consisted of 12 classrooms, 1 corridor, 6 toilets and a cleaning storage area, and was served by one air handling unit. Most of the classrooms are occupied by approx. 20-25 humans for a few hours per day during the normal school week. It was possible to establish positive pressure in this building by a simple fan speed control frequency adjustment in the air handling unit. The layout of the studied part of the building and orientation are presented in Fig. 2.

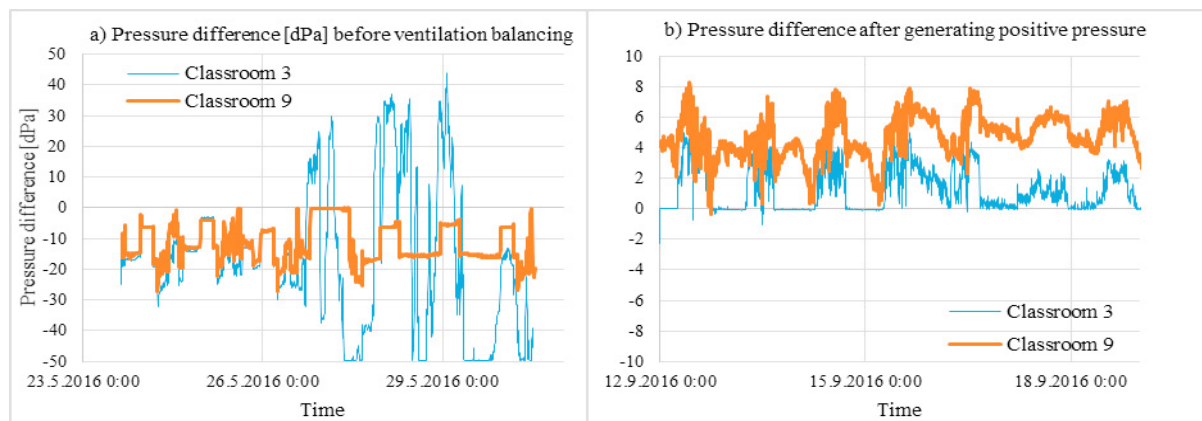
Fig. 3. Pressure differences (indoor-outdoor) in classrooms 3 and 9: (a) before ventilation system balancing and (b) after ventilation system balancing and generating positive pressure.

Pressure difference across the building envelope was measured continuously for one week before the ventilation system balancing and after generating the positive pressure in classrooms 3 and 9. Results are shown in Fig. 3. Before the ventilation balancing, pressure differences fluctuated within a large range during a one week period, and both measured rooms were at a significant level of negative pressure. It should be noted that the prolonged readings of -50 Pa could also be caused by mistreating the measurement devices in classroom 3. After balancing, the pressure differences across the envelope were stable and moderately positive.

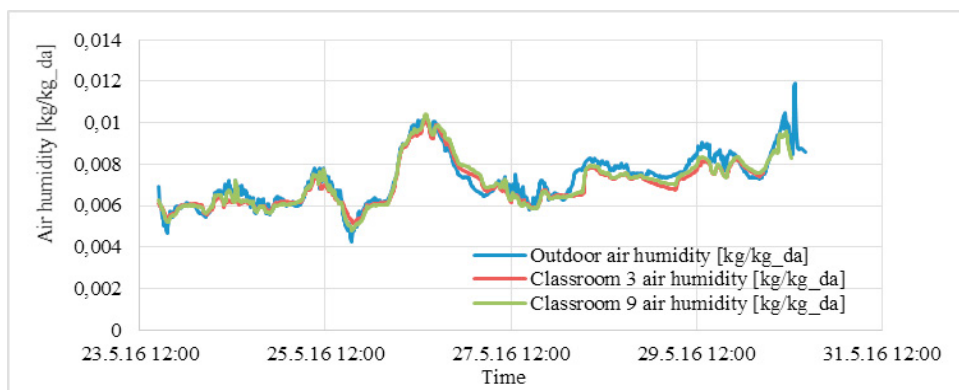
Fig. 4. Air humidity (kg per kg of dry air) in classrooms 3 and 9 and outdoors.

Indoor air moisture excess was studied via the humidity of indoor and outdoor air (Fig. 4). Humidity was calculated based on the measured T and RH [5]. The total atmospheric pressure was assumed to be 101325 Pa. Fluctuations were minimal and even slightly negative moisture excess values were measured. Based on these results, humidity generation by occupants was not substantial and no risk of moisture condensation during positive pressure was shown. A longer measurement period is needed to determine typical moisture excess values to assess the condensation risk.
