Seppänen, Olli; Xiao, Yu; Khalid Masood, Mustafa; Byvshev, Petr; Pham, Truong; Aikala, Antti; Lundström, Pontus
Reality Capture (RECAP) project final report

Reality Capture (RECAP) project final report

30.1.2020

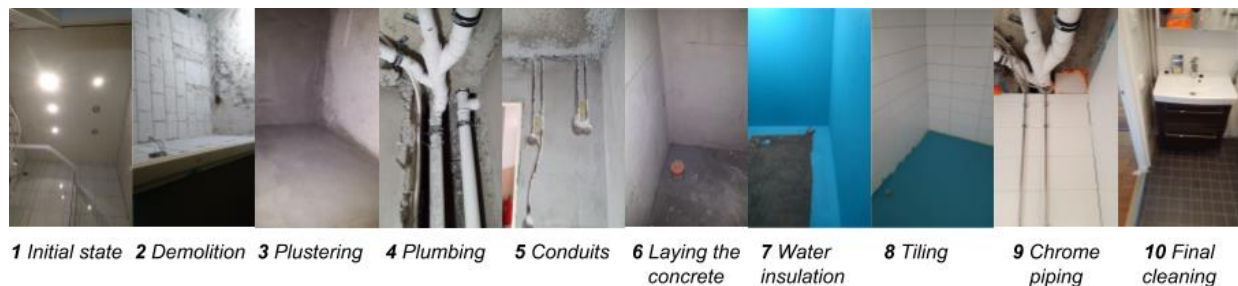
Fig.3. Example photos of 10 stages of bathroom innovation.

The Reno-2018 dataset consists of two parts: bathroom photos and kitchen photos, each covering a different renovation process. The bathroom part is composed of photos, taken from 7 bathrooms at 10 different renovation stages. The kitchen part covers 8 renovation stages observed in 6 kitchens. All photos were taken during February-March of 2018. Samsung SM-G920F mobile camera (resolution 5312×2988) and Sony E6653 (resolution 3840×2160) were used to take photos. The photos were labeled by

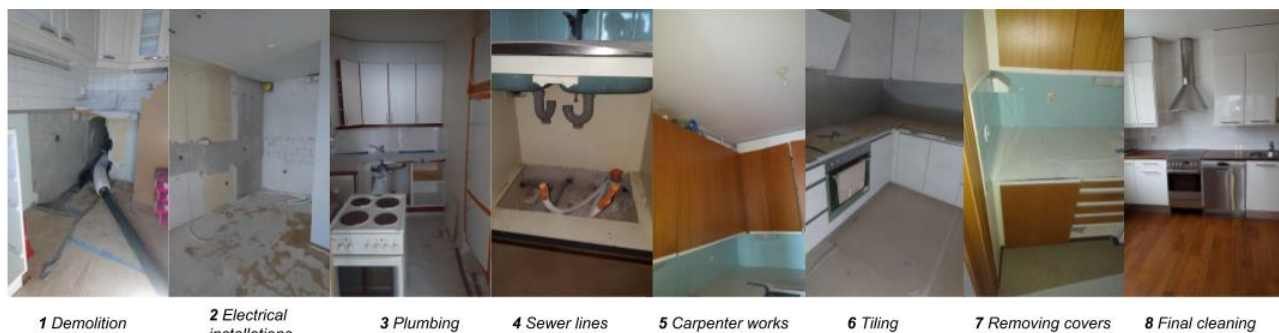
Fig.4. Example photos of 8 stages of kitchen innovation.

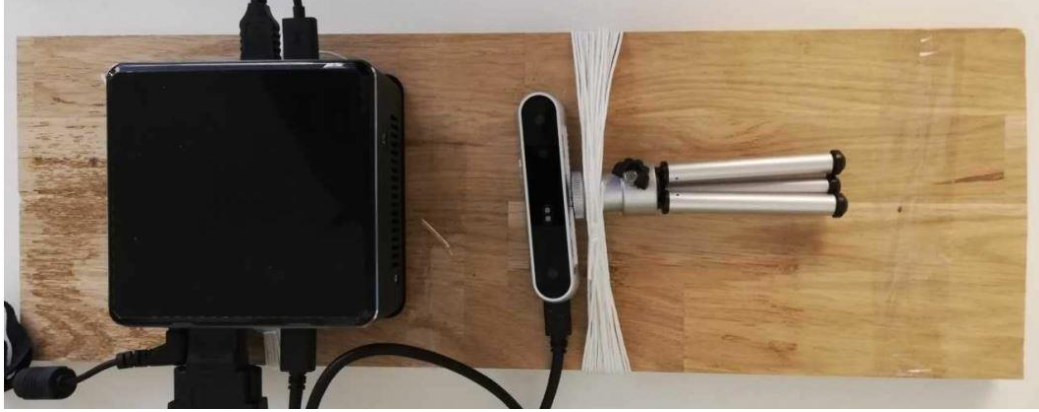
Figure 12: The mini-PC and camera installed in the factory

The camera system includes a mini PC for taking captured photos from camera and a depth camera for capturing photos in the factory (Figure 12). The camera was setup on a ceiling-mounted crane so that when the crane moved in the factory, the camera would be correctly positioned to take pictures of the element station (Figure 13).

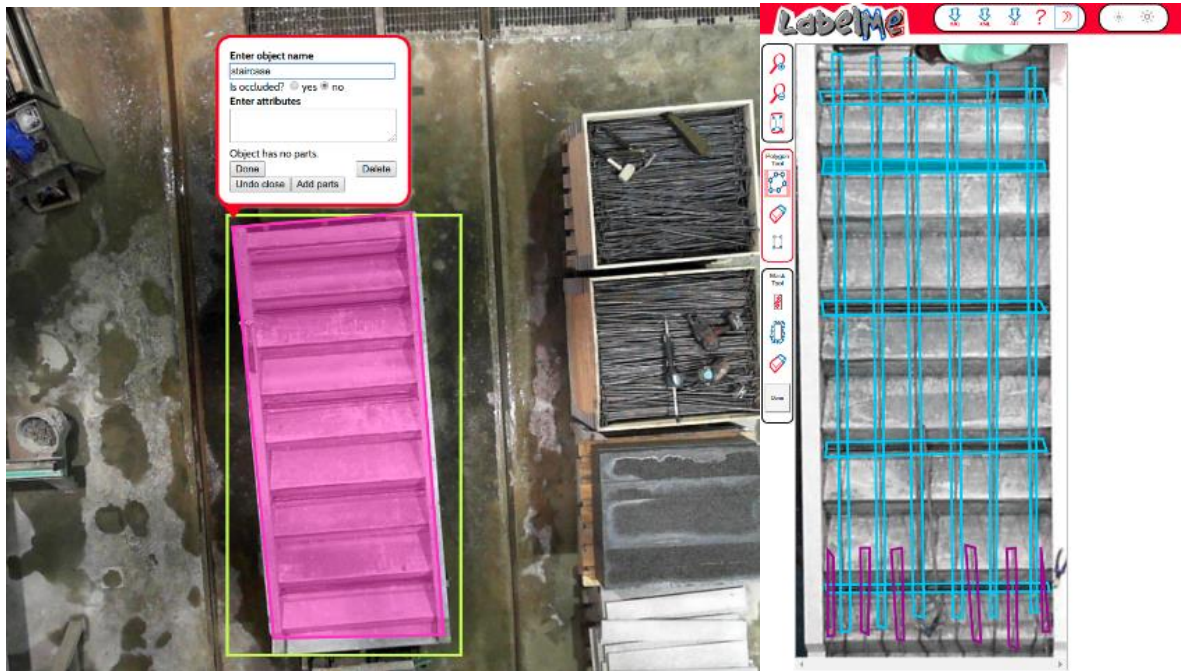
Figure 15. Manual labeling the data. The left image shows the way we labeled the staircase in the image. The right image shows the rebars labeling output.

We labeled manually 670 photos with a localized staircase and then labeled the rebars as illustrated in Figure 15. Three types of rebars, including A1-A2-MODIX , X5-Y7 and U3, are illustrated shown in Figure 16.
